ROUTINE AND FRACTURE CRITICAL BRIDGE INSPECTION REPORT

**BRIDGE # 2019-ANDROSCOGGIN RIVER BRIDGE
NORTH MAIN STREET OVER ANDROSCOGGIN RIVER
PERU, OXFORD COUNTY
MAINE DOT REGION 3 (WESTERN)**

**Start Date of Inspection: 08/09/2012
Finish Date of Inspection: 08/14/2012**

**Prepared For
Maine Department of
Transportation
Bridge Maintenance Division**

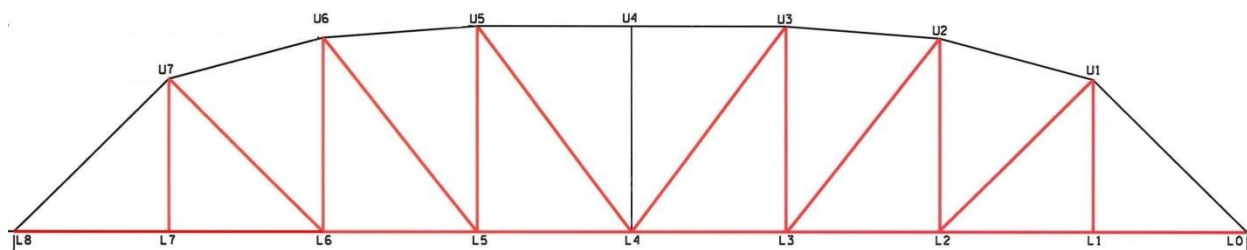
Truss diagram showing Panel Point numbering system

Fracture Critical tension Members shown in **Bolded Red** linestyle (per original contract plan design loads)

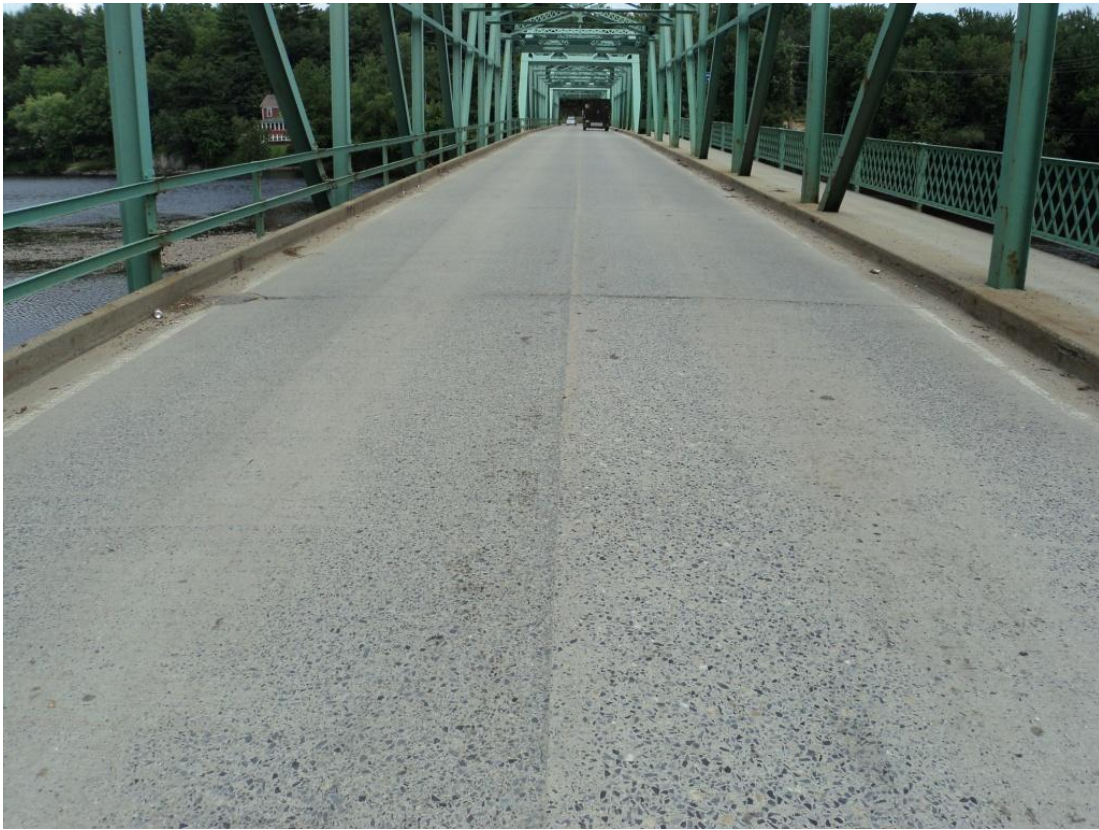
4. There are substandard steel bridge traffic railings connected to the inner faces of the truss verticals and diagonals along the roadway truss line (Photos 3 & 4). The

traffic railings have impact damage at several locations, damaged or missing bolts at several locations, and are generally in poor condition with missing paint and active corrosion throughout. The steel bar lattice bicycle/pedestrian railing at the outboard edge of the sidewalk is also substandard (Photos 3 & 4).

Photo 3 – General top of deck, looking north in Span 3 from the south abutment.

Recommendation: Replace the steel bridge and sidewalk bicycle/pedestrian railings with new railings which meet current safety standards and criteria.

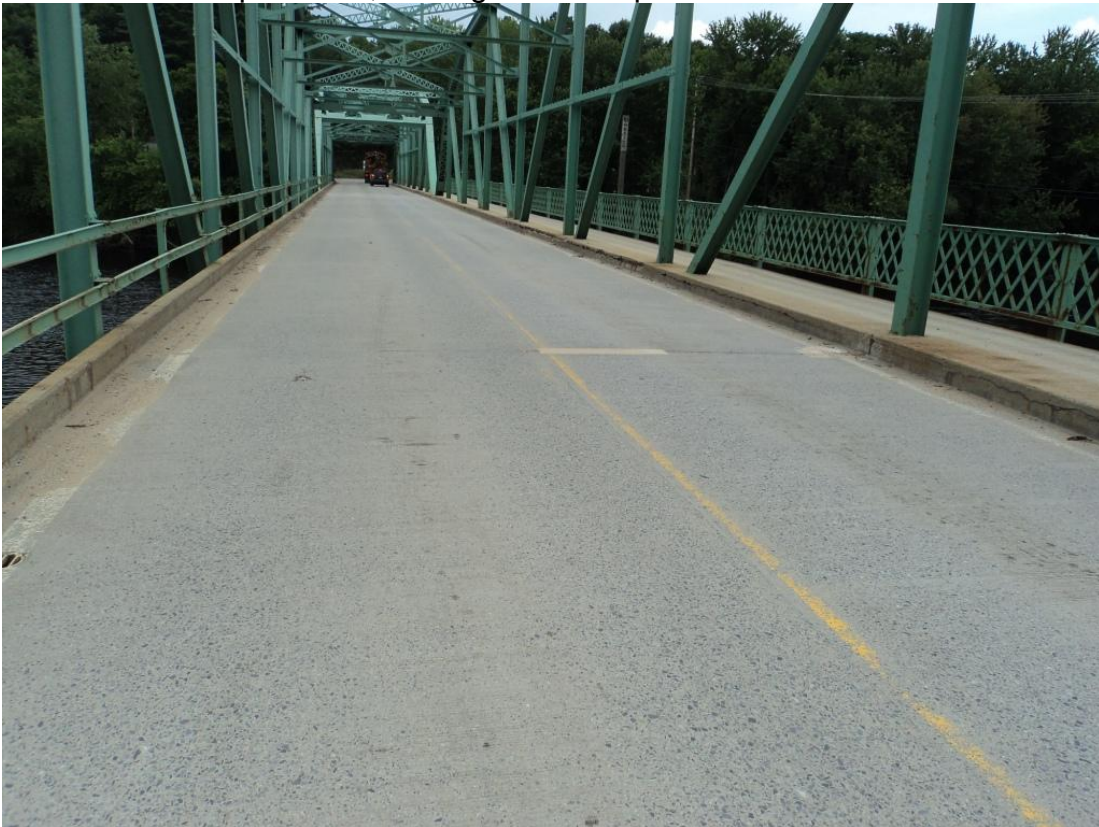
Photo 4 – Top of deck, looking north from above the south pier (Pier 2).

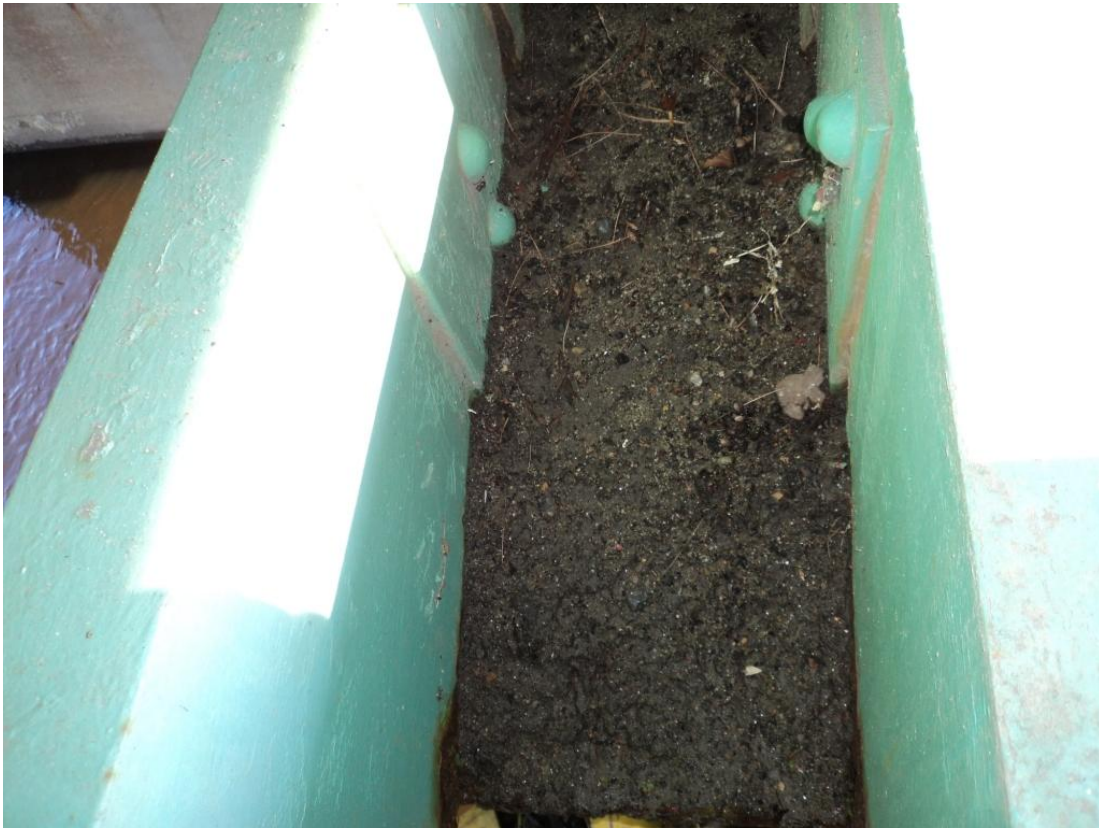
7. The Span 3 L1-L2 sidewalk truss has up to 8 inch deep debris accumulations between the side channels on the top of the L1 lower tie plate (Photo 31). The Span 3 sidewalk truss at L2 has 9-12 inch deep debris accumulations between the side channels on the lower lateral connection plate (Photo 32). Similar heavy debris accumulations were observed at L6 and L7 in Span 3 with 12 inch and 8 inch depths, respectively.

Photo 31 – The Span 3 L1-L2 sidewalk truss has up to 8 inch deep debris accumulations between the side channels on the top of the L1 lower tie plate.

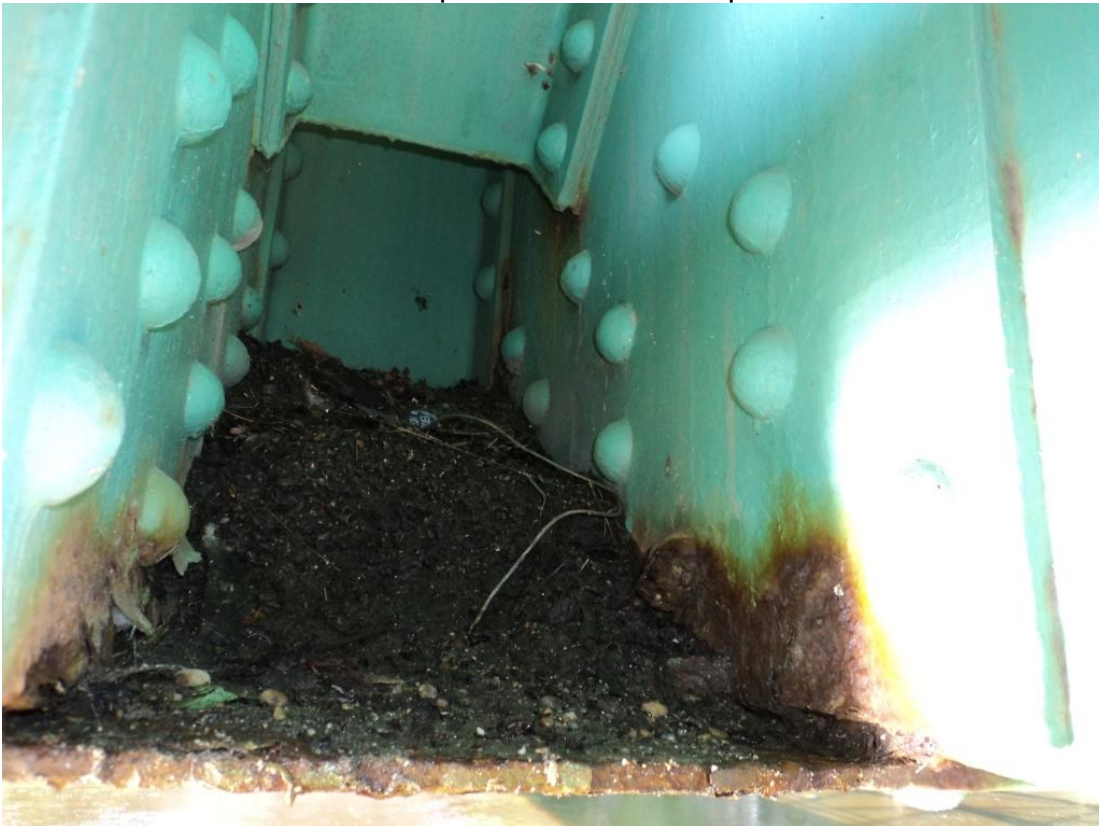
Photo 32 – The Span 3 sidewalk truss at L2 has 9-12 inch deep debris accumulations between the side channels on the lower lateral connection plate.

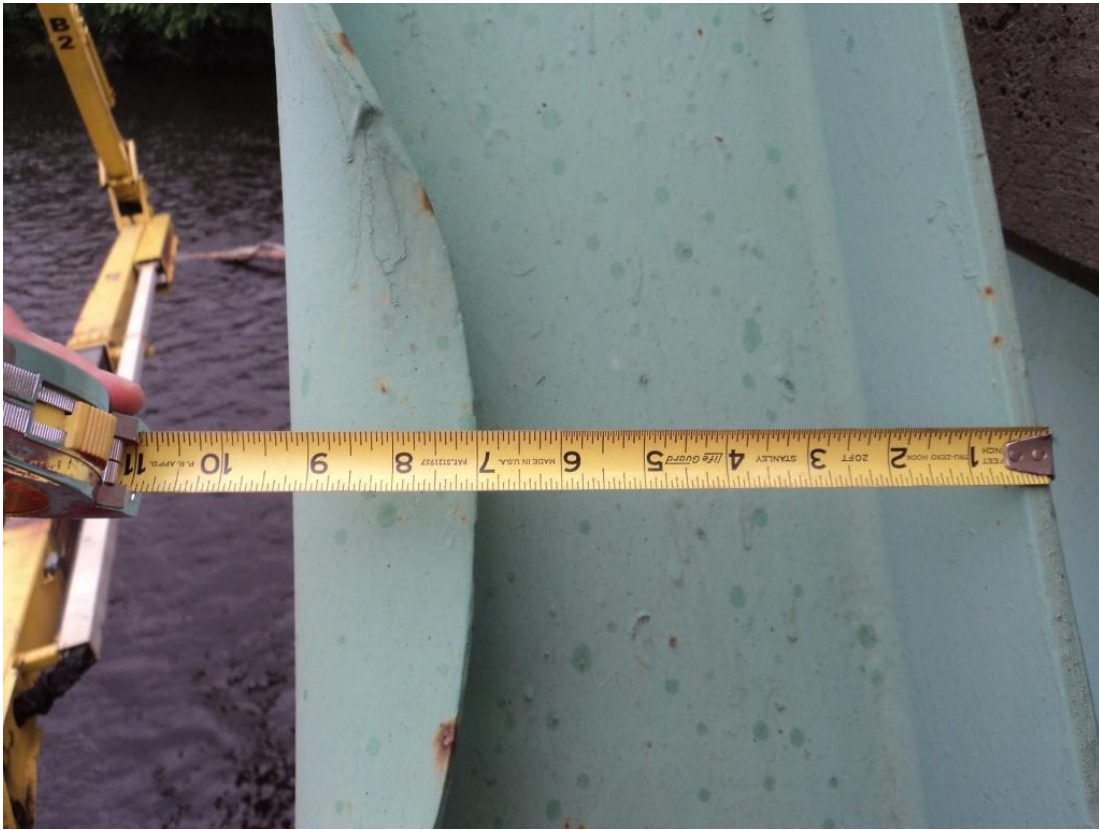
At L3 in the Span 2 roadway truss the vertical and diagonal have sustained damage at 2 feet above the lower chord, which has caused localized twisting of the flanges over a one foot length in each member (Photo 36). The west flange of the diagonal U2-L3 is permanently deformed and bent inward by 2-1/2 inches (Photo 37). The west flange of the vertical U3-L3 is permanently deformed and bent outward by 1-1/2 inches (Photo 38). The most likely cause for this damage is large floating debris during a high water event, such as a trapped tree branch getting lodged between the two members.

Photo 37 – The west flange of the Span 2 roadway truss diagonal U2-L3 is permanently deformed and bent inward by 2-1/2 inches. Looking north.

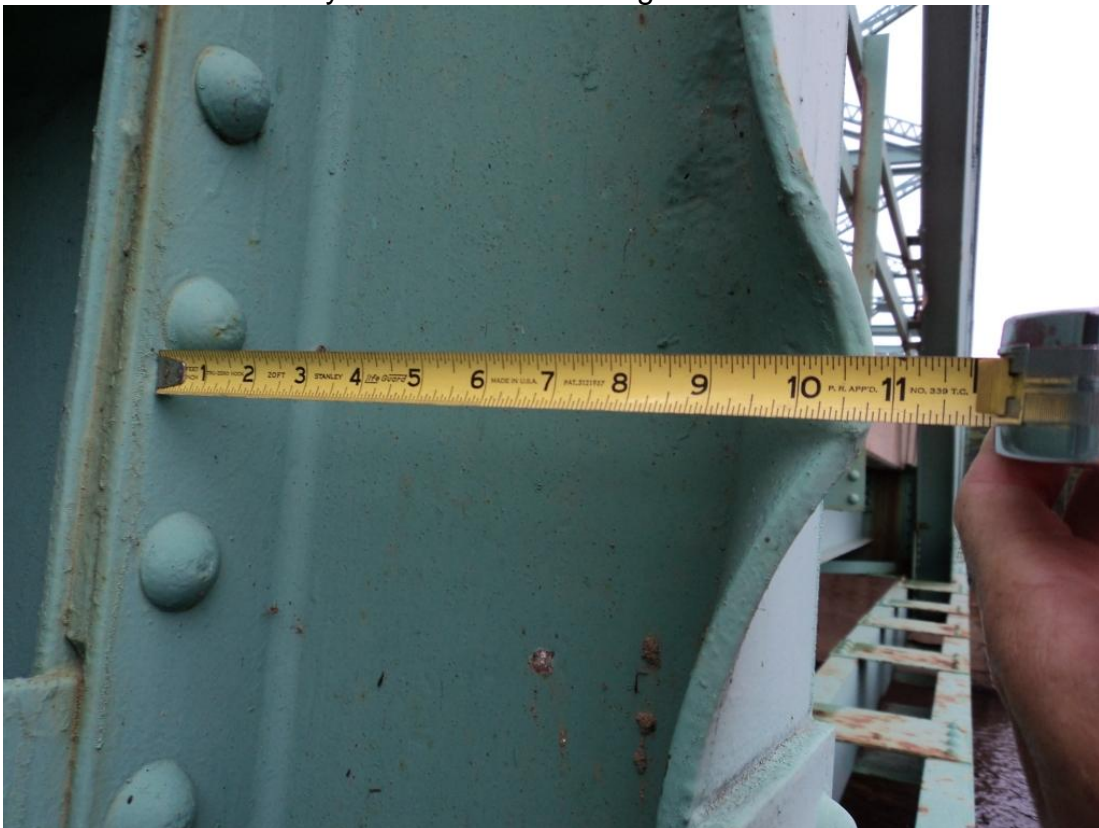
Photo 38 – The west flange of the Span 2 roadway truss vertical U3-L3 is permanently deformed and bent outward by 1-1/2 inches. Looking south.

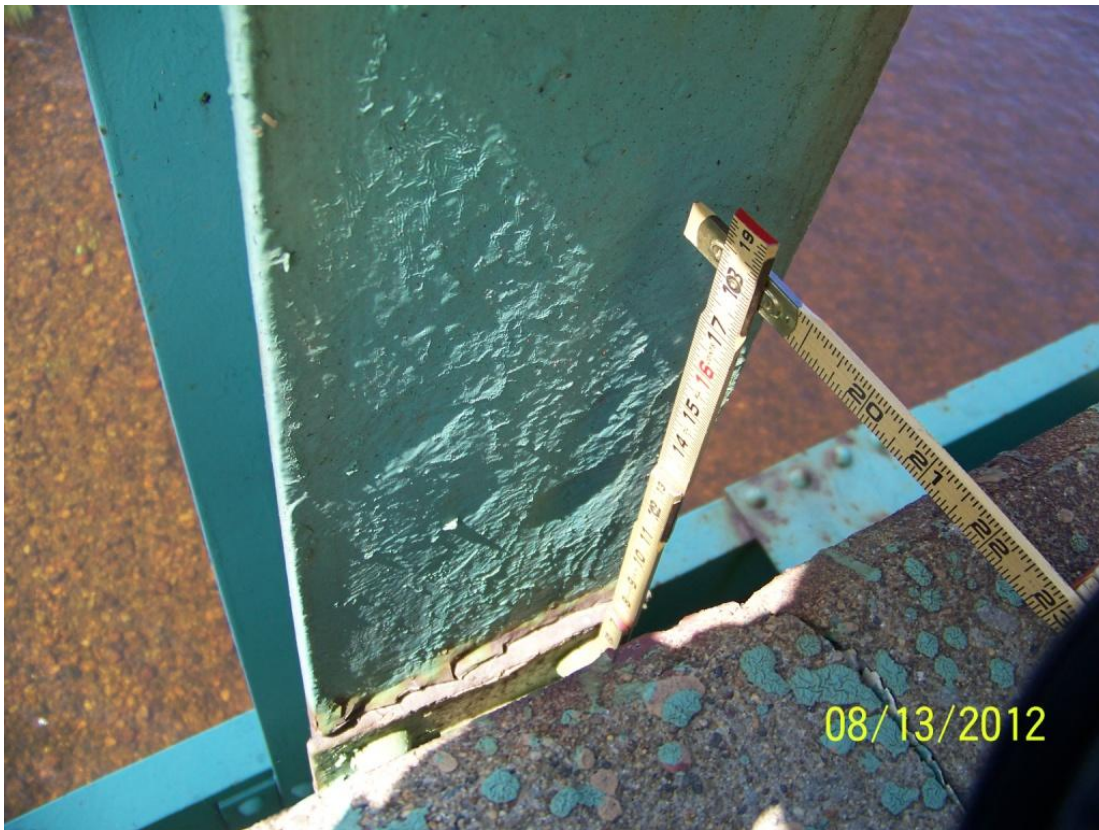
Photo 39 – The Span 2 roadway truss U7-L7 vertical has section loss on east face of flange up to 3/16 inch deep and 2 inches wide located a foot above top of the floorbeam.

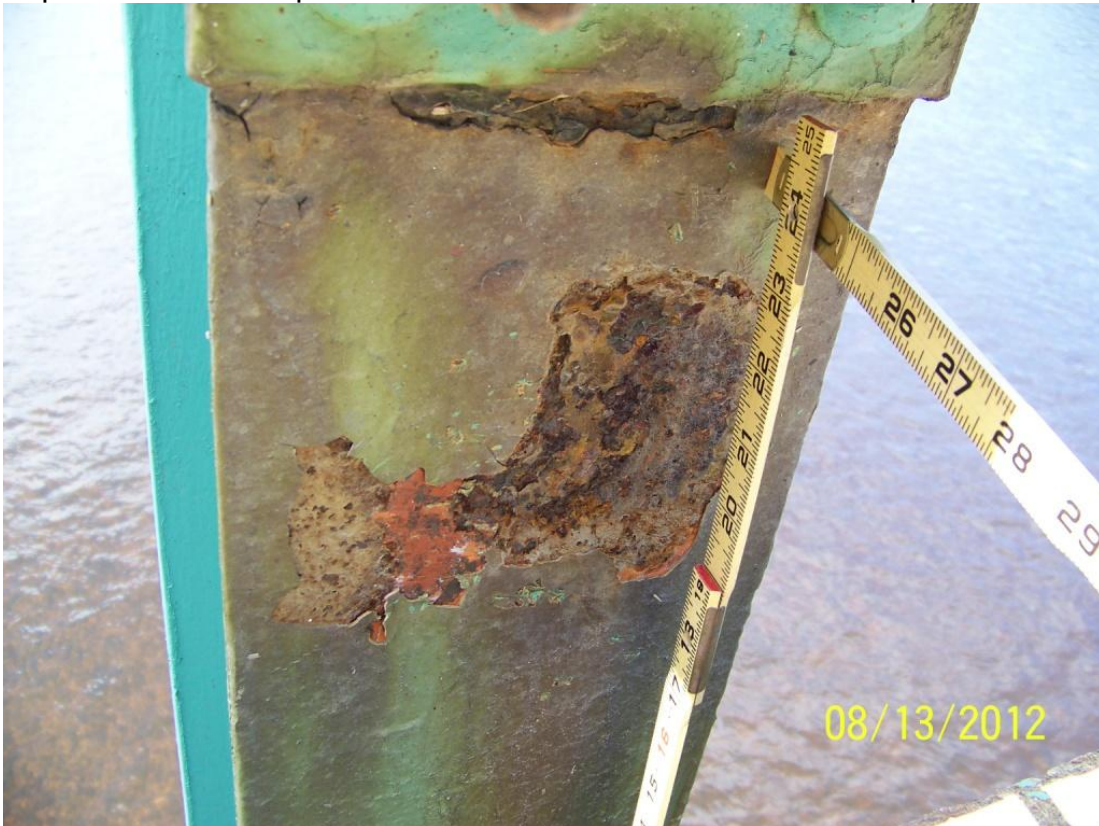
Photo 40 – Span 2 roadway truss U6-L6 vertical has section loss on east face of flange up to 1/4 inch deep and 4 1/2 inches wide located two feet above top of floorbeam.

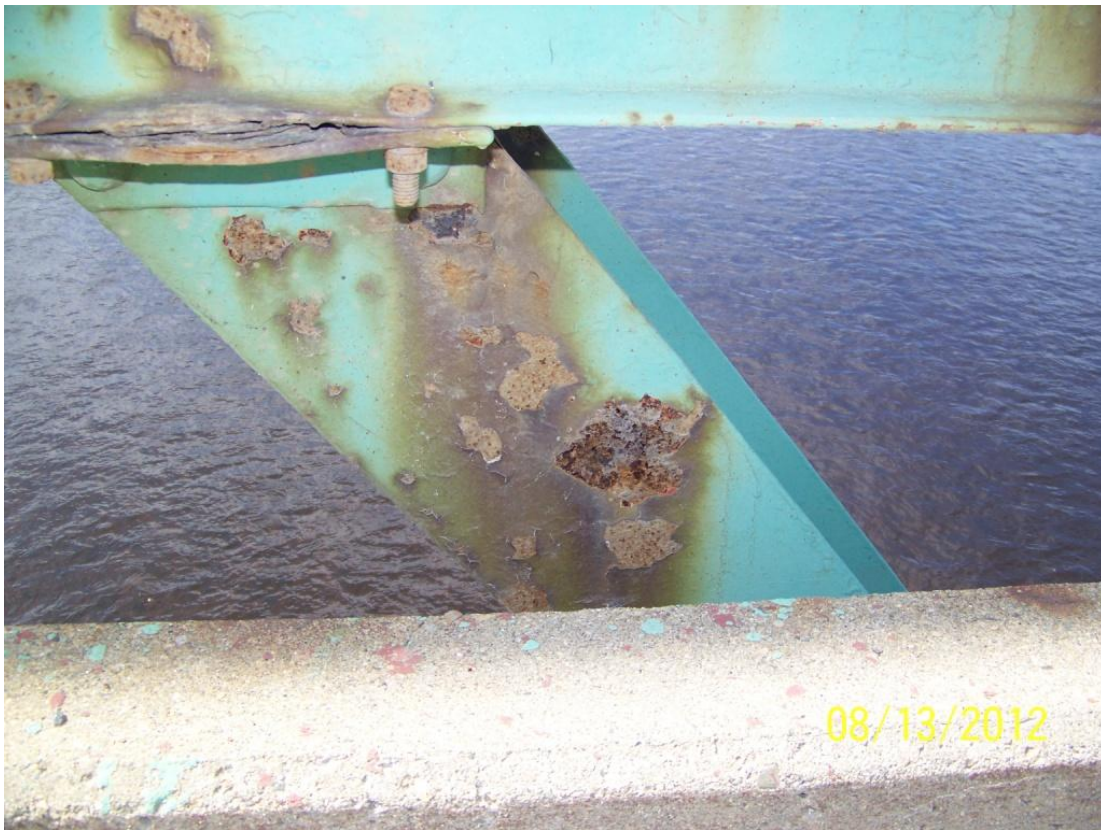
Photo 41 – Span 2 roadway truss L5-U6 diagonal has section loss on the east face of the flange up to 3/16 inch deep and 4 inches wide located at top of curb level.

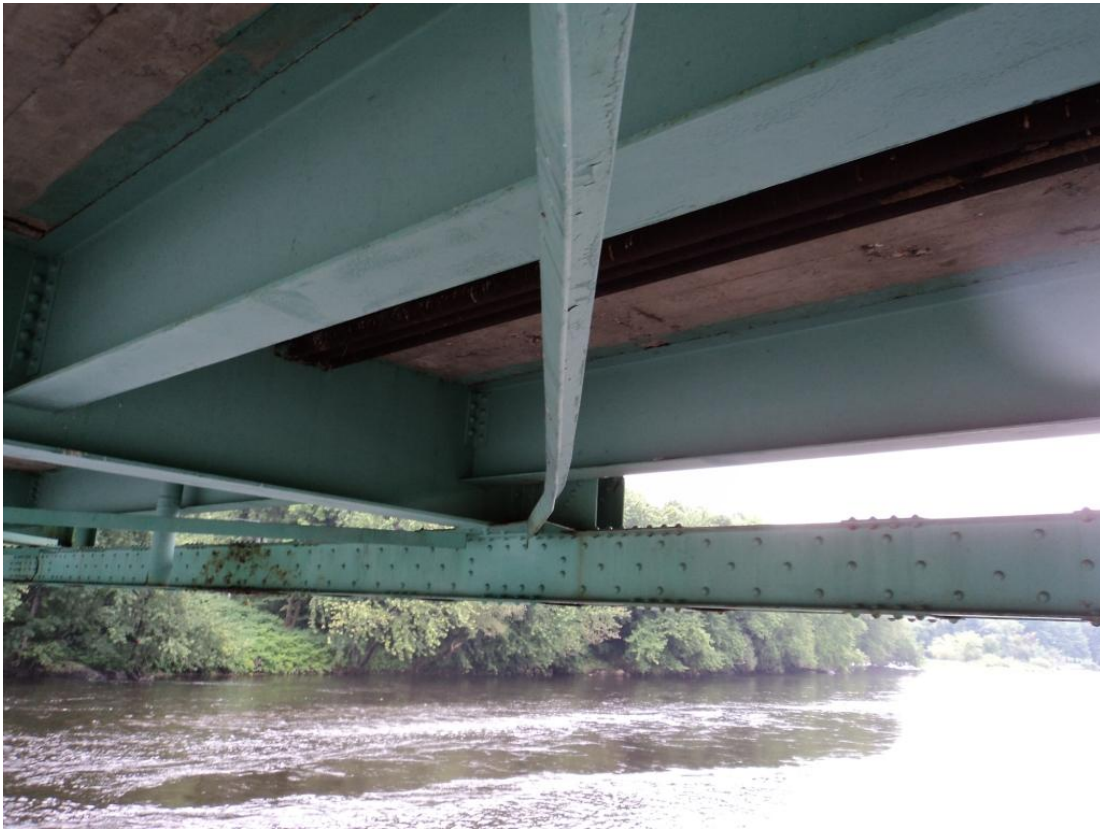
The lower lateral bracing angle in Span 2 connecting the FB1 sidewalk truss and FB2 roadway truss is displaced laterally in the horizontal plane by 4 inches (Photo 50). The lower lateral bracing angle in Span 2 connecting FB4 sidewalk truss and FB5 roadway truss is displaced laterally in the horizontal plane by 6 inches (Photo 59). The lower lateral bracing angle in Span 3 connecting the FB1 sidewalk truss and FB2 roadway truss is displaced laterally in the horizontal plane by 6 inches. The lower lateral bracing

Photo 59 – The lower lateral bracing angle in Span 2 connecting FB4 sidewalk truss and FB5 roadway truss is displaced laterally in the horizontal plane by 6 inches.

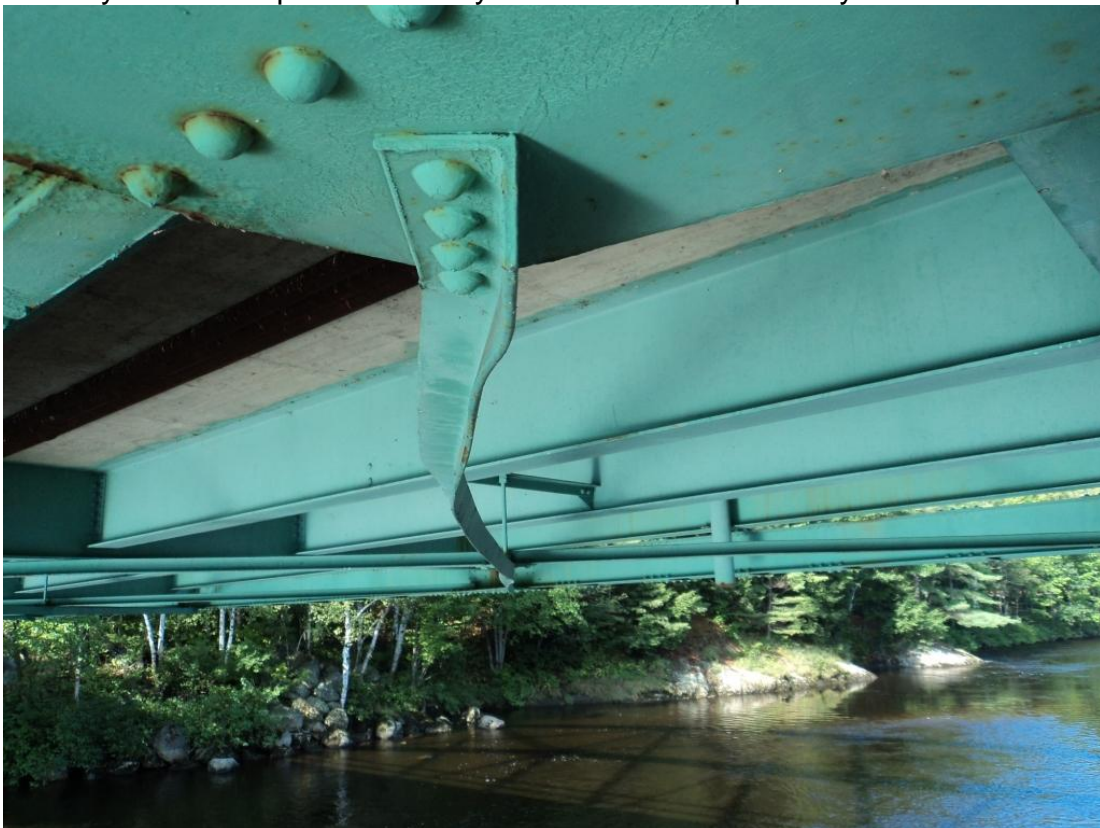
angle in Span 3 connecting the FB2 sidewalk truss and FB3 roadway truss is displaced laterally in the horizontal plane by 4 inches. The lower lateral bracing angle in Span 3 connecting the FB3 sidewalk truss and FB4 roadway truss is displaced laterally in the horizontal plane by 9 inches (Photo 60). The most likely cause of lateral displacement of the lower lateral bracing angles is impact damage from large floating debris during a high water event, such as tree limbs. The direction of the displacements was confirmed to be consistent with the downstream waterway direction in all instances. Vertical displacement of approximately six inches was observed in the lower lateral bracing angle in Span 3 connecting the FB5 sidewalk truss and FB6 roadway truss.

Photo 60 – The lower lateral bracing angle in Span 3 connecting the FB3 sidewalk truss and FB4 roadway truss is displaced laterally in the horizontal plane by 9 inches.

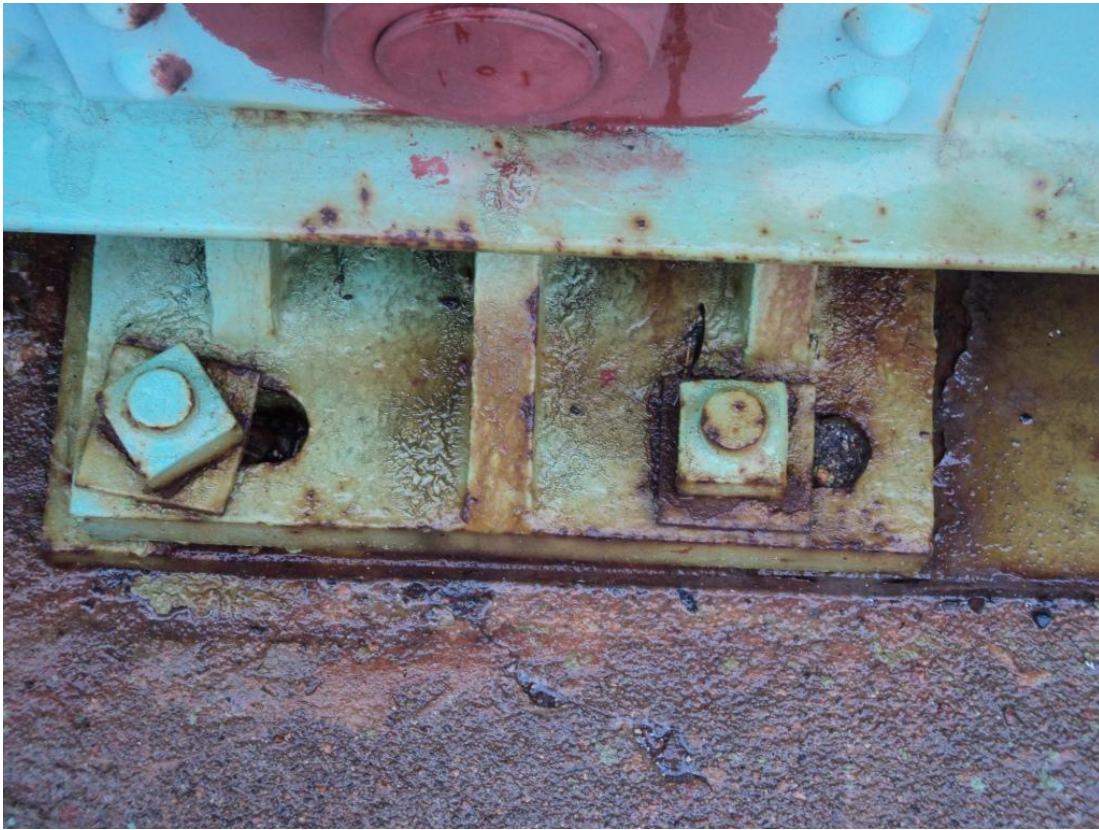
13. The Span 1 roadway truss expansion bearing at Pier 1 has debris accumulations filling the slot for the southwest anchor bolt, inhibiting free thermal movements (Photo 61). The south abutment expansion bearings have heavy 3-4 inch deep debris accumulations around the bearing and also completely filling the expansion slots and inhibiting free thermal movements (Photo 65).

Bearings: The Span 1 roadway truss expansion bearing at Pier 1 has debris accumulations filling the slot for the southwest anchor bolt, inhibiting free thermal movements (Photo 61).

Photo 61 – The Span 1 roadway truss expansion bearing at Pier 1 has debris accumulations filling the slot for the southwest anchor bolt, inhibiting free movements.

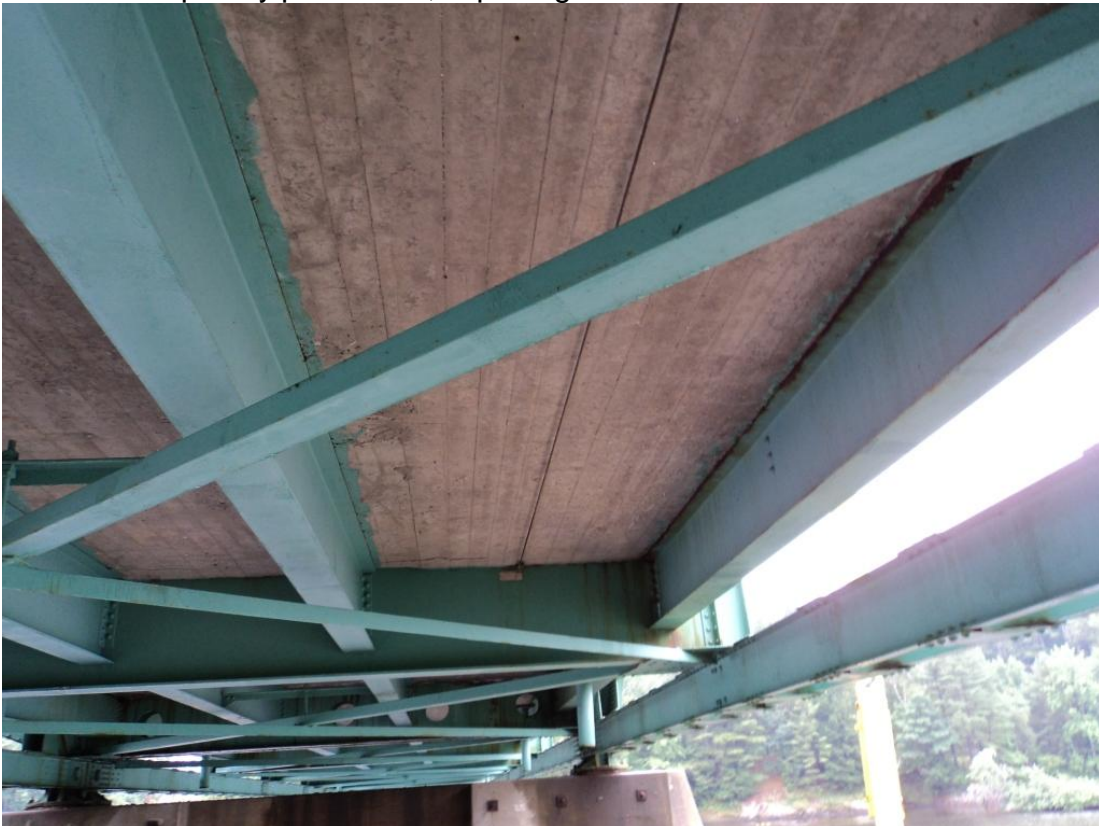
Between S5 and S6 in Span 1 there is an abandoned former messenger cable which extends over portions of the bridge length (Photo 78).

Photo 78 – Between S5 and S6 in Span 1 there is an abandoned former messenger cable which extends over portions of the bridge length. Looking south.
