**QUALITATIVE HABITAT EVALUATION INDEX AND MACROINVERTEBRATE
SURVEY BASELINE REPORT
NORDIC AQUAFARMS INC. LAND-BASED AQUACULTURE FACILITY
285 NORTHPORT AVENUE
BELFAST, MAINE**

Project 171.05027.009
August 24, 2021

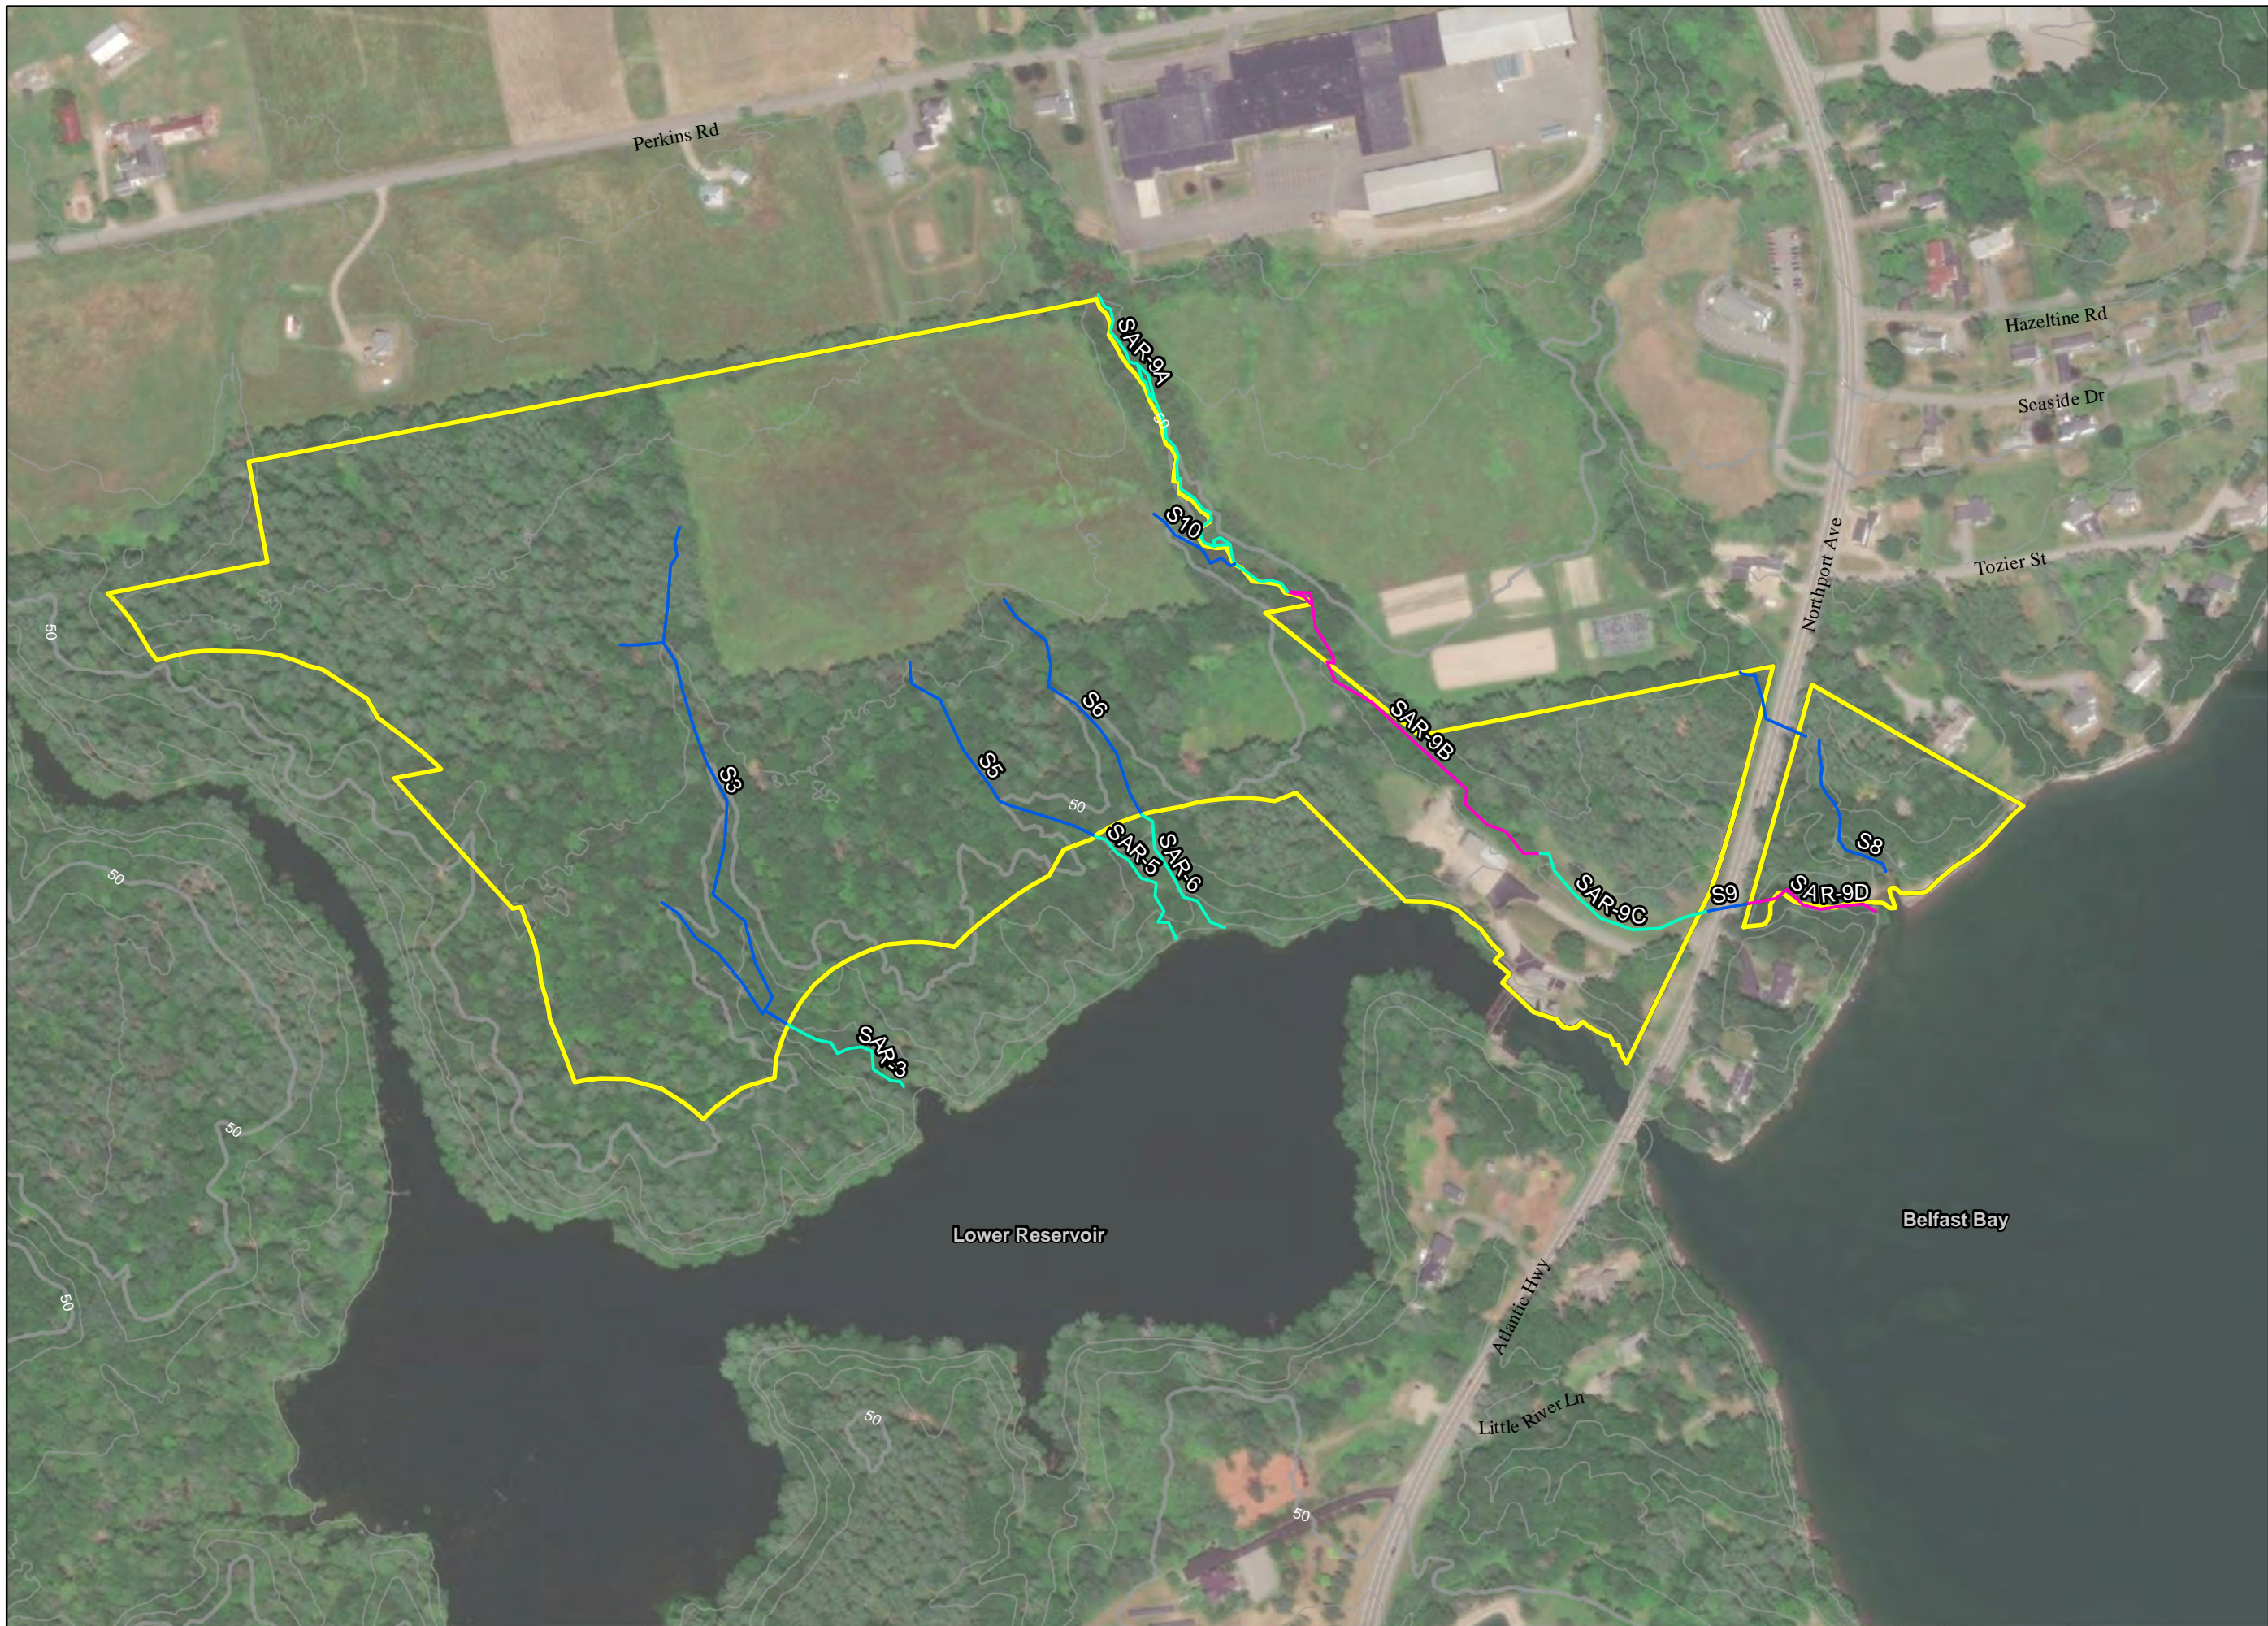
Figure 1
QHEI Stream
Assessment Reaches

Stream 6 was assessed from the southerly project boundary downstream to the stream’s outlet at Belfast Reservoir No. 1, for a length of approximately 280 feet (SAR-6 on Figure 1). Stream 6 is relatively narrow and much of the stream bed was dry or damp (no water observed) during the field visit. Photos 8 and 9 show Stream 6 at the upstream end of the reach and middle of the reach near the hiking trail, respectively. No flowing water was observed, although there were occasional pools of standing water (up to 2 inches deep). The stream substrate was primarily silt and gravel, although some cobbles, boulders, and a concrete culvert (see Photo 10) were also observed. Instream cover types observed at Stream 6 included overhanging vegetation and logs or woody debris. Due to the shallow water found in this stream, the instream cover types were assumed to provide limited habitat function. Some erosion was observed along the stream, particularly the right bank, and the riparian zone was moderately wide on the left bank but very narrow on the right bank, where the bank rises sharply to a higher forested ridge. Land use surrounding this stream reach is a mix of public and private and includes a hiking trail. Overall, Stream 6 is a small headwater stream with intermittent flow and, therefore, scored relatively low on several of the QHEI metrics. This stream reach had a total score of 34, which corresponds to a “poor” quality rating.

Stream 9, Reach A (SAR-9A) extends from the northerly project boundary downstream for a length of approximately 650 feet (Figure 1). This stream reach was characterized by a dense, overgrown riparian zone with old fields occurring beyond the riparian zone on both sides of the stream. Much of the stream bed was dry or damp (no water observed) during the field visit. No flowing water was observed, although there were scattered pools of standing water (up to 4 inches deep). The stream substrate was dominated by silt and cobble, with some gravel, boulders, and detritus also occurring in the stream bed. Instream cover types observed at SAR-9A included undercut banks, overhanging vegetation, boulders, and logs or woody debris. Due to the shallow water found in this stream, the instream cover types were assumed to provide limited habitat function. Moderate erosion was observed along the stream, and some riffle-like areas were noted but did not contain sufficient water depth or flow to qualify as true riffles. Photos 11 and 12 provide typical views of this stream reach. Overall, SAR-9A is a small-to-medium intermittent stream that scored relatively low on several of the QHEI metrics. This stream reach had a total score of 34, which corresponds to a “poor” quality rating.

Stream 9, Reach B (SAR-9B) extends from SAR-9A downstream for a length of approximately 680 feet (Figure 1). In comparison to SAR-9A, this stream reach had a less herbaceous, more wooded riparian corridor and forests extending beyond the riparian zone on one or both sides of the stream. Much of the stream bed was dry or damp (no water observed) during the field visit, although more pools were observed within this reach and contained standing water up to 10 inches deep. Little evidence of flowing water was observed, although some areas appeared to have flowing water (up to 1.5 inches deep). The stream substrate was dominated by silt and cobble, with some gravel, boulders, and detritus also occurring in the stream bed. Instream cover types observed at SAR-9B included overhanging vegetation, rootmats, and logs or woody debris. Moderate erosion was observed along the stream, and some riffle-like areas were noted but did not contain sufficient water depth or flow to qualify as true riffles. Photos 13 and 14 provide typical views of this stream reach. Overall, SAR-9B is a small-to-medium intermittent stream

Stream 9, Reach D (SAR-9D) extends from the existing culvert under Northport Avenue (Route 1) downstream and into the intertidal zone of the bay, a length of approximately 290 feet (Figure 1). This reach of Stream 9 (SAR-9D) is located in a forested area that also includes a few residences, and, unlike SAR-9C, does not appear to have a history of disturbance. Water was present throughout the stream reach and was typically less than 2 inches deep, although some areas contained up to 8 inches of water. Some small fish were observed in the deeper water of this stream. The stream substrate was dominated by cobble and gravel, with some silt, boulders, and detritus also occurring in the stream bed; this stream reach scored high on the substrate metric due to the predominance of higher quality substrate types. Instream cover types observed at SAR-9D included overhanging vegetation and logs or woody debris. Erosion was observed along the stream, particularly on the right bank, and some riffle-like areas were noted but did not contain sufficient water depth or flow to qualify as true riffles. This stream segment includes the portion of Stream 9 that enters the intertidal zone, where a rocky substrate and little instream cover were observed. Photos 17 and 18 provide typical views of this stream reach in the forested area, while Photo 19 shows the area where water flows into the cobble beach and intertidal zone of the bay. SAR-9D is a medium-sized intermittent stream that had a total score of 45.5, which corresponds to a “fair” quality rating. SAR-9D had the highest score of the stream reaches that were assessed for this report.
