UPPER AND LOWER LITTLE RIVER DAMS DAM ASSESSMENT REPORT

PREPARED FOR RANSOM CONSULTING, INC.

JULY 2018

WRIGHT-PIERCE

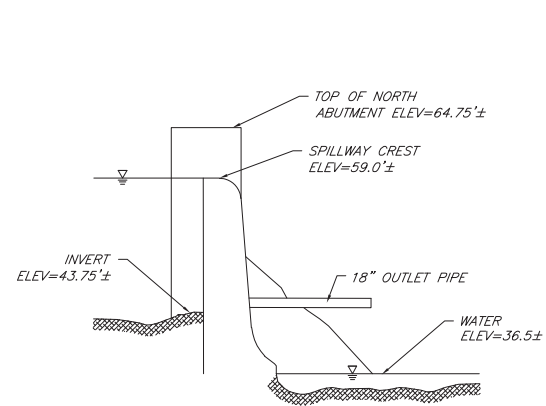
SECTION A
SCALE: 1"=10'
C-1

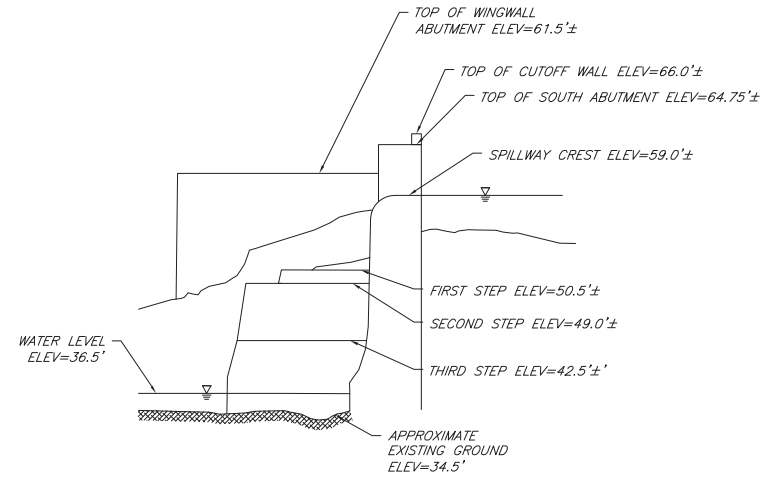
SECTION B
SCALE: 1"=10'
C-1

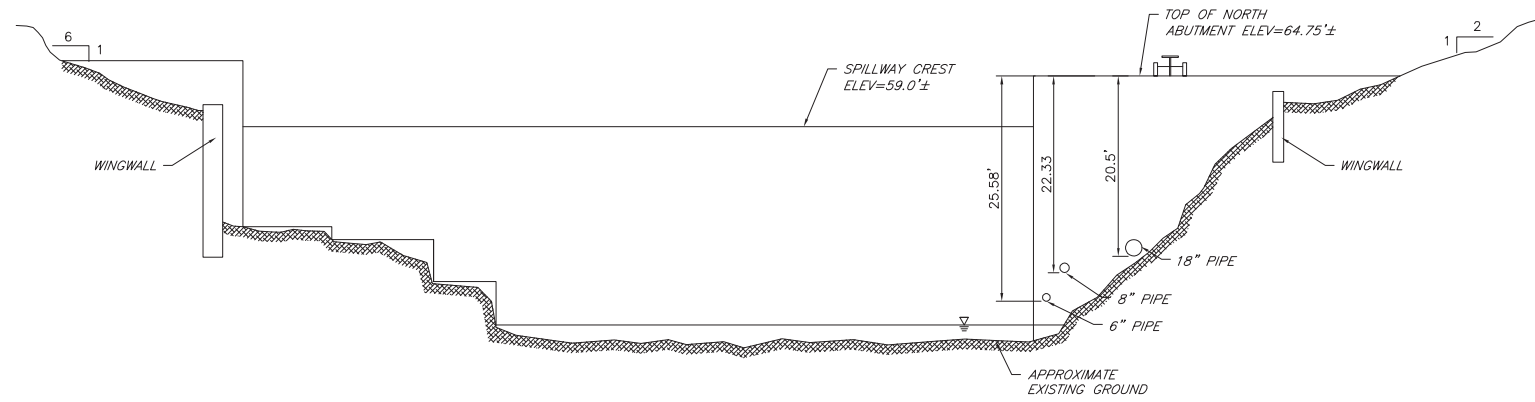
SECTION C
SCALE: 1"=10'
C-1

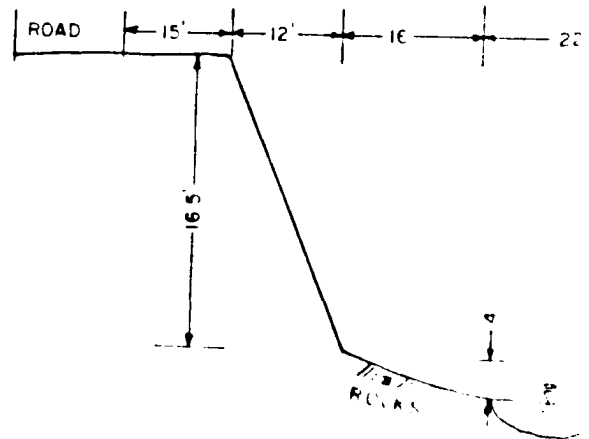
66.0' Top of Cut Off Wall
 64.9' Top of South Abutment
 59.0' M.S.L. Spillway Crest
 50.6' M.S.L. First Step
 49.1' M.S.L. Second Step
 2.5' M.S.L. Third Step
 5' M.S.L. Streambed

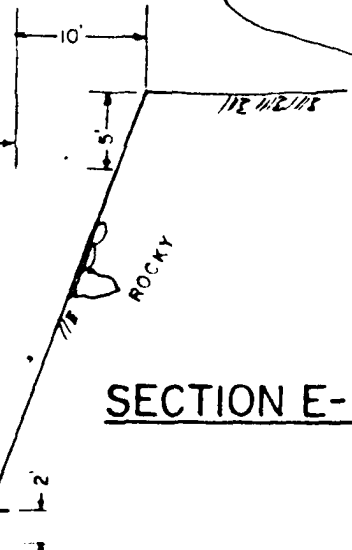
SECTION E-E

NOTE: ALL ELEVATIONS ARE BASED ON SPILLWAY CREST ASSUMED ELEVATION OF 59' M.S.L. DATUM (NGVD)

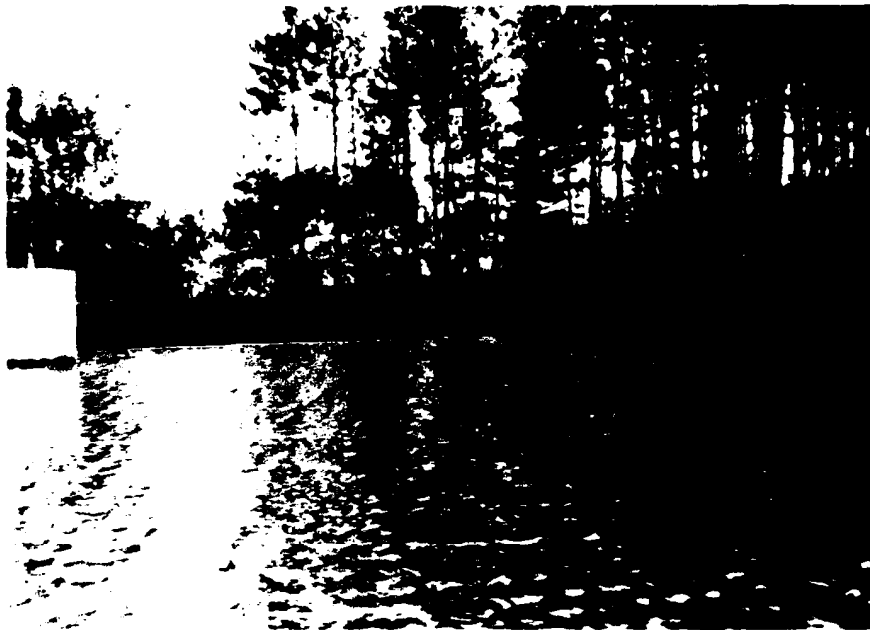
September 17, 1979
Figure 3 - View of upstream face of Little River
Upper Dam.

b. Dam. Little River Upper Dam is a concrete ogee shaped gravity dam 30 feet high (hydraulic), 216 feet long, and 3.0 feet wide at the crest, with a vertical upstream face and a downstream face battered at 1H:12V. (See Appendix C - Figures 2 and 3.) The central overflow spillway section of the dam is 114 feet long with a slight curved alignment. At the south end of the overflow spillway section there is a concrete training wall extending 22.8 feet downstream from the dam. Between this wall and the south abutment earth has been placed against the upstream and downstream faces of the concrete dam. At the north end of the spillway, there is a concrete intake structure, beyond which the dam extends to the north abutment. (See Appendix C - Figure 4.) Earth has been placed against the upstream and downstream faces of the concrete dam near the abutment. The ends of the dam where the concrete wall is flanked by earthfill on both the upstream and downstream sides are referred to as embankment sections in subsequent sections of this report and in the checklist. Bedrock exposures on the south side of the valley downstream of the dam show that that end of the dam is founded on bedrock. (See Appendix C - Figure 5.) Soil cover and brush growing on the north side of the valley make it impossible to determine visually whether that end of the dam is founded on bedrock.

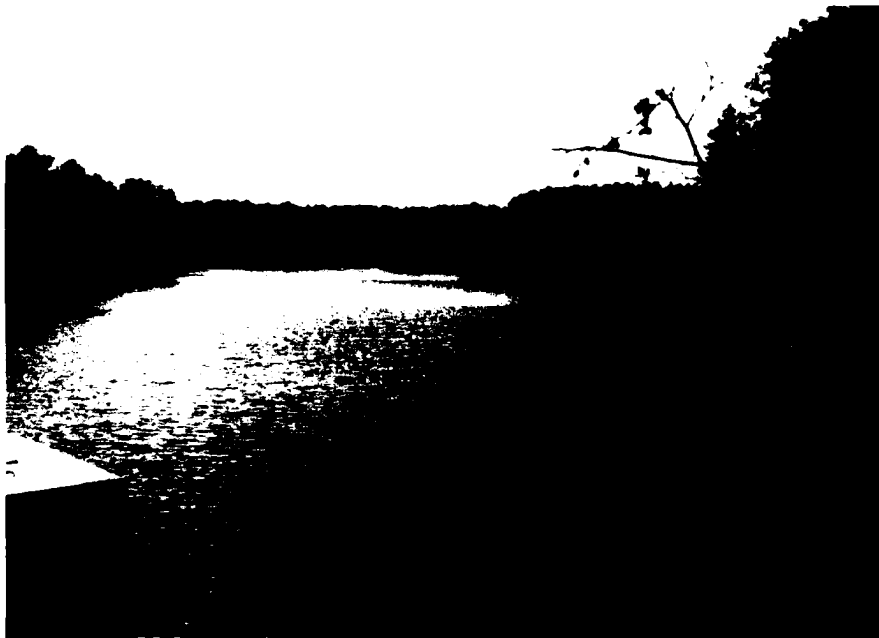
September 17, 1979
Figure 12 - Looking upstream at the reservoir from the
top of the north abutment.

d. Reservoir Area. The watershed above the reservoir is rolling and partially wooded. (See Appendix C - Figure 12.) No structures were observed on the shore of the reservoir. No evidence of significant sedimentation in the reservoir was observed.

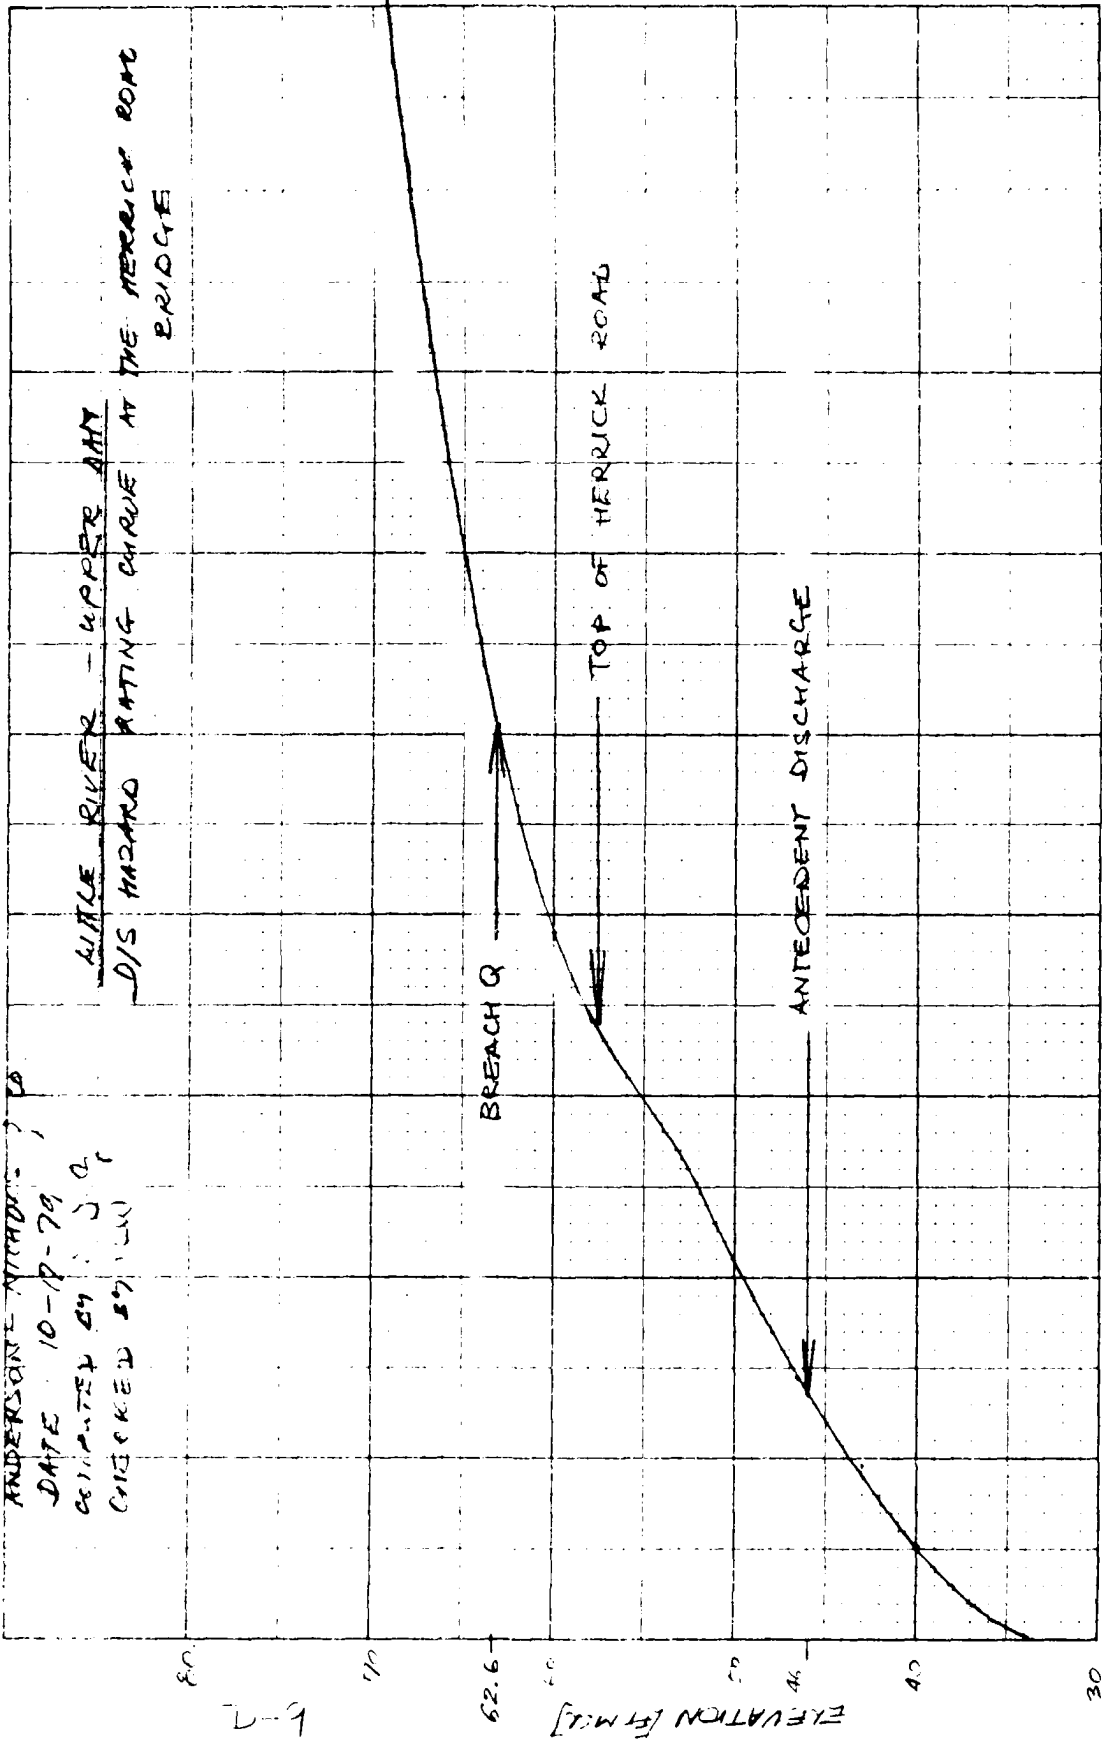
LAKE RIVER - UPPER ARM
 DISCHARGE CURVE AT THE HERRICK ROAD
 BRIDGE

4,000 8,000 12,000 16,000 20,000 24,000 28,000 32,000 36,000
 DISCHARGE [CFS]

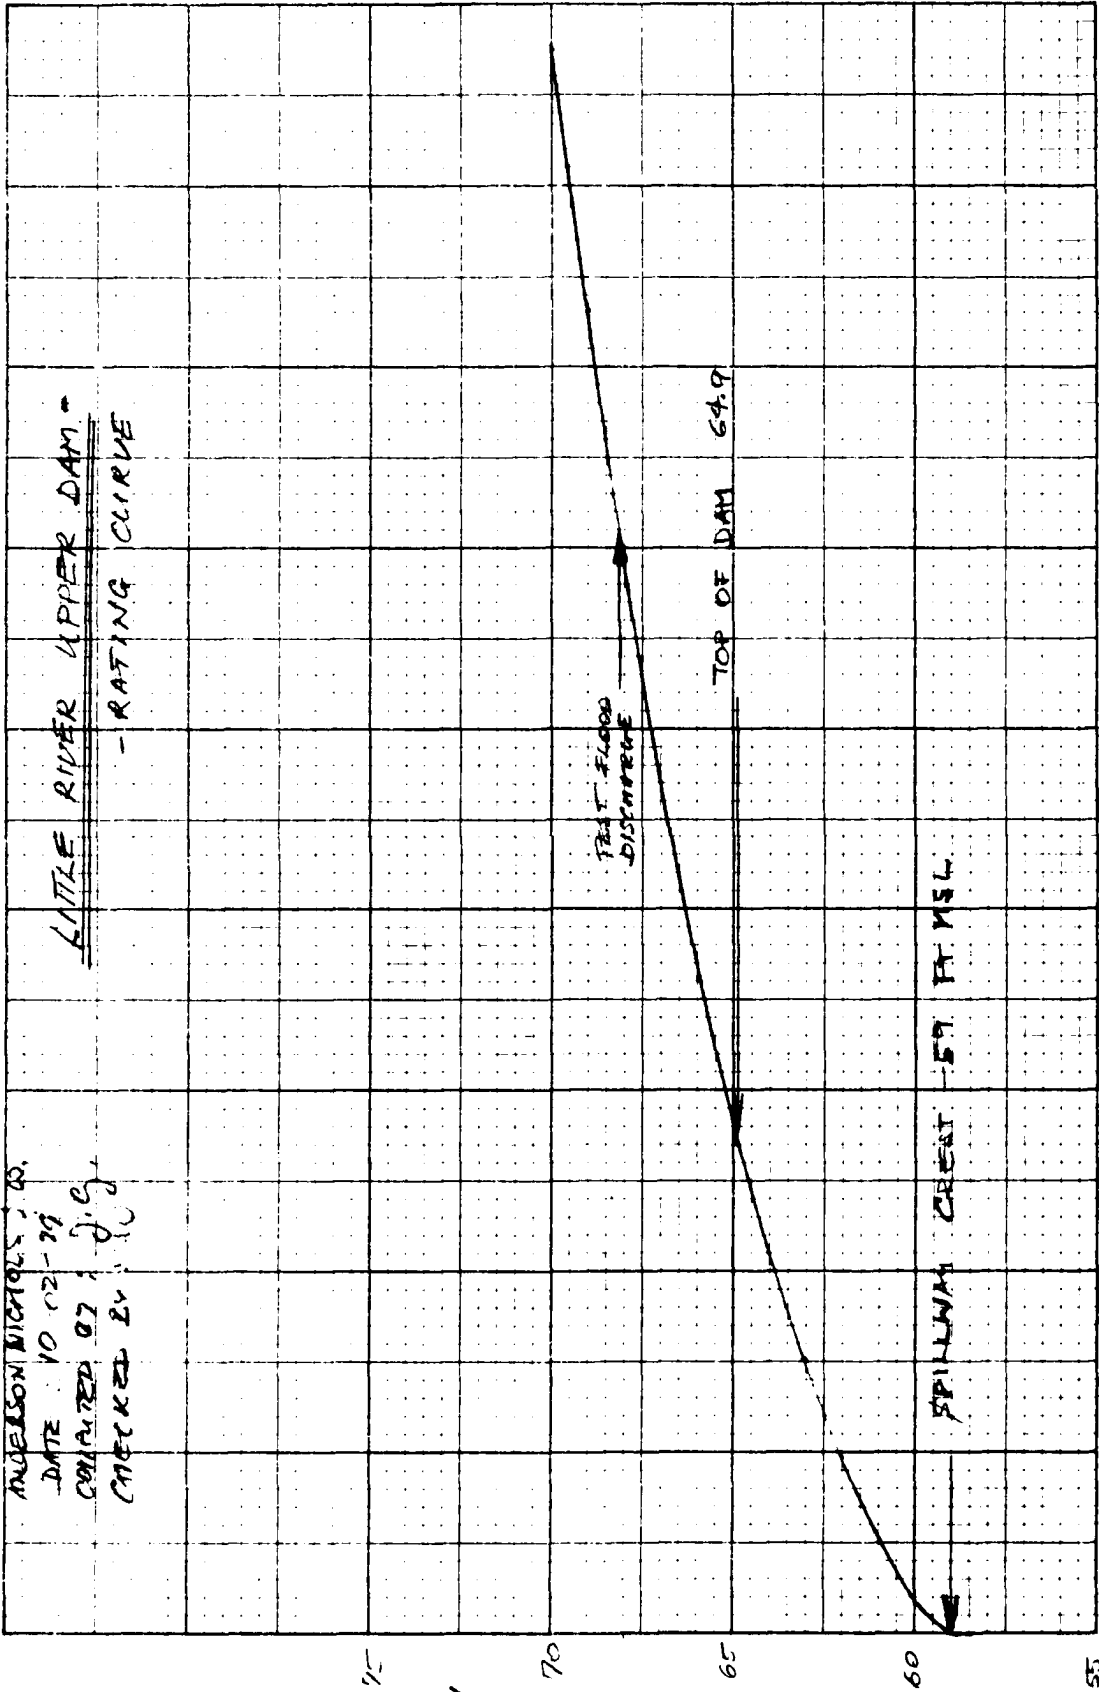
LITTLE RIVER UPPER DAM
- RATING CURVE

ELEVATION FEET M.S.L.

DISCHARGE [CFS]

STEP # 2A DETERMINE SURCHARGE HEIGHT TO PASS
 Q_{PI} OF 12,800 CFS. TO OBTAIN THIS, A DISCHARGE
RATING CURVE MUST BE CALCULATED FOR UPPER
RESERVOIR DAM. OUTFLOW WOULD OCCUR FIRST OVER
THE PRINCIPAL SPILLWAY. HIGHER FLOOD WATERS WILL
FLOW OVER THE DAM EMBANKMENTS AND SIDE SLOPES,
NOW THROUGH TWO OUTLET PIPES (6" AND 8" DIAMETER)
FROM VALVE CHAMBER IS INCONSIDERABLE. SIZE OF
EMERGENCY GATE IS UNKNOWN, GATE OPERATING MECHANISM
IS RUINED AND IN POOR CONDITION. THERE IS NO INDICATION
OF RECENT OPERATION. 18" TOP OUTLET PIPE FROM THE
BASE IS LEAKING ABOUT 30 GPM. BECAUSE OF ITS
CONDITION POSSIBLE FLOOD THROUGH EMERGENCY GATE
WILL NOT BE CALCULATED.

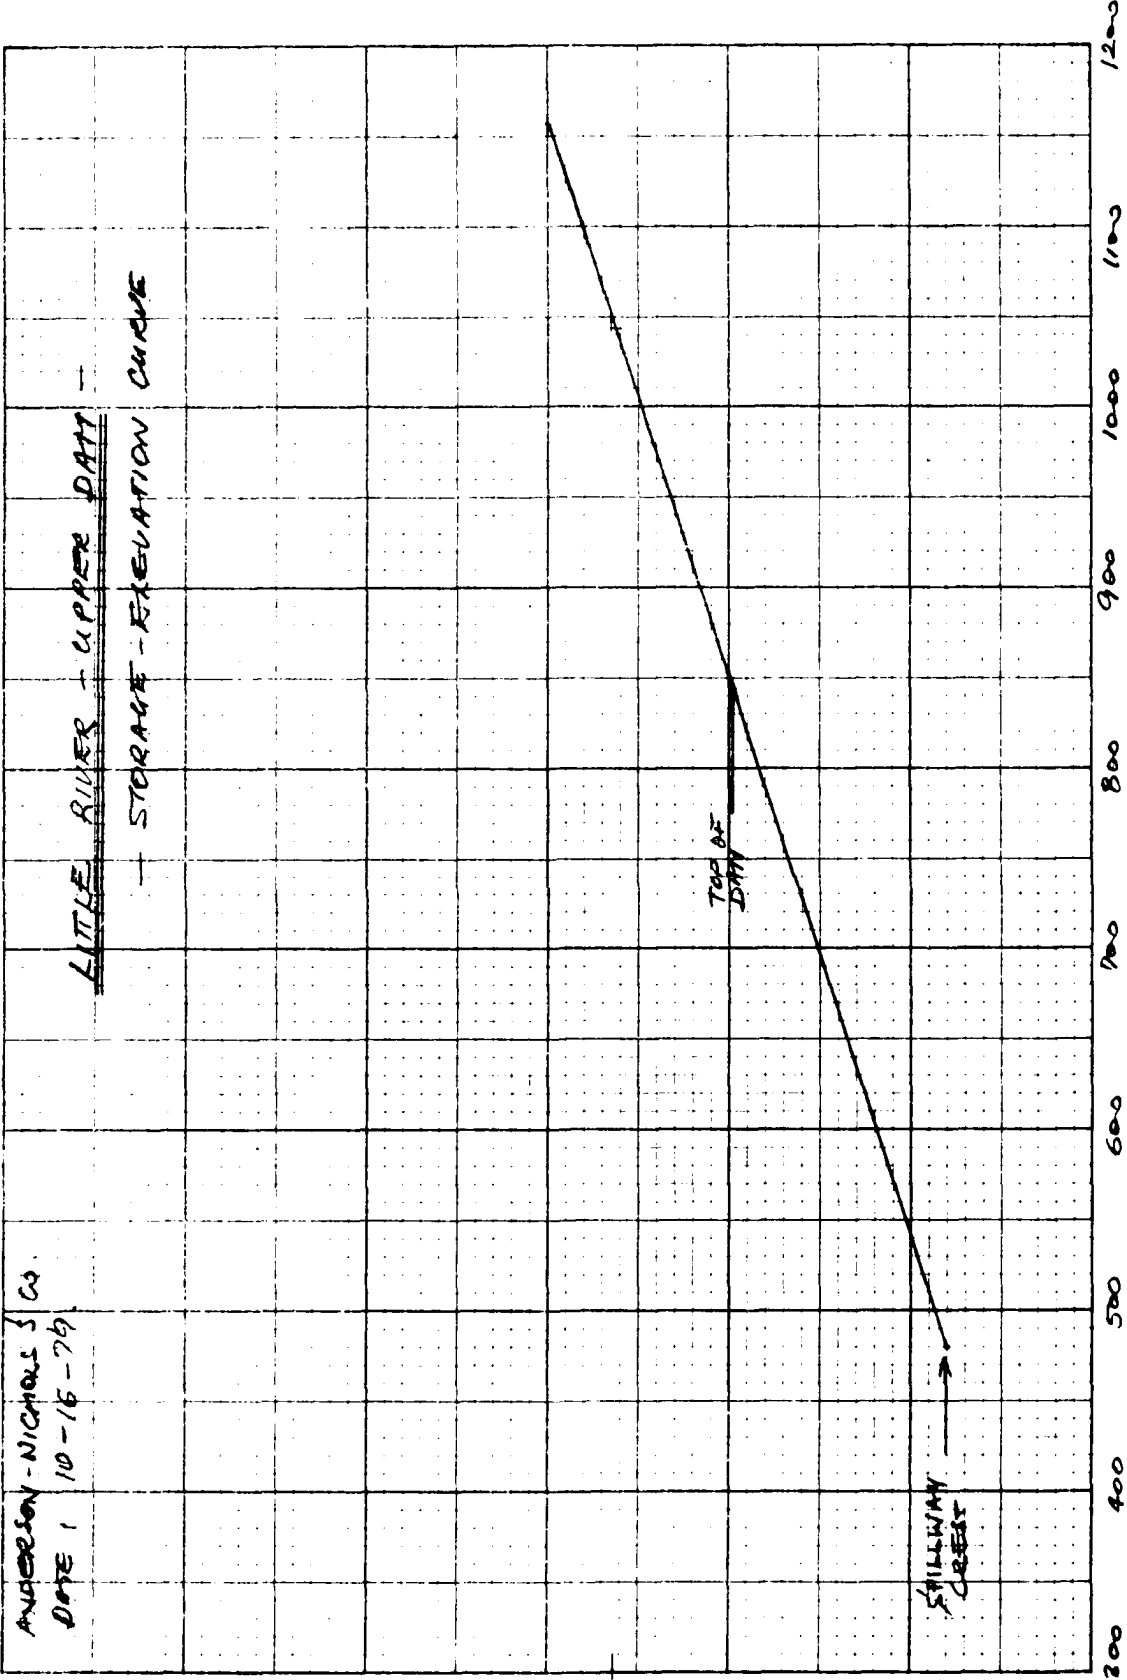
LITTLE RIVER - UPPER DAM
- STORAGE - ELEVATION CURVE

ELEVATION FT MSL
60
59

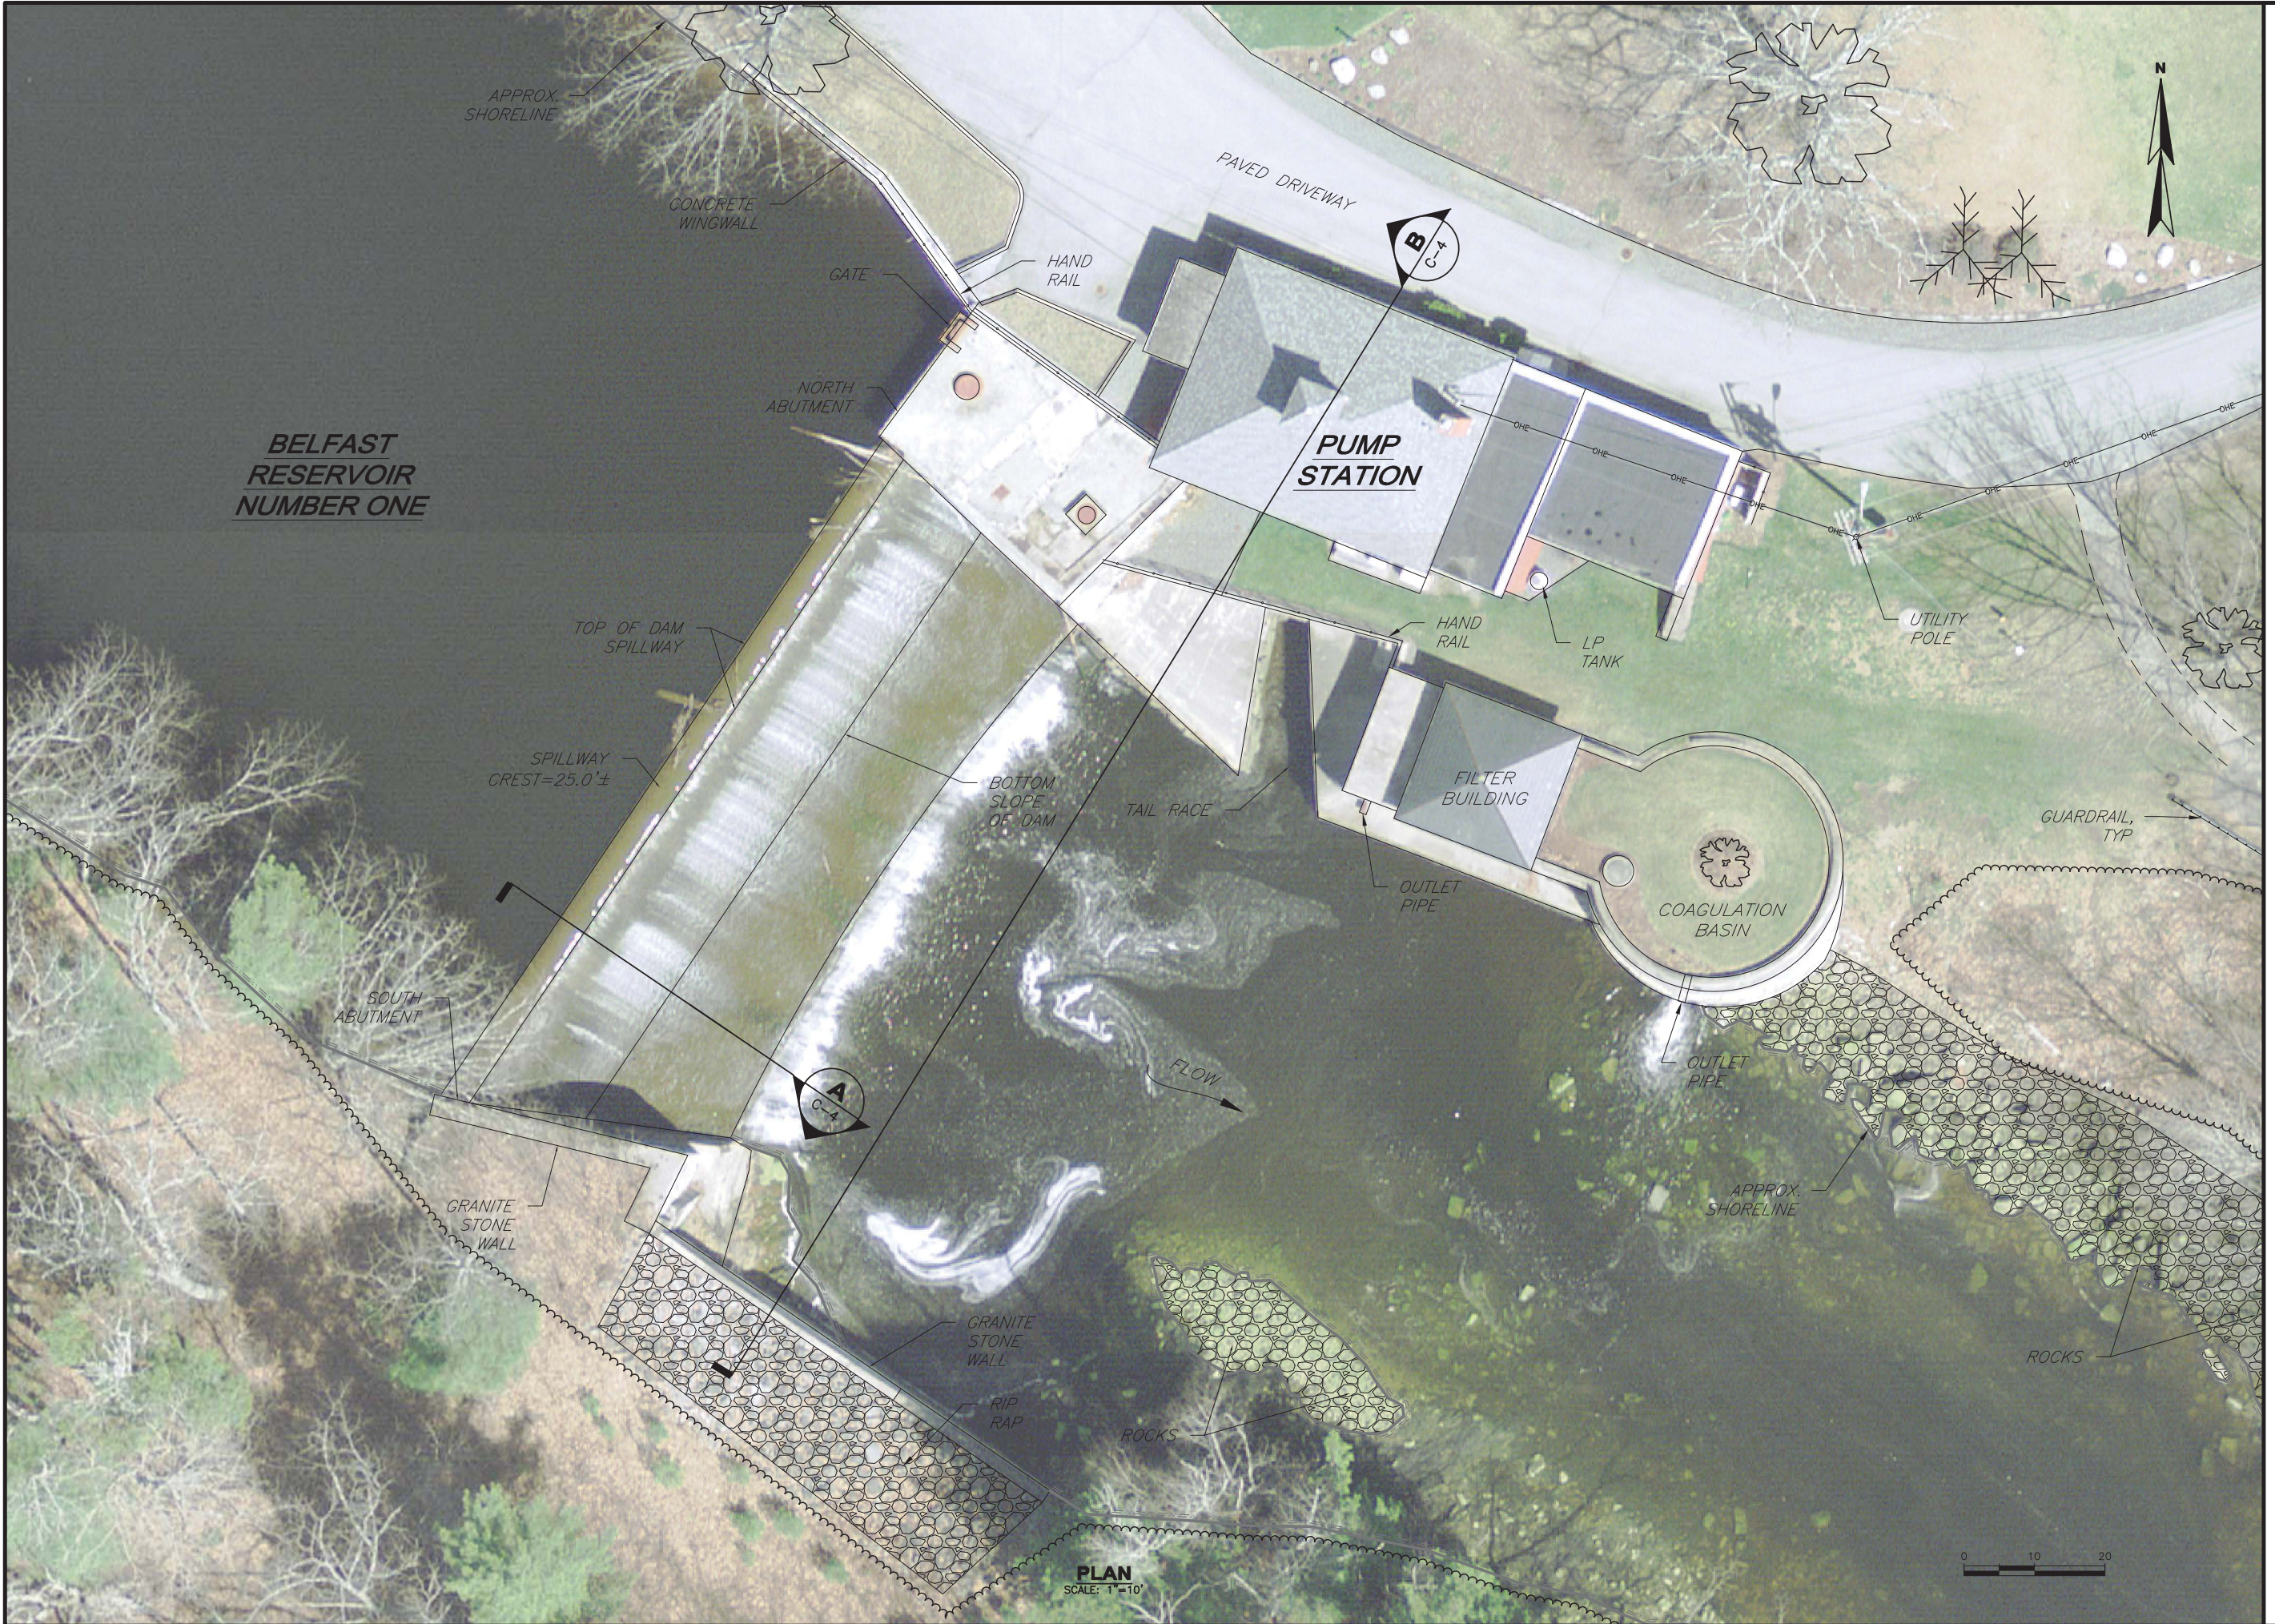
DRAWING
 C-3

LOWER DAM EXISTING CONDITIONS

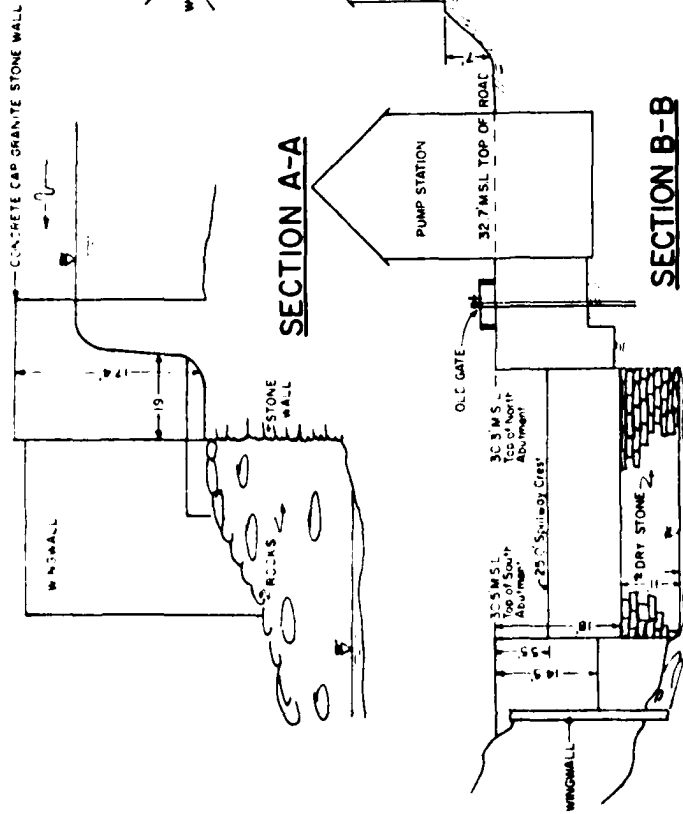
SECTION A-A

SECTION B-B

SECTION C-C

SECTION D-D

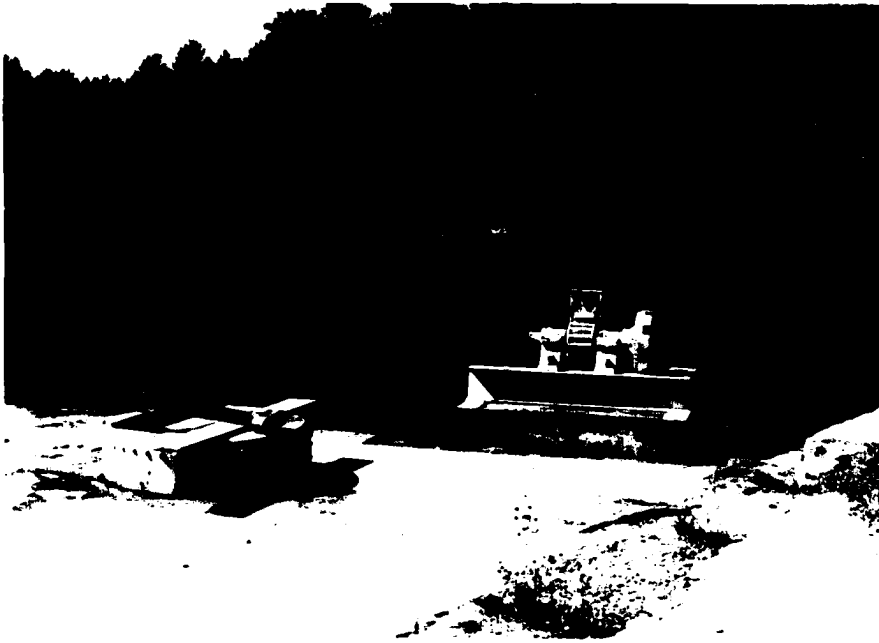
September 17, 1979
Figure 4 - Gate mechanism at the north abutment.

At the north end of the dam there is a massive intake structure which appears to be dry-stone-masonry encased in concrete on the top, upstream face, and river-side face. (See Appendix C - Figures 3 & 4.) The downstream face is dry-stone-masonry. (See sketch plan, Appendix B.)

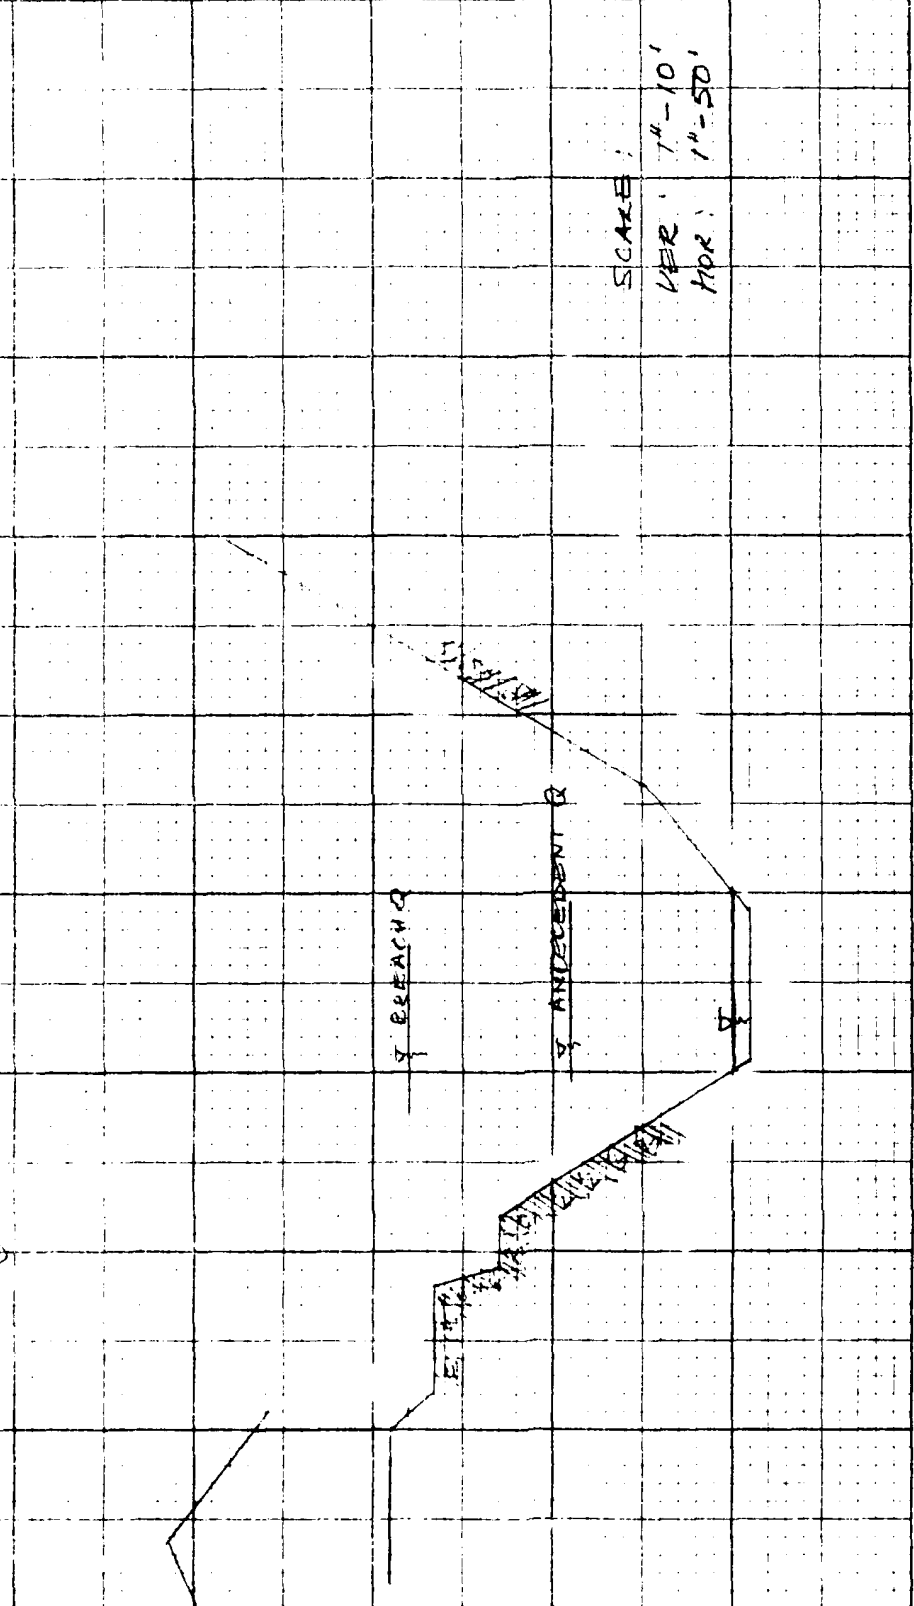
LITTLE RIVER - LOWER DAM
 V-SECTION DOWNSTREAM
 BRIDGE CROSSING

REACH # 2

SCALE:
 VER: 1"=10'
 HOR: 1"=50'

n = .05 S = .0025

DEPTH [FT]	AREA	WPER	Q [CFS]
0	0	0	0
4	242	82	736
8	626	111	2932
12	1113	137	6618
16	1720	174	11648
20	2490	226	18105

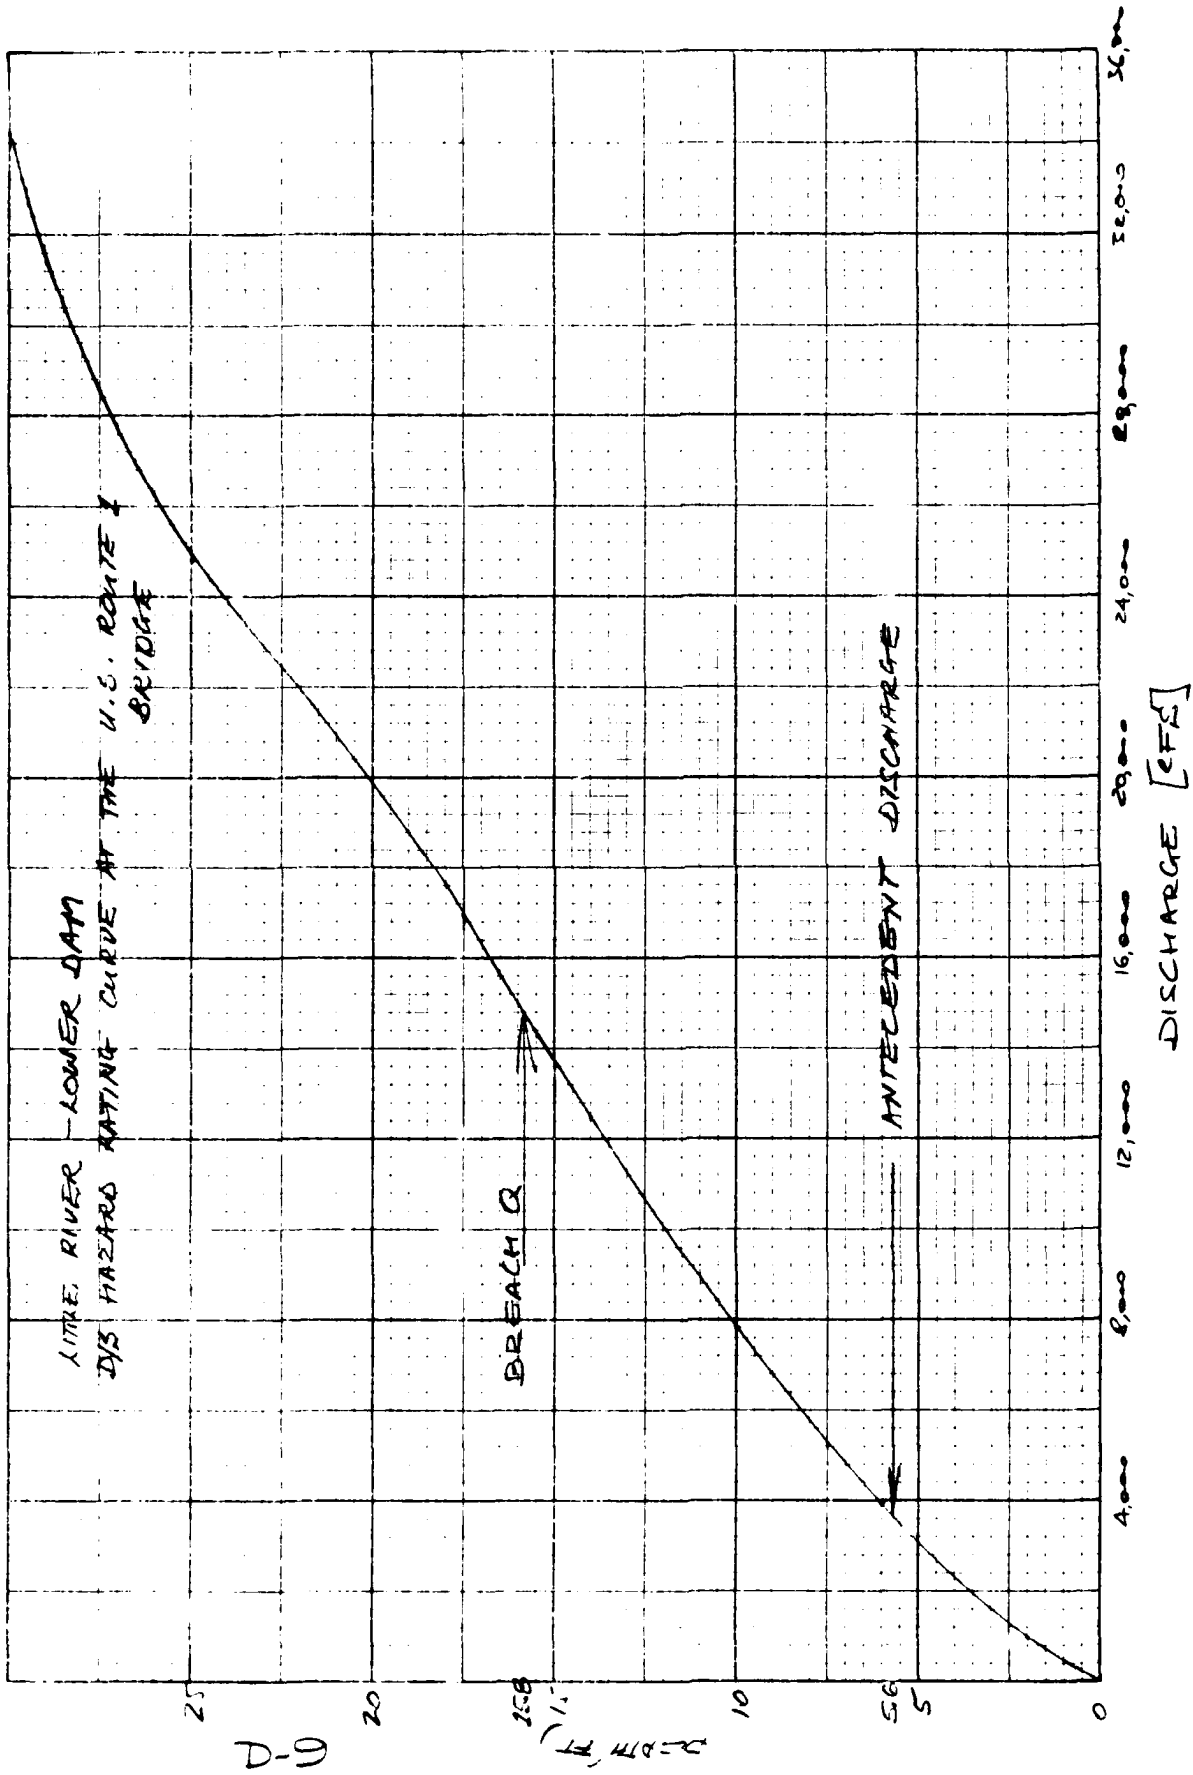
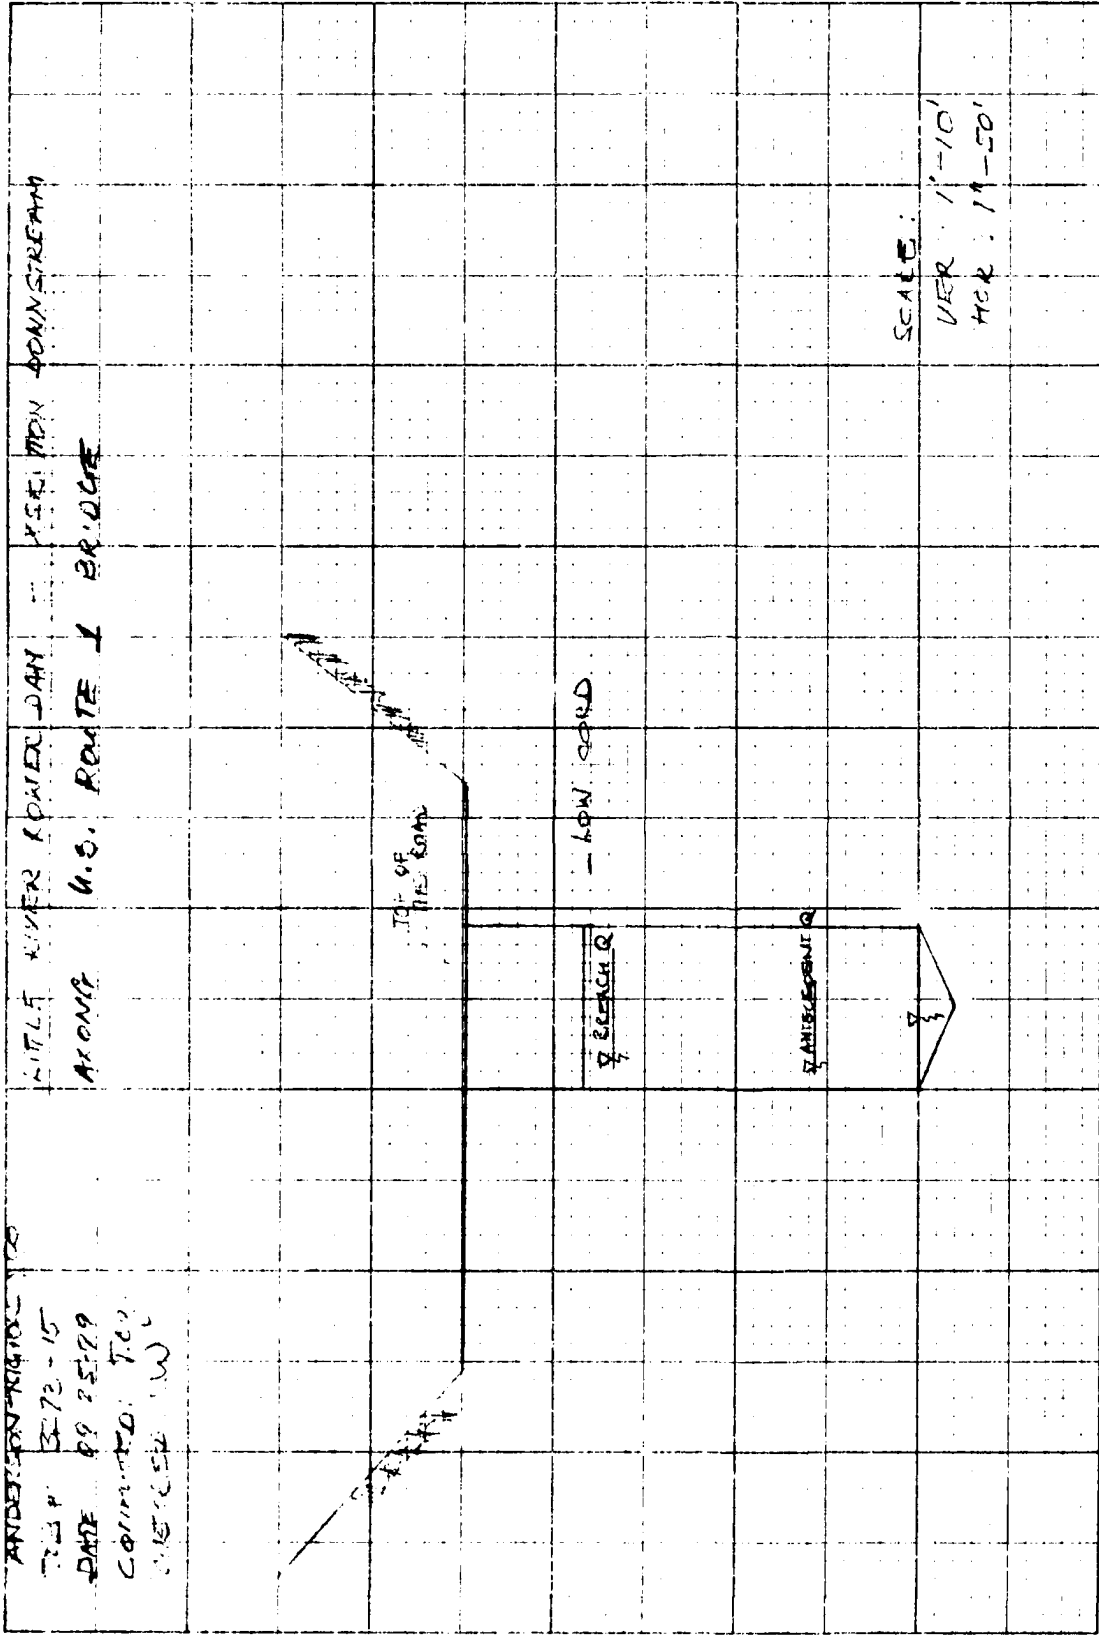
LITTLE RIVER LOWER DAM
 ALONG U.S. ROUTE 1 BRIDGE
 U.S. ROAD DOWNSTREAM

$$C = .92$$

1. REVISION OF EQUATION 17'
 2. FOR CONCRETE BRIDGE WITH
 BIRTH BOTTOM = 0.00
 3. HYDRAULIC ATTACK
 INTAKE AND EXIT POINTS =
 = 1.10

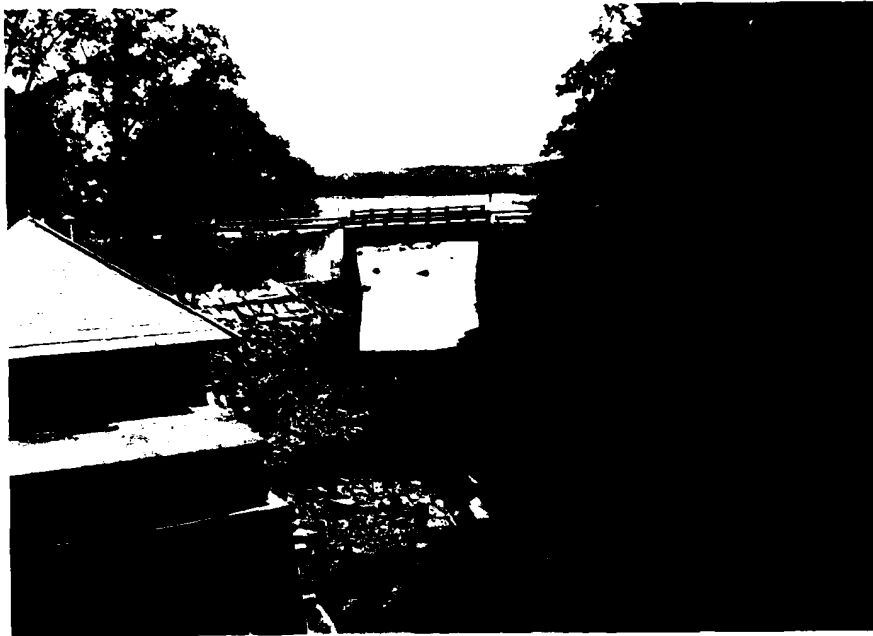
September 17, 1979
Figure 12 - Looking downstream at U.S. Route 1 bridge
from the north abutment of the dam.

e. Downstream Channel. The downstream channel is bedrock. Trees overhang the south side of the channel. About 400 feet downstream of the dam is the U.S. Route 1 bridge that crosses the channel. (See Appendix C - Figure 12.) Little River discharges into Penobscot Bay through a channel lined with well-placed derrick stone. (See Appendix C - Figure 13.)

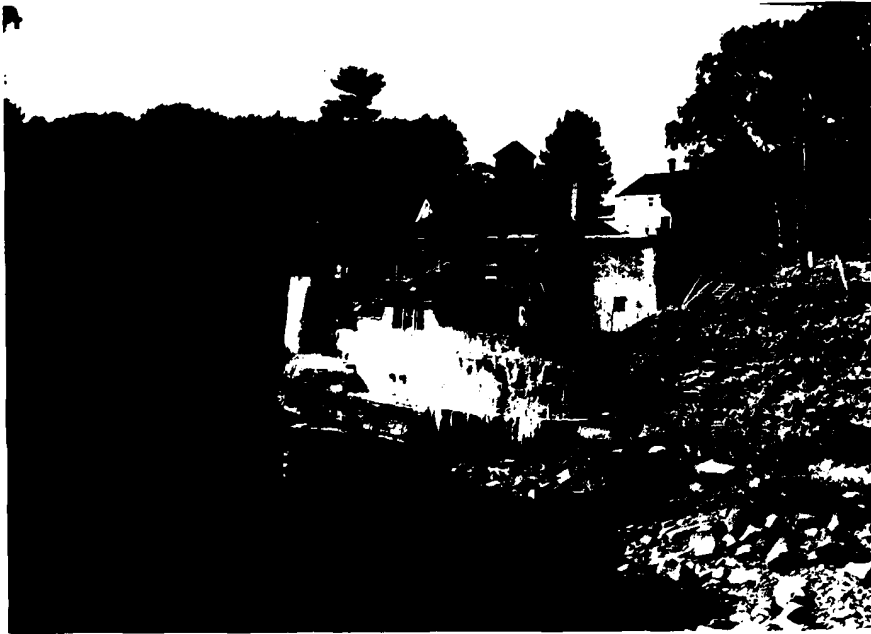
September 17, 1979
Figure 10 - View of the north bank of the downstream
channel from the U.S. Route 1 bridge.

A 5-foot-diameter steel pipe exits at the bottom of the training wall on the north bank of the downstream channel. The outlet of the pipe is plugged with sand and gravel to about one-third of its height. (See Appendix C - Figure 9.) The gate mechanism on the north abutment is inoperable; the gate size is unknown. (See Appendix C - Figure 4.) The mechanism is in poor condition with no indication of maintenance. A pump station building and a filter house for a water supply system is located integrally with the north abutment. A concrete wall which exists on the river side of these buildings is an extension to the downstream retaining wall. (See Appendix C - Figure 10.)

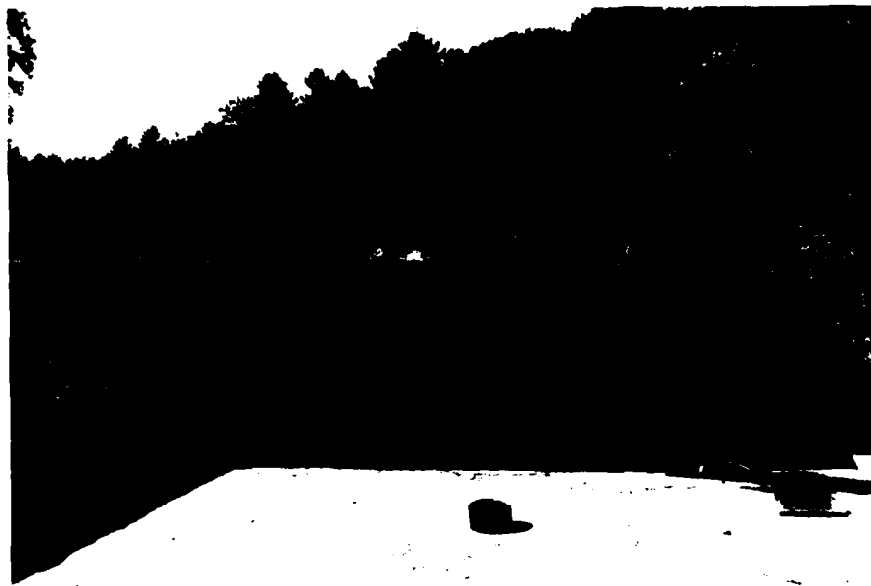
September 17, 1979
Figure 11 - Looking upstream at the reservoir from
the north abutment.

d. Reservoir Area. The watershed above the reservoir is rolling and partially wooded. (See Appendix C - Figure 11.) No structures were observed on the shore of the reservoir. No evidence of significant sedimentation in the reservoir was observed.
