UPPER AND LOWER LITTLE RIVER DAMS DAM ASSESSMENT REPORT

PREPARED FOR RANSOM CONSULTING, INC.

JULY 2018

WRIGHT-PIERCE

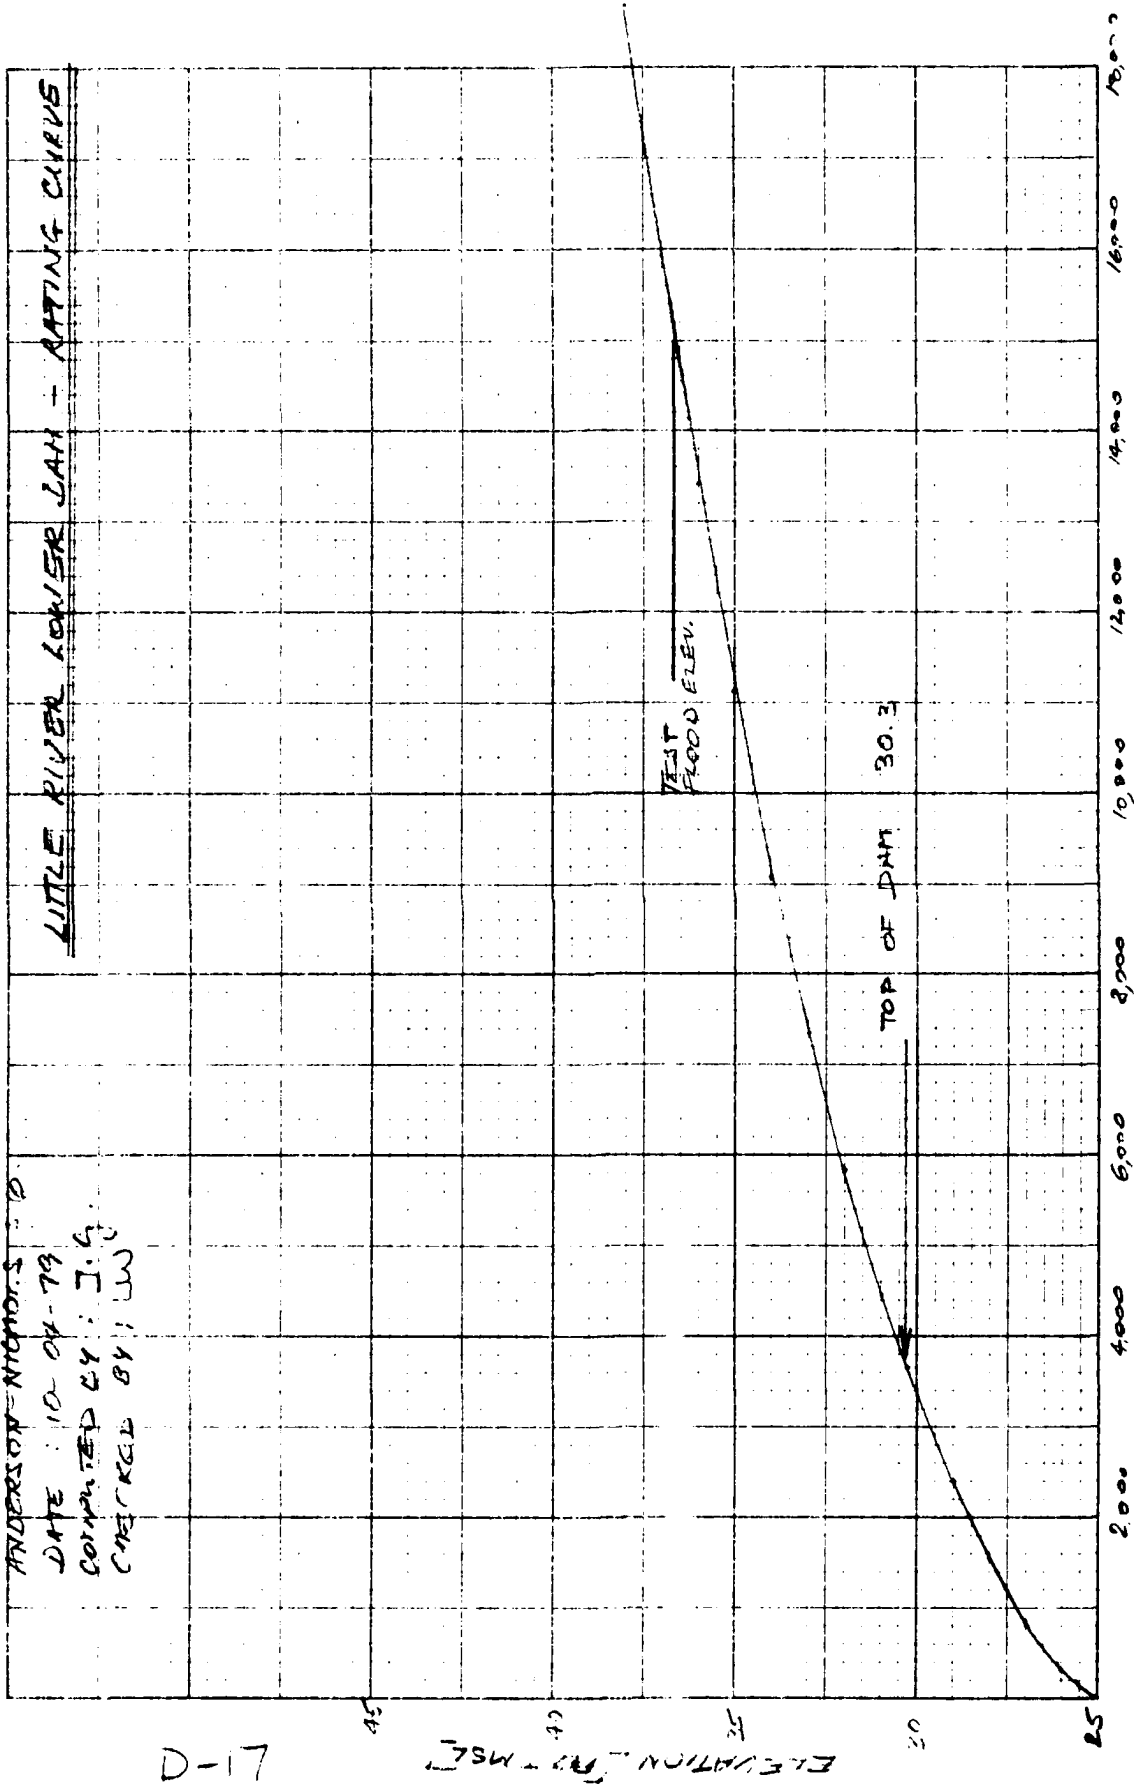
LITTLE RIVER LOWER DAM - RATING CURVE

ELEVATION (ft - MSL)
