PURPOSE AND NEED FOR ACTION

Dyke Bridge (Br#2246) carries Route 1 over the Middle River in the Town of Machias, Maine. The Middle River joins the tidal portion of the Machias River at/immediately downstream of the bridge. The bridge consists of four box culverts within an embankment structure (causeway). The culverts are constructed of timber and stone masonry and are approximately 130 feet long, 6 feet wide and 5 feet high. Each culvert has top-hinged flap gate installed on its seaward side. The causeway is constructed of timber cribbing with rubble and earthen fill and is over 1,000 feet long.

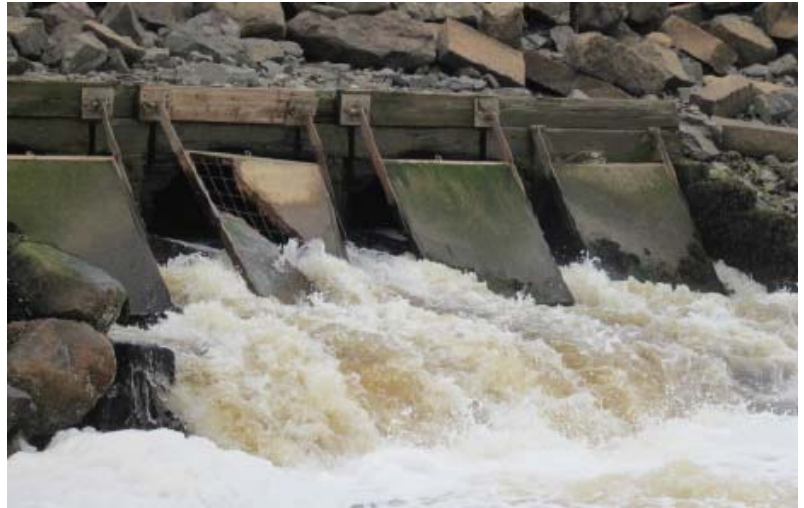
Photo 2. Dyke Bridge culverts with flap gates.

The culverts and the flap gates are deteriorated. MaineDOT completed a dive inspection of the Dyke Bridge on 9/21/2016 and routine inspections on 12/27/2016 and 4/28/20. The inspections indicated large spalls, heavy scaling, wide cracks, loss of and rotten timber members, and roadway settlement. MaineDOT Bridge Maintenance has replaced broken flapper gates in 2012 and repaired pavement (Light Capital Paving) in 2017.
