2014 TIGER DISCRETIONARY GRANT APPLICATION

Bridge Number 2019 Federal Project STP-1849(800) Work ID Number 018498.00

PROJECT TITLE: Replacement of Androscoggin River Bridge Peru – Mexico, Maine

LEAD APPLICANT: Maine Department of Transportation

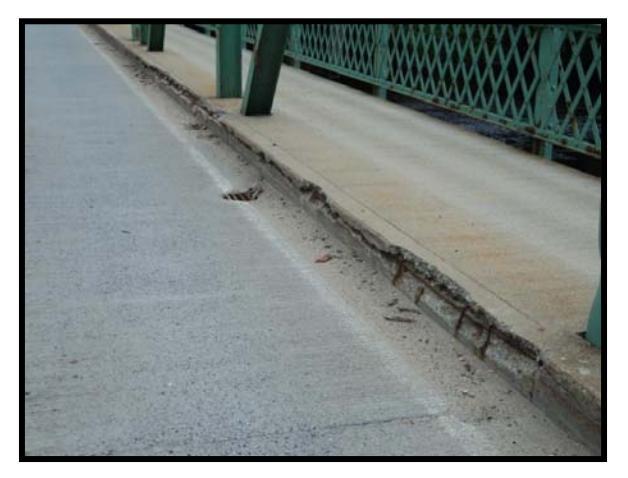
East sidewalk curb face in Span 2 has a long spall with exposed reinforcing extending from L4 to L6. Looking northeast.

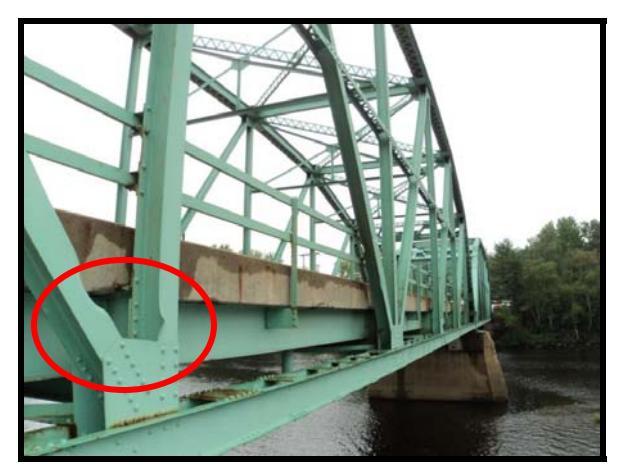
At L3 in Span 2 roadway truss, the vertical and diagonal have sustained damage 2' above the lower chord, with localized twisting of the flanges.

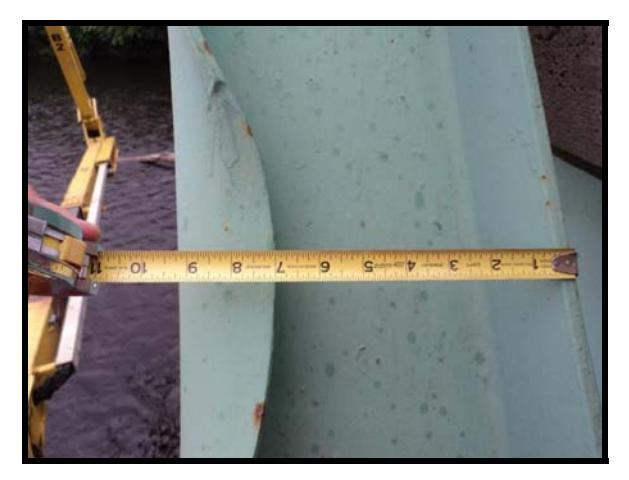
West flange of Span 2 roadway truss diagonal U2-L3 is permanently deformed and bent inward by $2\frac{1}{2}$ ". Looking north.

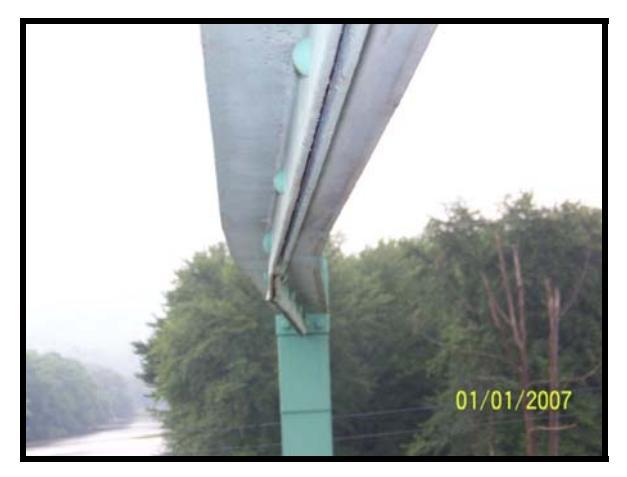
Impact damage to sway frame lower transverse member along with lateral displacement of 6" in the horizontal plane was observed at Span 3 U3.

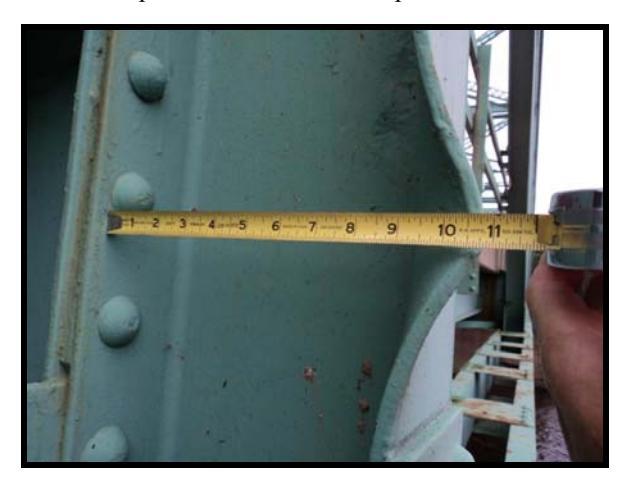
West flange of Span 2 roadway truss vertical U3-L3 is permanently deformed and bent outward by 1½". Looking south.

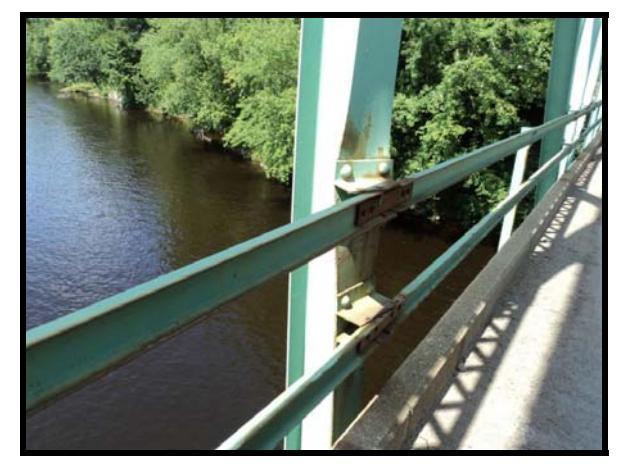
Span 1 roadway truss U5-L5 has sustained impact damage at railing level with localized twisting over a 3' length and a permanent bend in the flange tip.

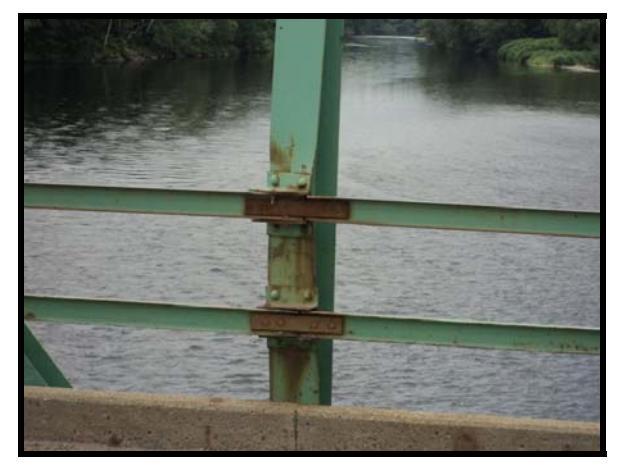
West traffic railing in Span 1 at L5 has a splice in both rails to repair previous impact damage. Note truss vertical is rotated from collision damage. Looking west.

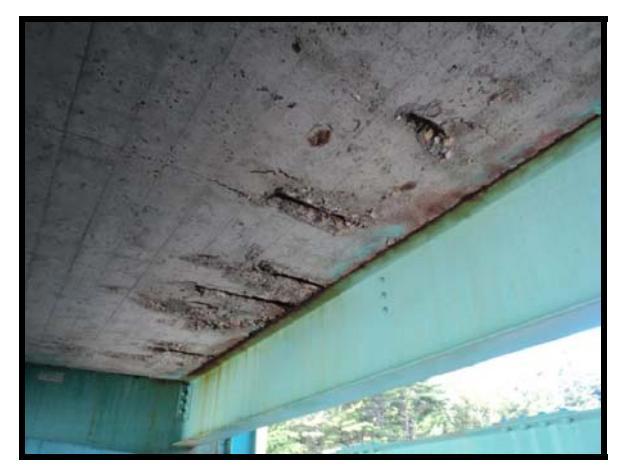
In Span 3 between FB0 and FB1 five spalls with exposed reinforcing were noted between S5 and S6. View is looking south.

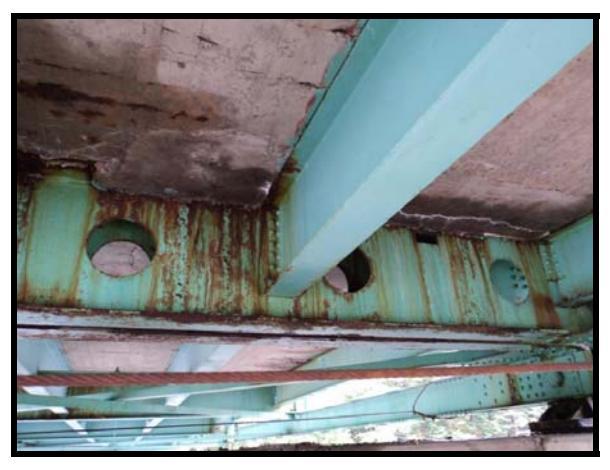
Above FB8 in Span 2, a 1' by 2' spall was observed in the floorbeam haunch zone between S4 and S5 at top left. Also note concrete patches in both bays.

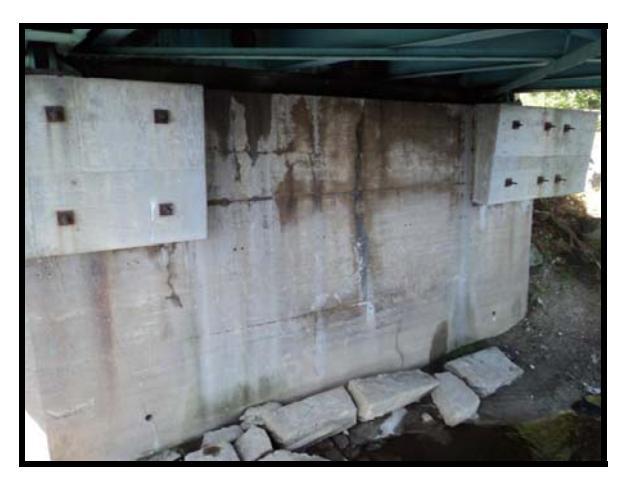
Both abutments have been temporarily repaired with Dywidag post-tensioned concrete encasement repairs immediately below both truss bearings.

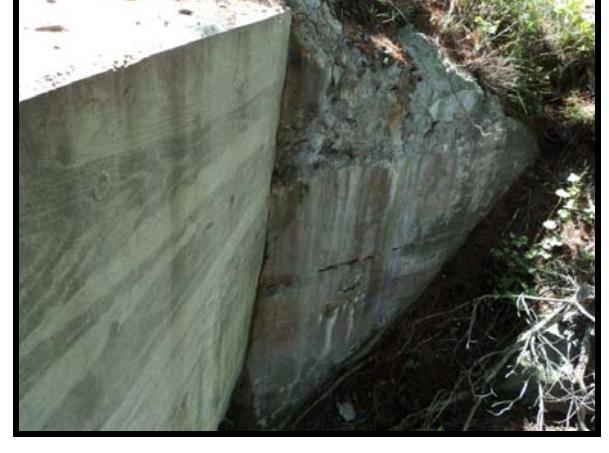
The southwest wingwall is in poor condition with a large deep spall continuous along the top for the full length of the wingwall.

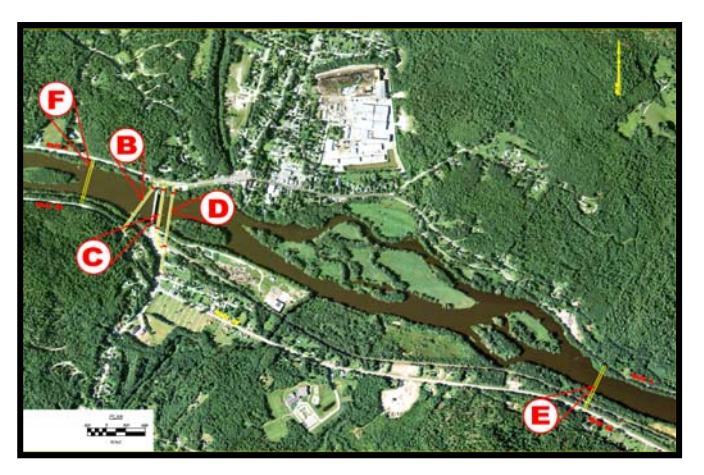
Figure 2: Alignment Alternatives

The recommended alignment Alternative D relocates the crossing approximately 300 feet south of and downstream from the existing bridge. Traffic would be maintained over the existing bridge during the construction of the new bridge and approaches. The proposed structure will consist of a multi-span bridge utilizing structural steel girders and a cast-in-place concrete deck protected by a high performance spray applied membrane. The bridge rail would be three-bar steel traffic rail on the non-sidewalk side and four-bar steel pedestrian/traffic rail on the sidewalk side.

Along with evaluating rehabilitation of the existing bridge (Alternative A), five separate roadway alignments (Alternatives B through F) were developed and evaluated during the Preliminary Design Report (PDR) development phase. Several of the proposed alternatives were deemed undesirable due to substantial alterations to the local traffic patterns, including reduced pedestrian accommodation. The five proposed alignments were then narrowed down to Alternative D. Alternative D is located approximately 300 feet downstream of the existing bridge and will maintain the existing traffic patterns between Peru, Mexico and Dixfield. Table 1 provides a comparison of features between the existing condition and the proposed Alternative D.

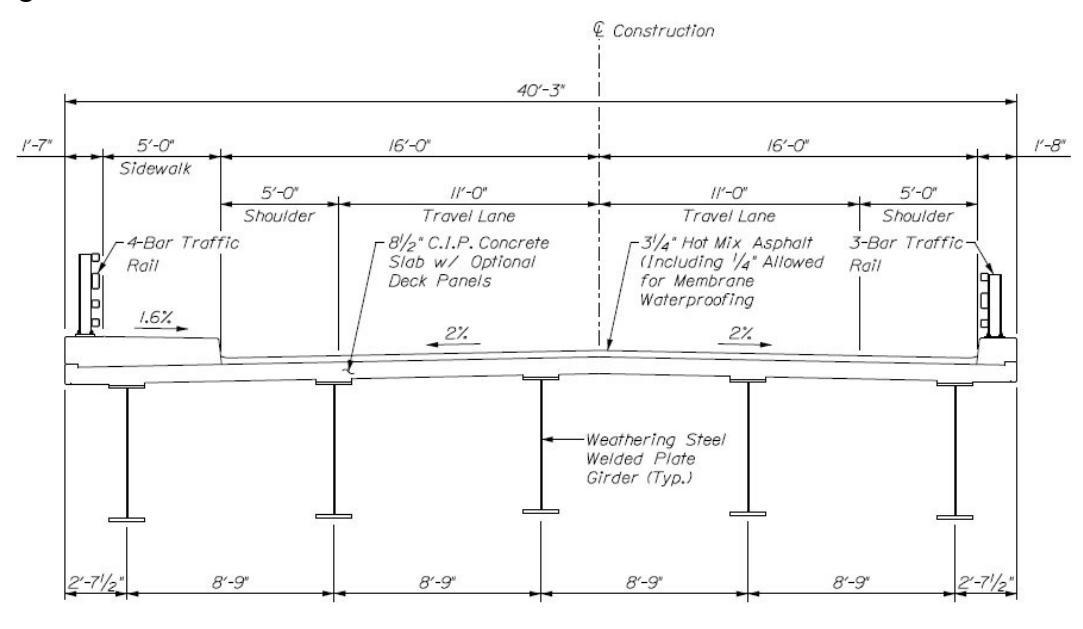
Figure 3: Proposed Bridge Section

The bridge will be founded on concrete abutments and mass piers, all supported by steel Hpiles for scour resistance. The bridge will provide a roadway width of 32 feet curb-to-curb, suitable for bicyclists and seasonal use by snowmobilers. A 5-foot sidewalk will be provided on one side of the bridge for year-round pedestrian use, including frequent use by school children. The improved pedestrian/bicyclist accommodation is an important feature of this project and is in keeping with national trend towards building Green Communities and ensuring Safe Routes to Schools.

The proposed bridge project will replace the existing bridge with a welded steel girder bridge that will be 844 feet long. The bridge roadway width will be 32 feet curb-to-curb, plus a 5-foot curb-to-rail sidewalk for pedestrians. The roadway will provide two 11-foot lanes and two 5-foot shoulders for bicycles and snowmobiles.
