Coastal Bluffs

Swans Island Quadrangle, Maine

Coastal bluff mapping by
**Corinn C. Koblinsky, Stephen M. Dickson,
and Joseph T. Kelley**

**Open-File No. 03-18
2003**

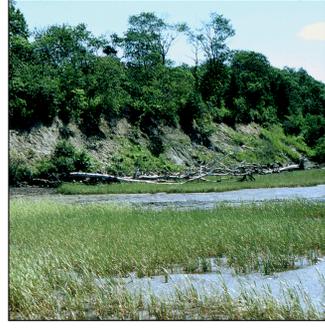
Highly unstable bluff with an unvegetated bluff face and a salt marsh shoreline. Sediments on the bluff face are exposed and fallen tree trunks lie at the base of the bluff. A salt marsh has recently formed on the tidal flat, partly on the top of an old landslide deposit.

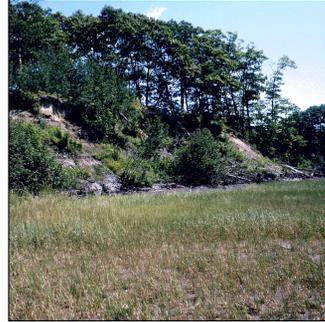
Unstable bluff with a partially vegetated bluff face and a salt marsh shoreline. This bluff, protected by a salt marsh, remains unstable. There are small bushes on the bluff as well as small non-vegetated areas that indicate continuing bluff retreat.

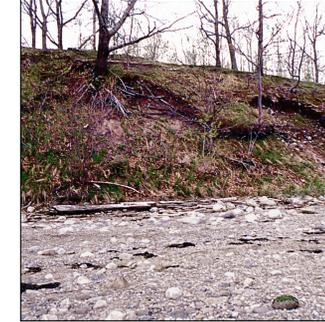
Unstable bluff with a partially vegetated bluff face and a beach/gravel flat shoreline. Slump scars on the bluff face expose sand, gravel, and roots. Fine sediments are removed by waves and currents, leaving gravel to form a beach at the base of the bluff.

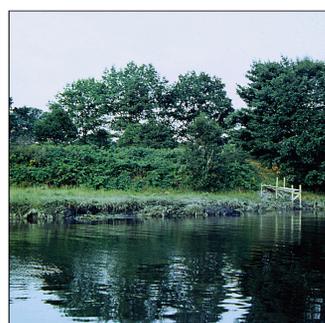
Stable bluff with a vegetated bluff face and a salt marsh shoreline. A low bluff face is covered by shrubs landward of a salt marsh terrace. In this location the mature marsh protects the base of the bluff from rapid erosion and slows bluff recession or retreat.
