# York Beach Quadrangle, Maine

Coastal landslide hazard mapping by

**Open-File No. 06-60**  
**2006**

## Coastal Landslide Hazards

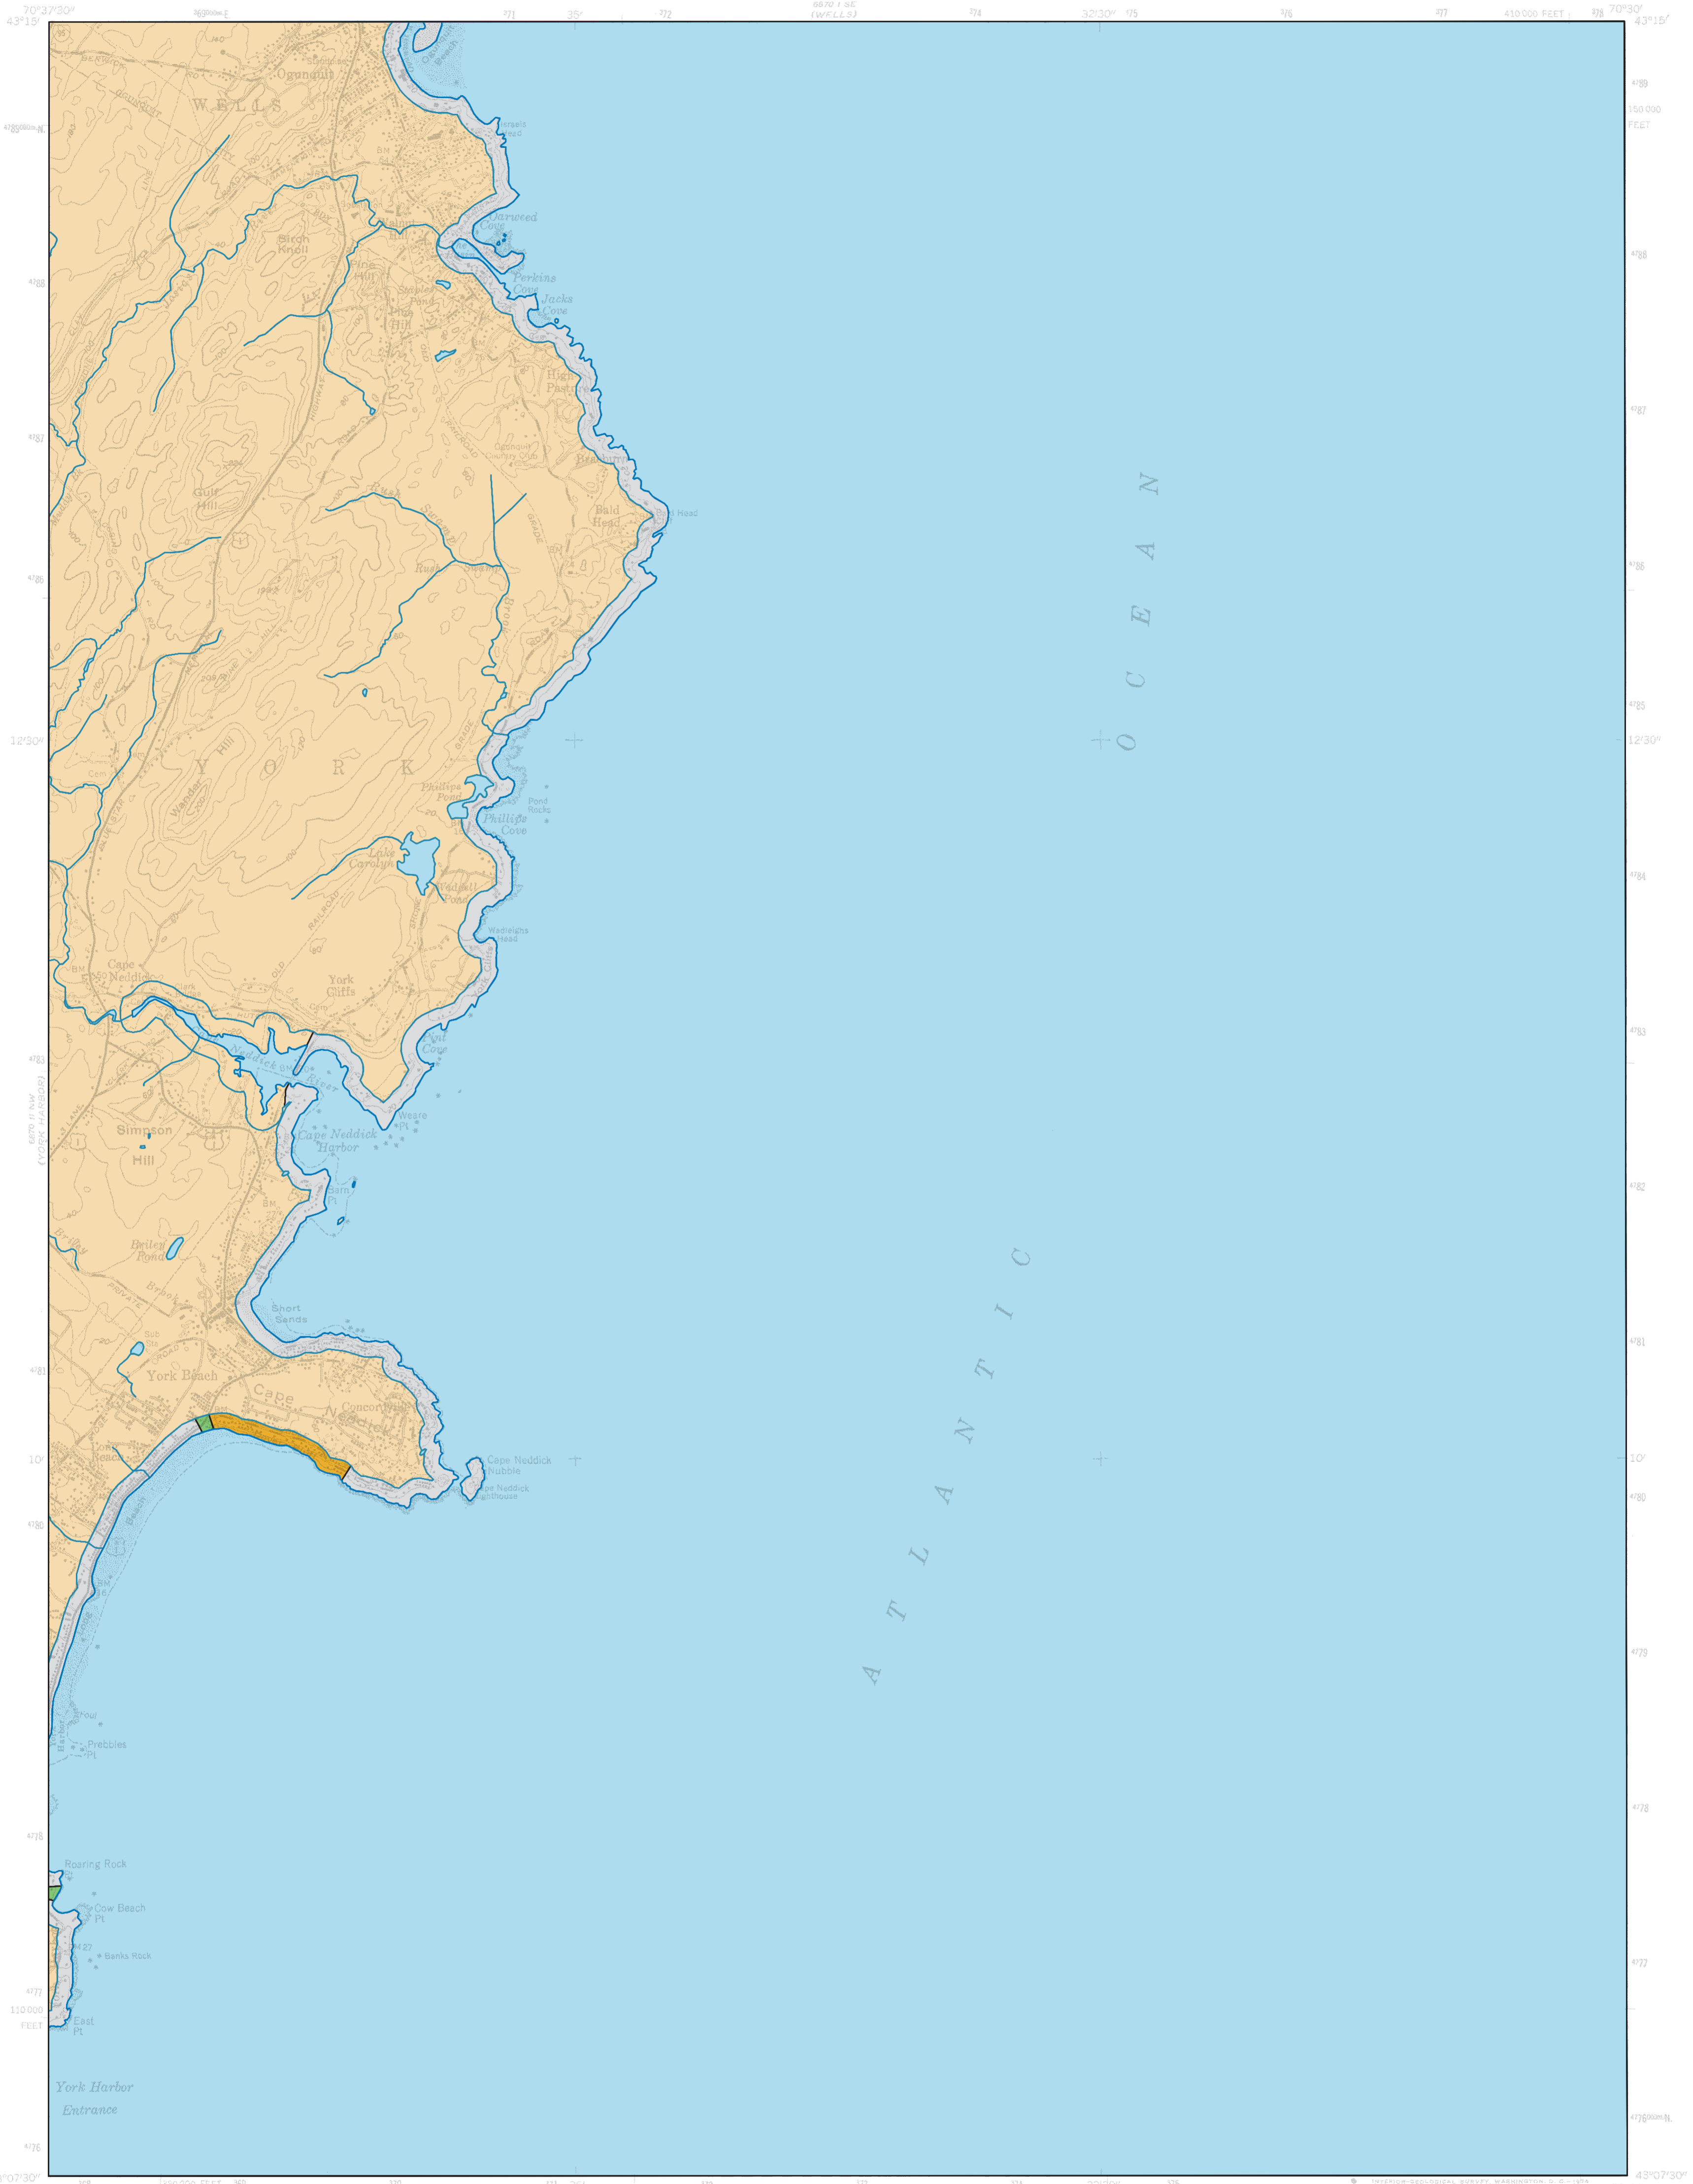
**Note:** The landslide hazard classification is indicated by a colored, patterned band extending landward from the shoreline (dark blue line). The width of the band does NOT indicate the distance inland that a landslide may occur. This distance is difficult to predict and will vary from site to site. The colored buffer is for illustration purposes only. Due to variations in coastal geology, not all units in the explanation below will appear on this map.

**Landslide Site** - Location of known or interpreted coastal landslide. Includes historically recorded landslides and slides interpreted from air photos.

**Landslide Risk Area** - Land features indicate conditions that may be suitable for a landslide to occur. Features often include a steep or arcuate scarp, slump blocks, sediment lobes, or uneven land surfaces. Bluff sediments are usually muddy and twenty feet or more in thickness.

**Potential Landslide Area** - Shoreline with a sedimentary coastal bluff twenty feet or more feet high. These bluff areas have not had field investigations that are necessary to evaluate the risk of a landslide. However, some similar high coastal bluffs have experienced landslides.

**Low Coastal Bluff** - Shoreline with a sedimentary coastal bluff that has less than twenty feet of relief immediately adjacent to the shoreline. Some bluffs over twenty feet in height are included in this map unit if the bluff face is not steep. In general, low coastal bluffs are not at risk of failing in the form of a landslide.

**Non-Bluff Shoreline** - Coastal areas without extensive sedimentary bluffs. Corresponds to the no-bluff unit on MGS Coastal Bluff Maps.

**Unmapped Shoreline** - These sites generally are in the inland reaches of estuaries or beyond the scope of the field effort in this region.

**Landslide Site** - Includes the following: (1) Locations based on historical records and eyewitness accounts. In general, these earth movements have occurred in the last three centuries. (2) Locations based on interpretation of aerial photography. The age of these features is usually unknown. Some may have formed in the last few years, others in the last century, and some possibly sometime in the last few thousand years.

**Landslide Risk Area** - This determination was based on the presence of a bluff as indicated on MGS Coastal Bluff Maps and the proximity of a twenty-foot topographic contour to the shoreline. By comparison with bluffs adjacent to previous landslides, these areas are less steep than those that have shown a tendency to fail due to weakness in the earth landward of the top of the bluff.

**Potential Landslide Area** - This determination was based on the presence of a bluff as indicated on MGS Coastal Bluff Maps and the proximity of a twenty-foot topographic contour to the shoreline (similar to areas adjacent to previous landslides), and geomorphology visible in air photos. These bluff areas have not had field investigations to fully evaluate landslide risk.

**Low Coastal Bluff** - This determination was based on the presence of a bluff as indicated on MGS Coastal Bluff Maps and the proximity of a twenty-foot topographic contour to the shoreline. By comparison with bluffs adjacent to previous landslides, these areas are less steep than those that have shown a tendency to fail due to weakness in the earth landward of the top of the bluff.

**Non-Bluff Shoreline** - This shoreline type was determined by visual observation from a small boat and corresponds to the no-bluff unit on MGS Coastal Bluff Maps. These shorelines can be composed of bedrock, salt marshes, beaches and dunes, or low-lying sediments without the presence of a bluff more than three feet high and 150 feet long. Within this category there may be short shoreline segments that contain bluffs. These small coastal bluffs are not illustrated on this map.

**Unmapped Shoreline** - In some locations, access to a shoreline was limited so some areas remain unmapped. These sites generally are in the inland reaches of estuaries or beyond the scope of the field effort in this region.

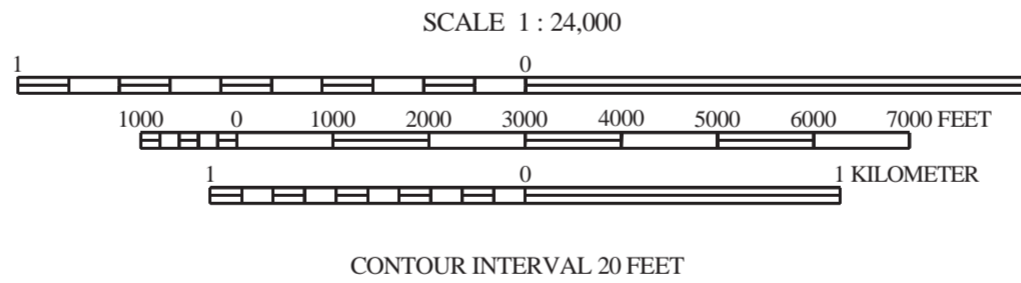
York Harbor	Wallops	Maine Geological Survey
Kittery

Topographic base from U.S. Geological Survey York Beach quadrangle, scale 1:24,000 using standard U.S. Geological Survey topographic map symbols.  
Index at left shows adjacent maps in this series.
