**MDOT Reconstruction Project:  
Route 2, Dixfield (PIN 10015.00)  
Preliminary Wetland Compensation Site Search Summary  
May 2006**

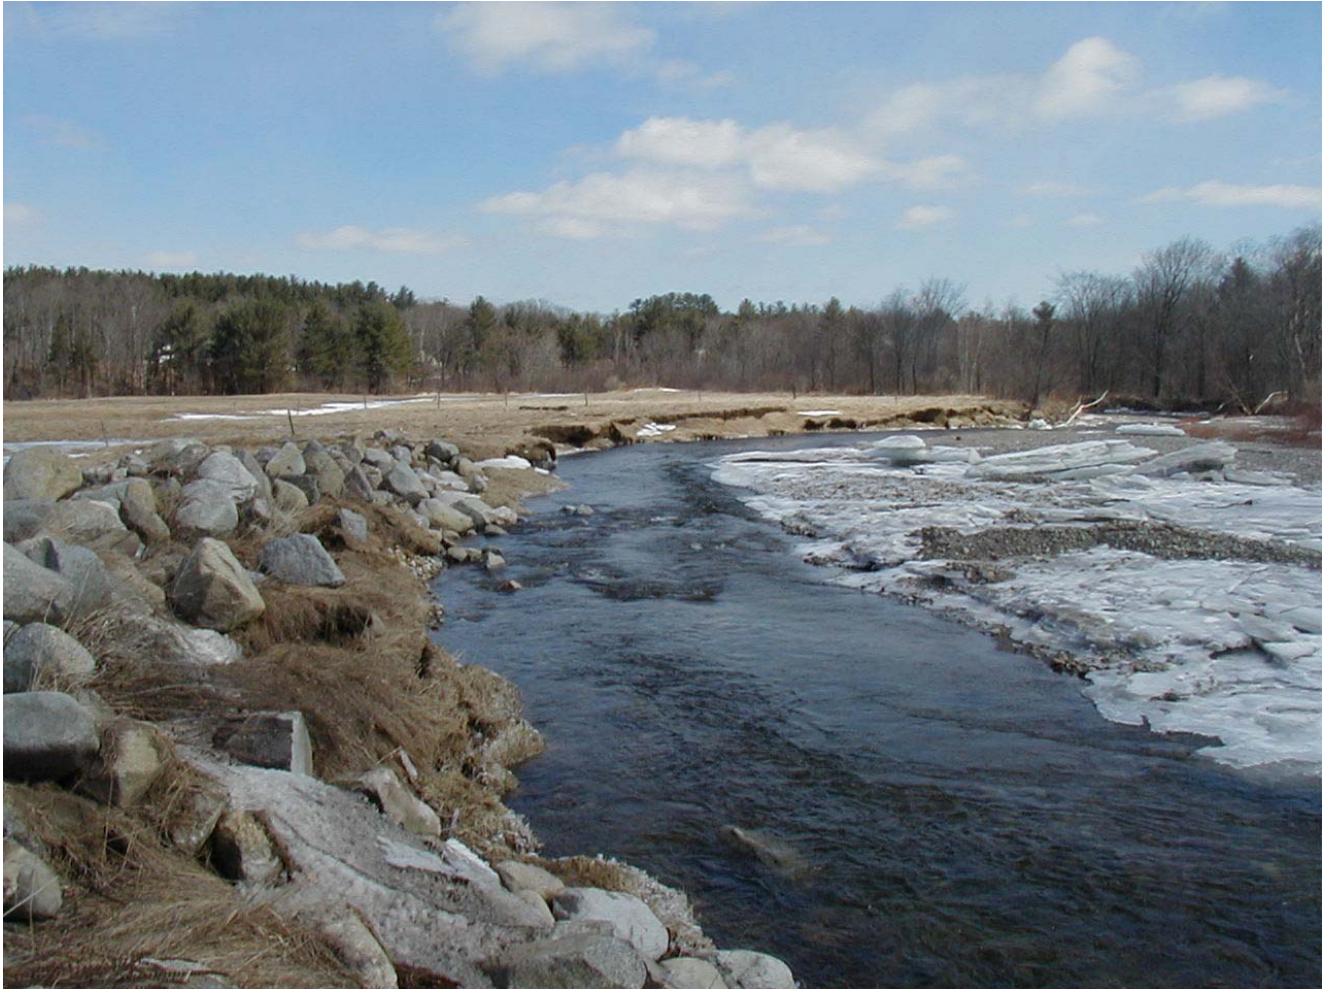
**Site 1:**

**Site Name:** Bailey Sites

**Location:** Andover

**Existing Conditions:** Proposed sites are located on active agricultural fields that are bisected by the Ellis River. These fields run adjacent to the river and have spotty deciduous riparian development. In two locations, the river is causing severe embankment loss during high flows. As a result, the suspended sediment/soils are affecting fisheries habitat and water quality in the Ellis River. Owner has been working with Candi Benwitz from NRCS on solutions to his land loss/erosion problems.

**Mitigation Potential:** Two locations on the Bailey property need stabilization. Both sites are similar in their needs. NRCS has developed plans for this repair work and is looking for financial assistance. The largest site is approx 350' long by 150' wide. It is actively eroding and losing about 30' of farm field per year. The mitigation design is based on soil stabilization and improved fish and wildlife habitat. The design combines an initial channel alignment modification with low cost, flow redirection rock structures and biotechnical measures to accomplish: a) a shift of the stream thalweg away from the eroding bank, b) increase channel roughness with the establishment of woody vegetation on the bank, c) reduce near bank velocity and create pools, and d) establish woody riparian plantings for improved wildlife protection and thermal shading.

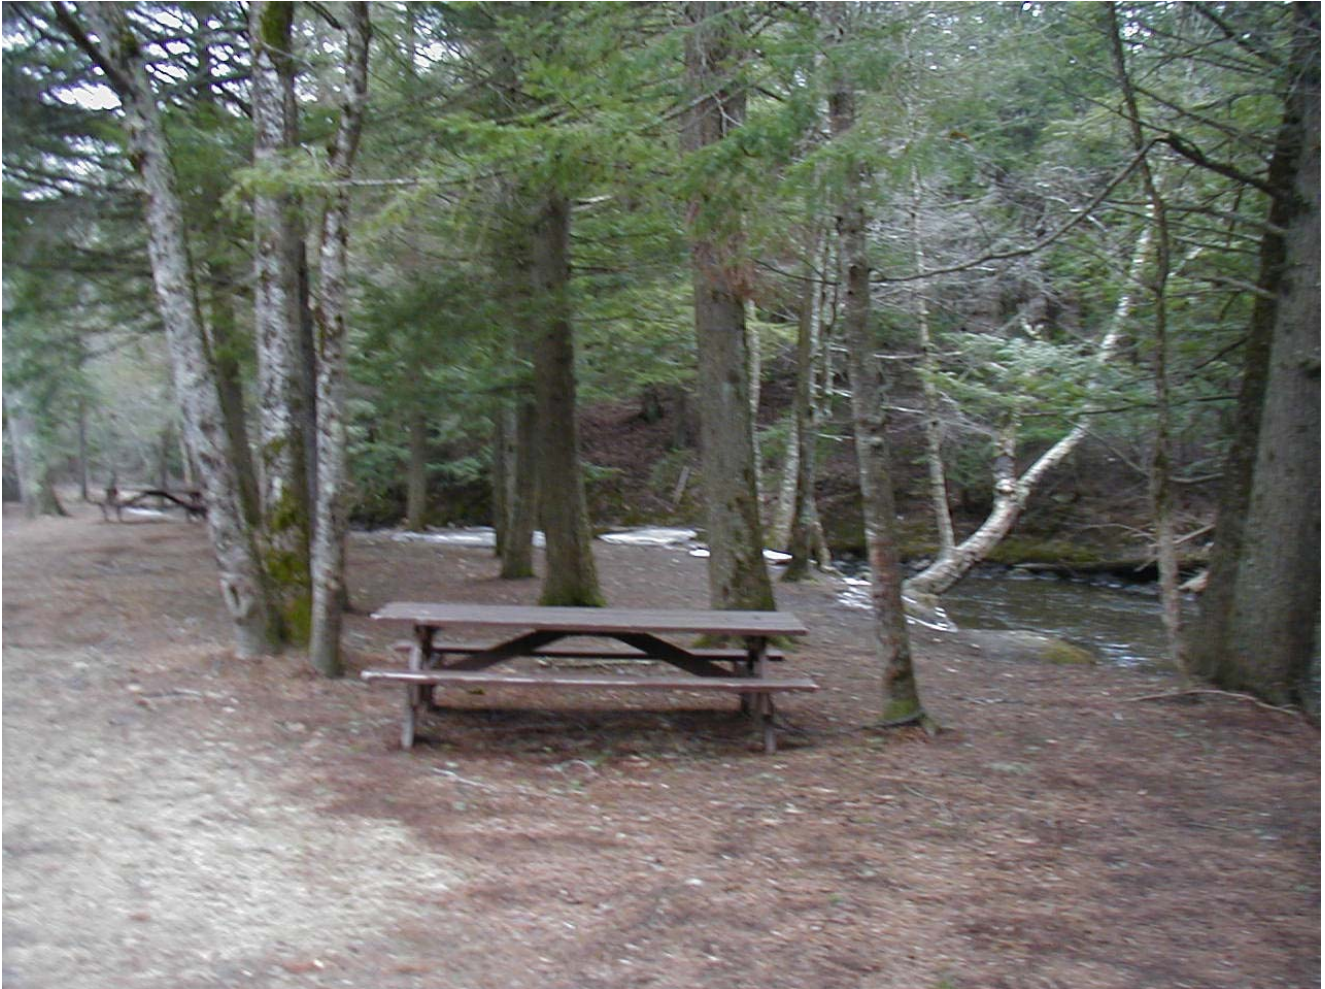
**Site 2:**

**Site Name:** Newton Brook Rest Area

**Location:** Route 2, Dixfield

**Existing Conditions:** This site is located on Route 2 adjacent to Newton Brook. This rest area provides parking, picnic tables and outhouse facilities to the traveling public. The site has lost most of the under story riparian plantings, but maintains an established over story of evergreen and deciduous trees. It appears that there is active foot traffic along the embankment of Newton Brook. There is a what appears to be, small gravel portage boat launch at the northern end of the rest area. The brook often floods up to and sometimes over Route 2 in this area during spring melt and severe storm events. Repeatedly, the brook washes out portions of the rest area parking lot.

**Mitigation Potential:** This project will restore the riparian under story along Newton Brook and provide public access points at specific locations. Large natural rock bollards will be placed to direct ice flows away from the new plantings. There appears to be a possibility to eliminate the portage boat launch at the northern end of the parking lot where storm water enters and floods the parking lot. Natural rock bollards will again be installed along with riparian vegetation in this area.

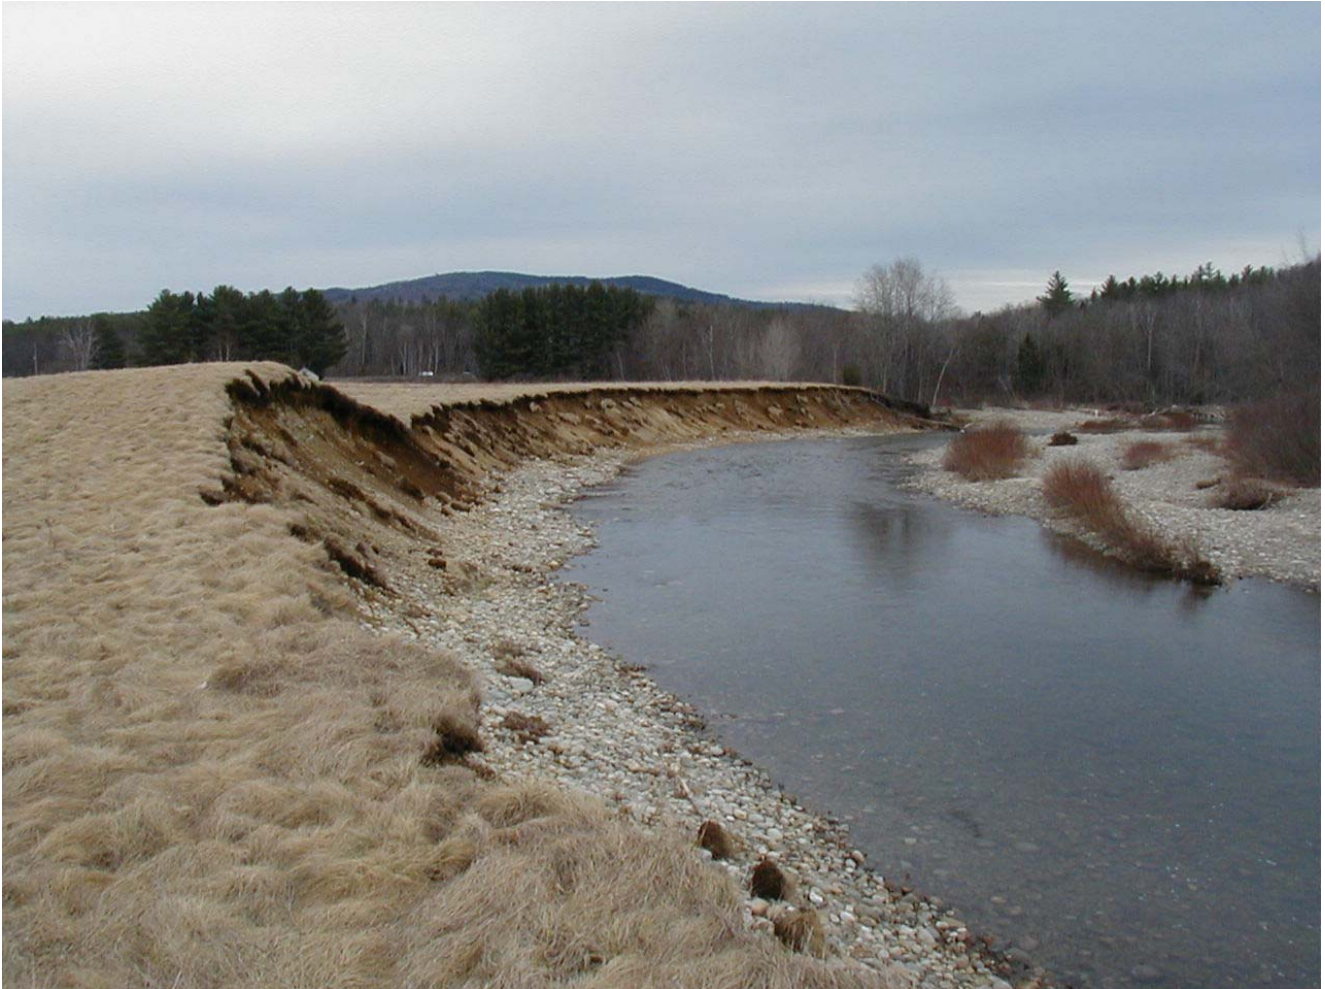
**Site 3:**

**Site Name:** Bear River Site  
**Location:** Newry  
**Owner:** Robert Chadbourne

**Existing Conditions:** This site is a large cut bank on the Bear River near the confluence with the Androscoggin River. The site is approximately 600' long and is migrating approximately .6 feet per year toward Route 26. The road is roughly 110' from top of bank. The bank appears to be relatively stable with minimal undercutting. Embankment angle of repose has no vegetation established.

**Mitigation Potential:** Restoration work will consist of installing riprap on the downstream 200 feet of eroded bank, as this appears to be the area changing most rapidly. Work will include re-grading the top of the bank back to a 1.5:1 or flatter slope, and install native stoloniferous vegetation on the upper areas of the eroded slope.

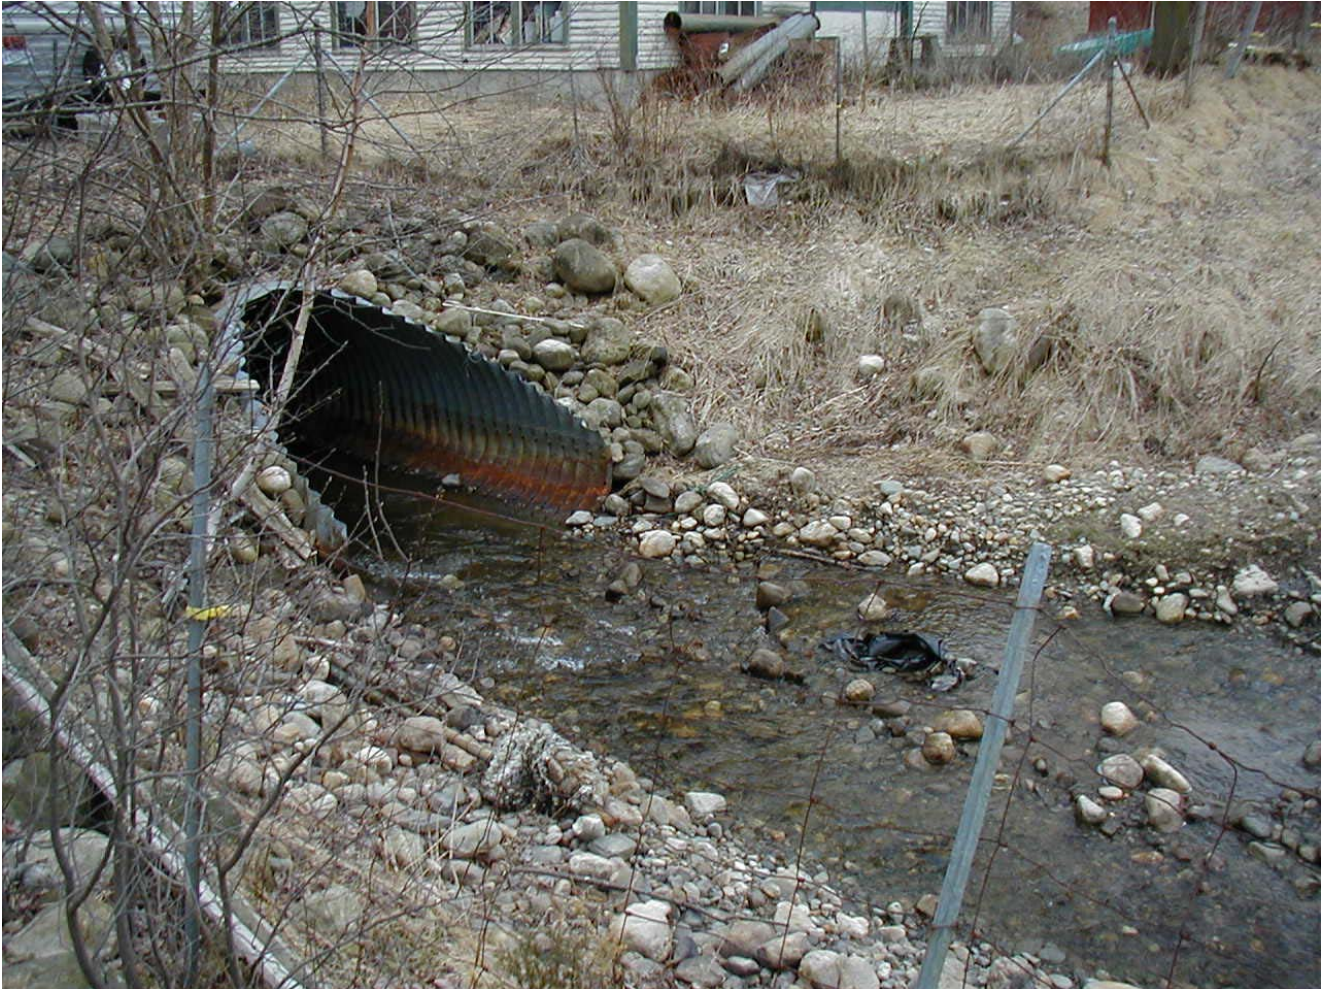
**Site 4:**

**Site Name:** Hall Farm Site

**Location:** East Dixfield

**Existing Conditions:** Located where Potash Brook crosses Route 2 through a large culvert and empties into Seven Mile Stream. This culvert is conveyance for Potash Brook under Route 2 and acts as a cattle pass to grazing land on the opposite side of the road. A substantial amount of eroded material has deposited in the culvert. Periodic maintenance has been necessary to clean out the pipe. Water quality issues are of concern, and NRCS has made several attempts to correct the situation.

**Mitigation Potential:** Mitigation will consist of eliminating the use of the cattle pass by installing a farm well near the outbuildings for cattle use. This would also include stabilizing the eroded embankments along Potash Brook with vegetated riprap. NRCS is currently negotiating with Mr. Hall on this proposed restoration project.

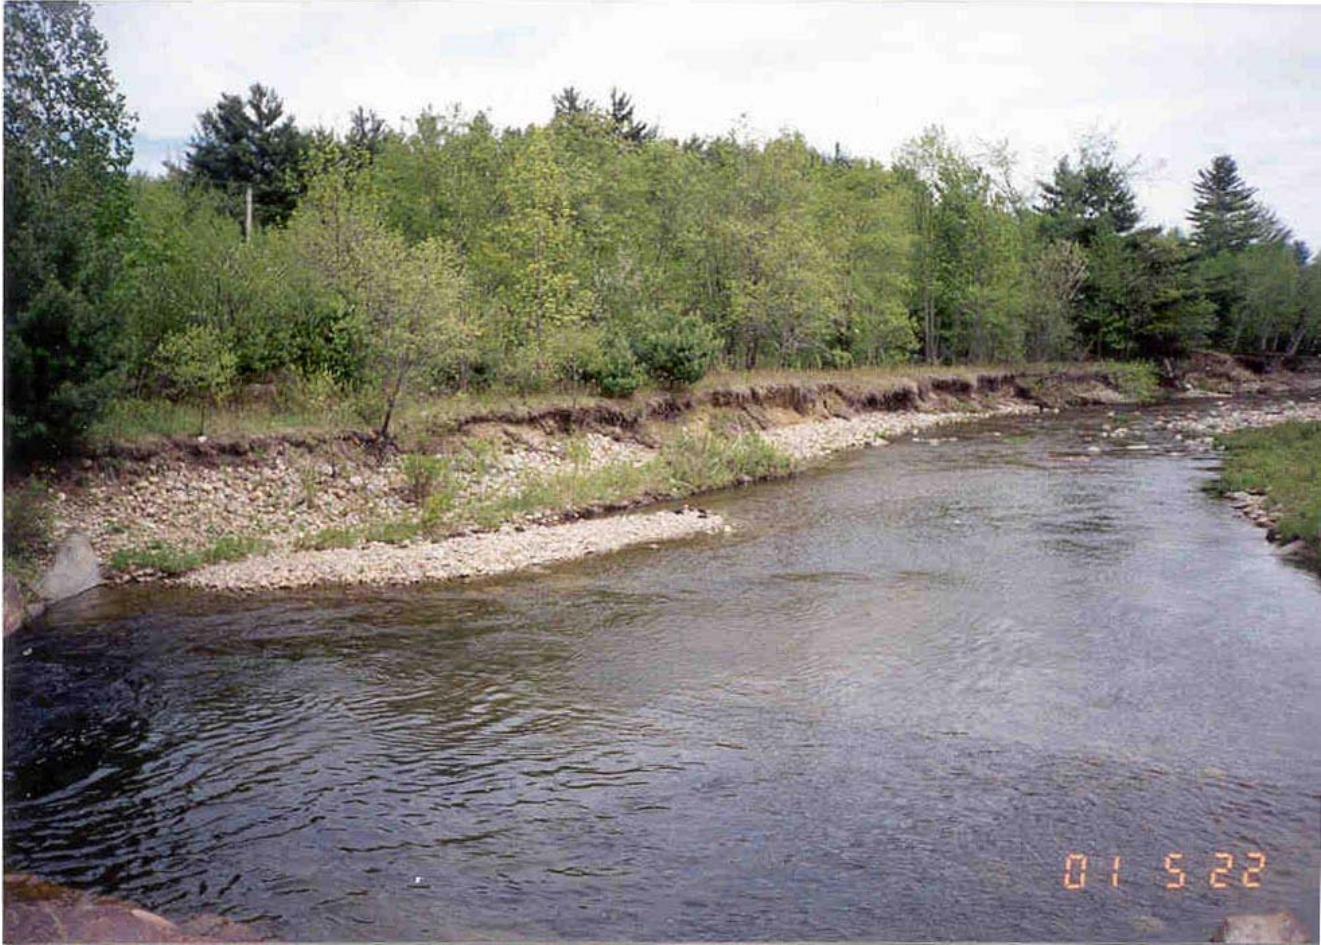
**Site 5:**

**Site Name:** Sevenmile Stream Site

**Location:** North Jay

**Existing Conditions:** Located in North Jay on Route 17. This site was recommended by Jeff Varricchione of MDEP and consists of an area where gravel was mined out of Sevenmile Stream. The area currently appears to have lost much of its fish habitat, with evidence of channel aggradation, degradation, widening and planimetric adjustments. There are no undercut banks, deep pools, or shading/cover present in this area.

**Mitigation Type:** Mitigation work will consist of re-grading the eroded embankment to a 3:1 slope in this 300 foot reach, and planting native stoloniferous vegetation. Work will also include the installation of J-hook vane structures or pool diggers to encourage deepening the channel to provide habitat for fish and aquatic invertebrates.

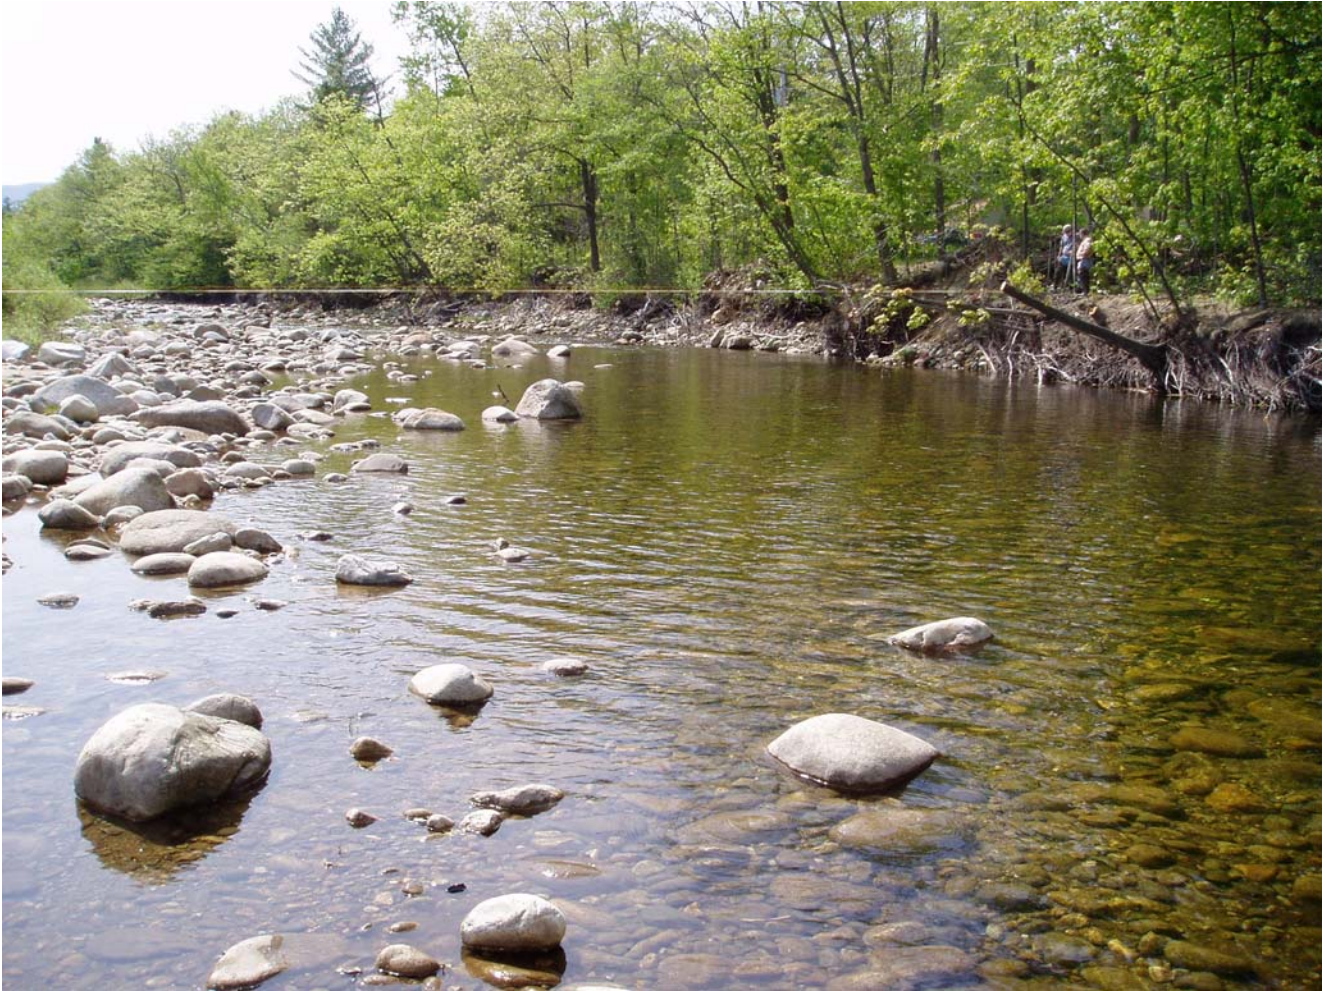
**Site 6:**

**Site Name:** Sunday River

**Location:** Newry

**Existing Conditions:** Located on the Sunday River Road. This site was recommended by the Sunday River Watershed Assessment Study, and consists of an area where excessive river bank erosion is occurring on an outside bend. The area has lost much of its riparian habitat and is currently threatening the road. The river is over widened in this location with a high width to depth ratio.

**Mitigation Type:** Mitigation work will consist of providing permanent stabilization of the river embankment in this 400 ft reach. This would include: installing J-hook vane structures to move the thalweg away from the river/road embankment; using bioengineering techniques; narrowing the channel to enhance sediment transport; and restoring the riparian plantings.
