On April 14, 2011, Scott Herman from Cold Mix Manufacturing Corp. demonstrated his company's Green Patch pothole patching product. The demonstration took place at MaineDOT's Western Region Maintenance yard and on a portion of US Route 2 near the office.

GreenPatch™ COLD MIX ASPHALT PRODUCT, Demonstration, Dixfield, ME

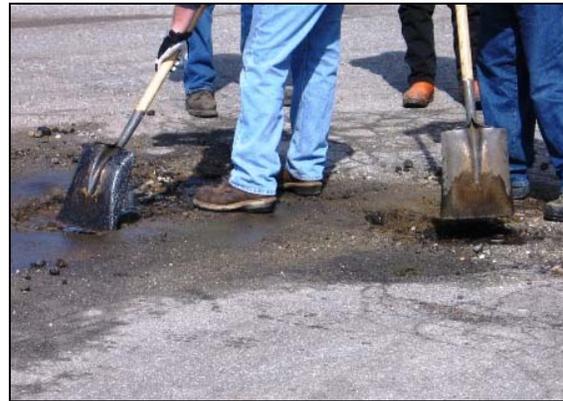
The crew prepared the potholes by first squaring off the edges of the hole and removing excess material from the holes. According to Scott, it is not necessary to completely remove all standing water prior to the Green Patch placement. The key is to confine the material within the hole.

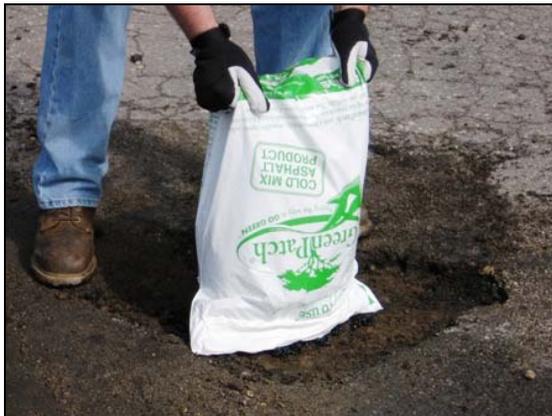
Green Patch is available in ready to use 50, 60, and 80 pound bags, by the ton, or in a liquid form ready to be mixed with aggregate onsite in a pugmill. Green Patch uses 40% recycled asphalt and contains no VOCs up to 650°. Instead of petroleum-based oils, only plant oils are used. According to the manufacturer, Green Patch can even be removed and re-used.

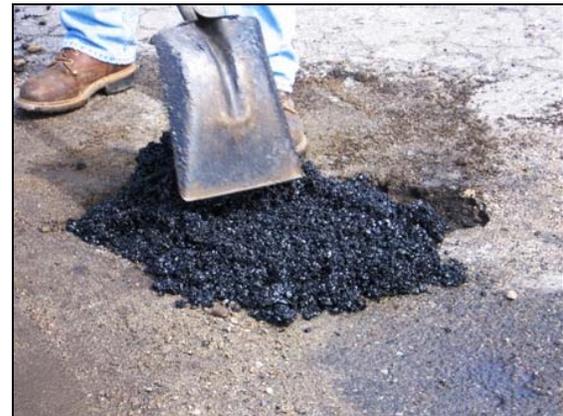
Initially, there was considerable consolidation of the material in the bags. Once the bags were loosened up a bit by striking on the ground (think: solidified bags of ice), the material seemed to "flow" out of the bags giving the appearance of hot mix asphalt. The material appeared to be very easy to work with and any clumps were easily broken up with the shovel point.

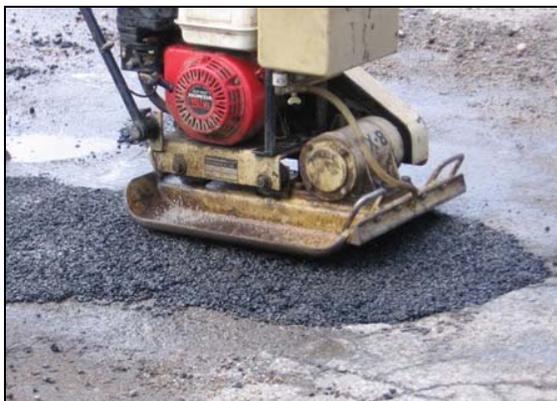
The material was left with a slight crown to allow water to shed off the patch. A plate vibratory compactor was used for the demo, but in the field compaction from a vehicle tire should prove adequate according to the sales representative.

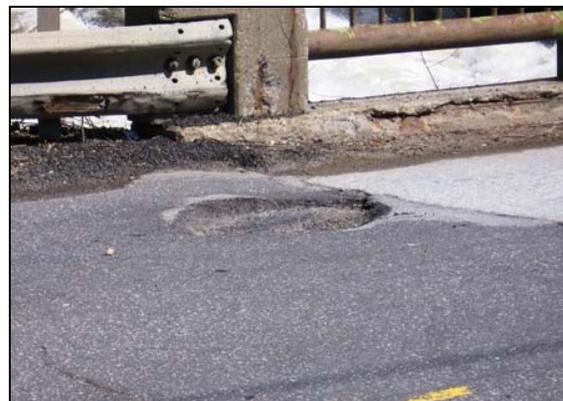
Following the demonstration in the yard, the material was used on some highway potholes. This particular pothole was an extreme example. While the adjacent pothole is scheduled to be replaced soon, patching a pothole of this magnitude now is critical.

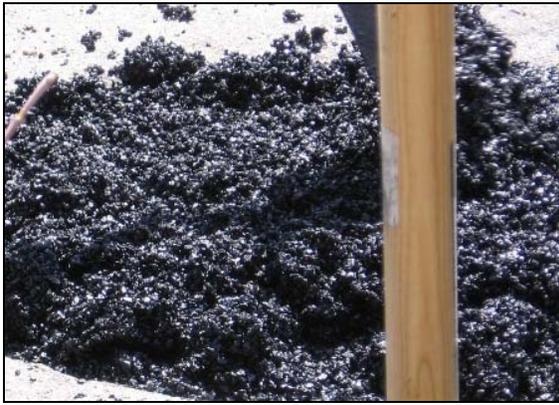
Here, loose material is being placed in the "crater." Three 50 pound bags were required for this one pothole alone. The intent of using bagged high-performance mix is not for every pothole, but rather the persistent potholes that require frequent repairs by crews. The hope is twofold: to cut down on material costs and reduce the crews' exposure to traffic.

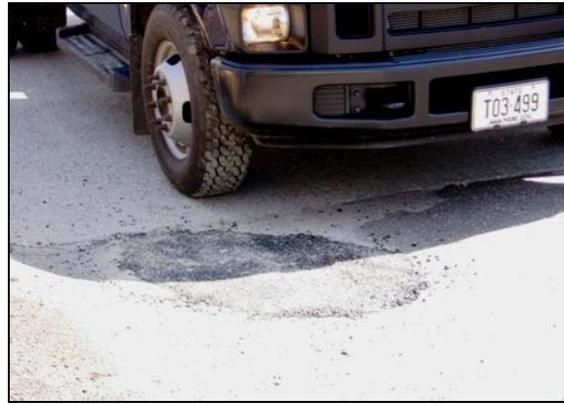
The material was compacted first with a hand tamper, and then by the Crew's truck. Several passes are made over the patch with each pass moving from side to side giving downward compaction along with the kneading action of the rubber tire.

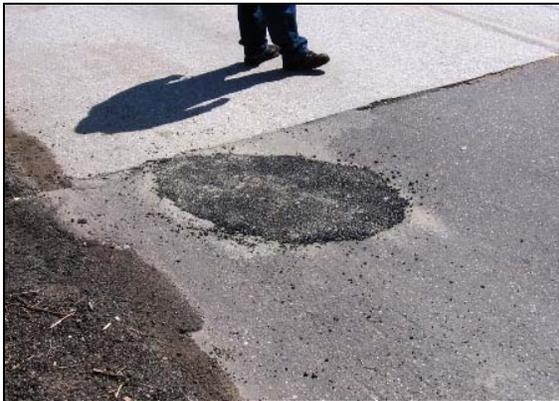
The repair nearly ready for traffic. The work involved in a high performance repair like this one is much more than for the typical "throw and go" method, but the hope is for a more durable, nearly permanent repair.

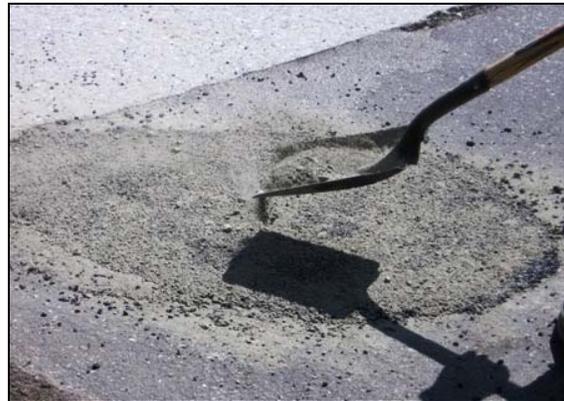
As a final touch, dry Portland cement is applied to the finished patches. This serves to hasten the setup time of the repair and acts as a de-tackifier to help reduce pickup of patching material by vehicles.
