# South Bog Stream Brook Trout Habitat Restoration

FISHERY INTERIM SUMMARY REPORT SERIES NO. 08-02  
SOUTH BOG STREAM BROOK TROUT HABITAT RESTORATION

SOUTH BOG STREAM BROOK TROUT HABITAT RESTORATION  
INTERIM SUMMARY REPORT NO. 3 (2003-2007)

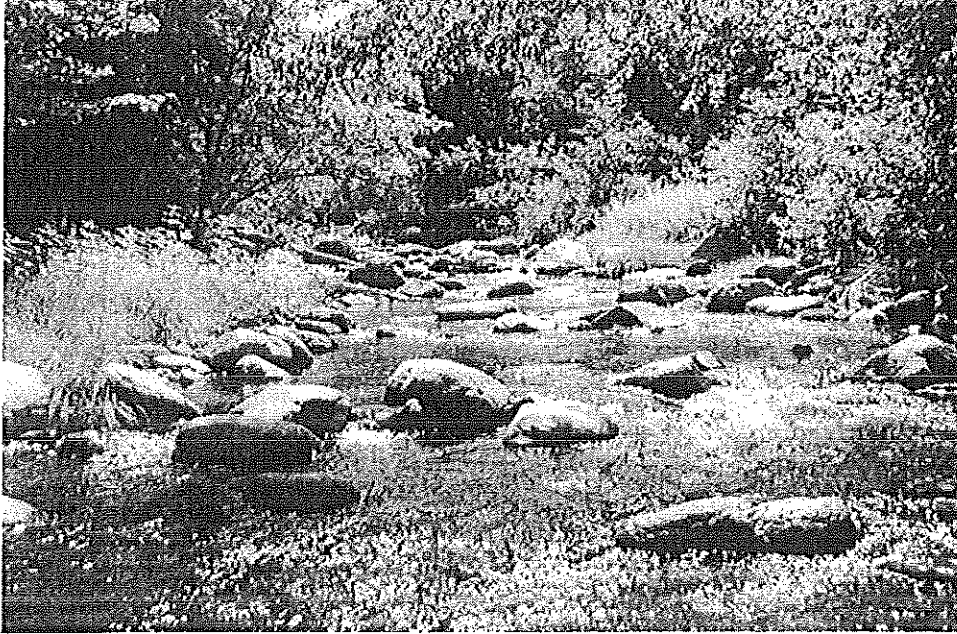
**Appendix C**  
Photos of Transects

Transect 1 (control) looking upstream, 2007.

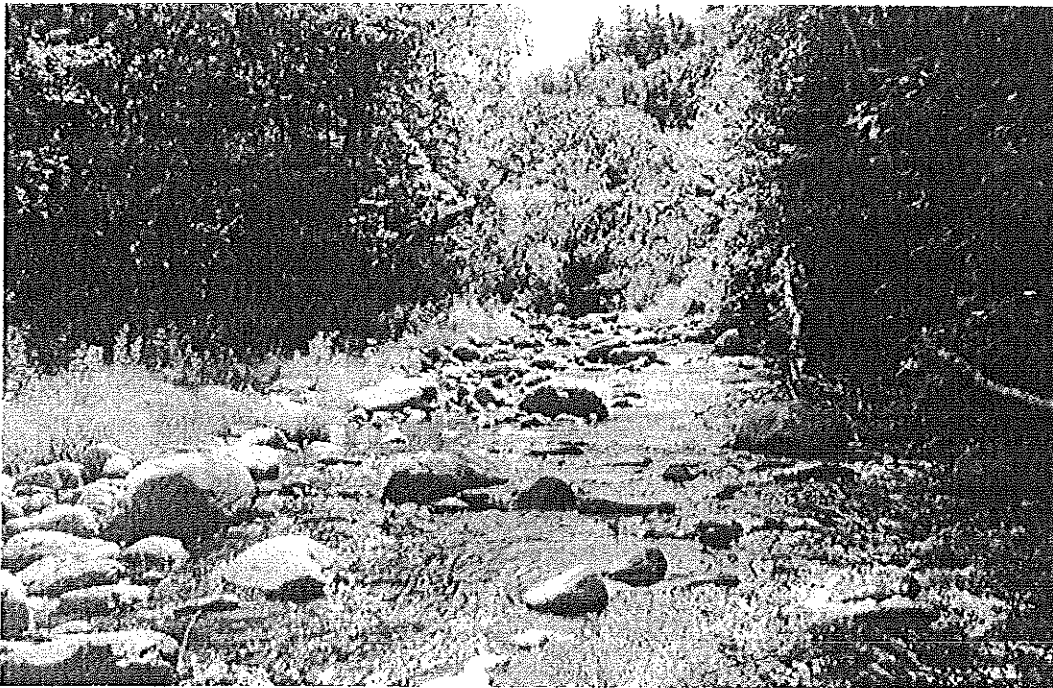
Transect 2 (control) looking upstream, 2007

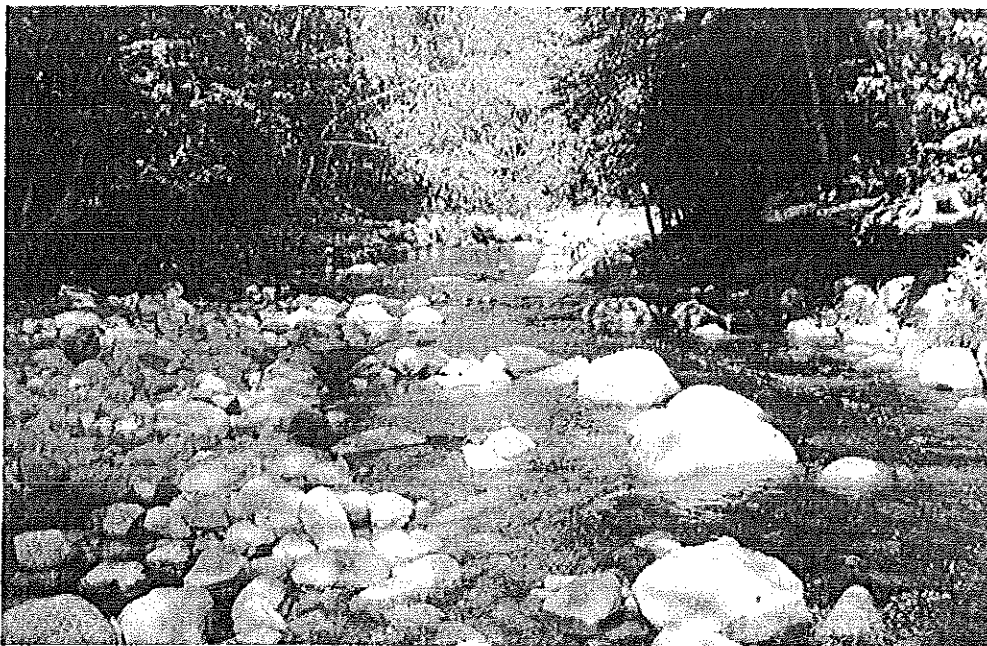
Transect 2 (control) looking downstream, 2007. Upper project area visible in distance.

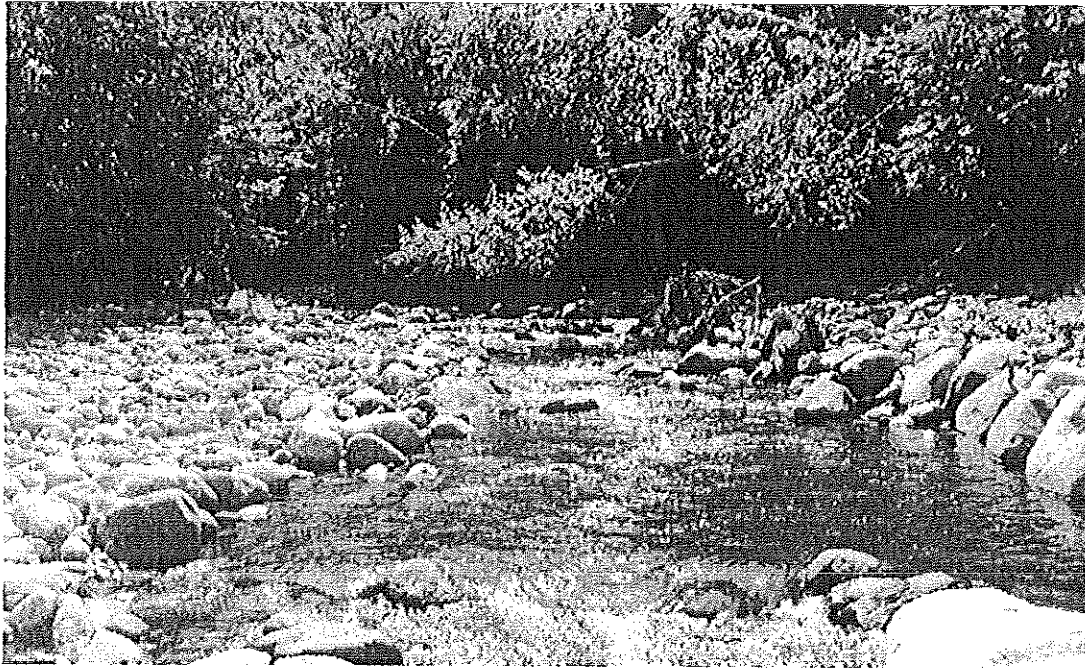
Transect 4 looking upstream, 2007, showing riffle/pool sequence.

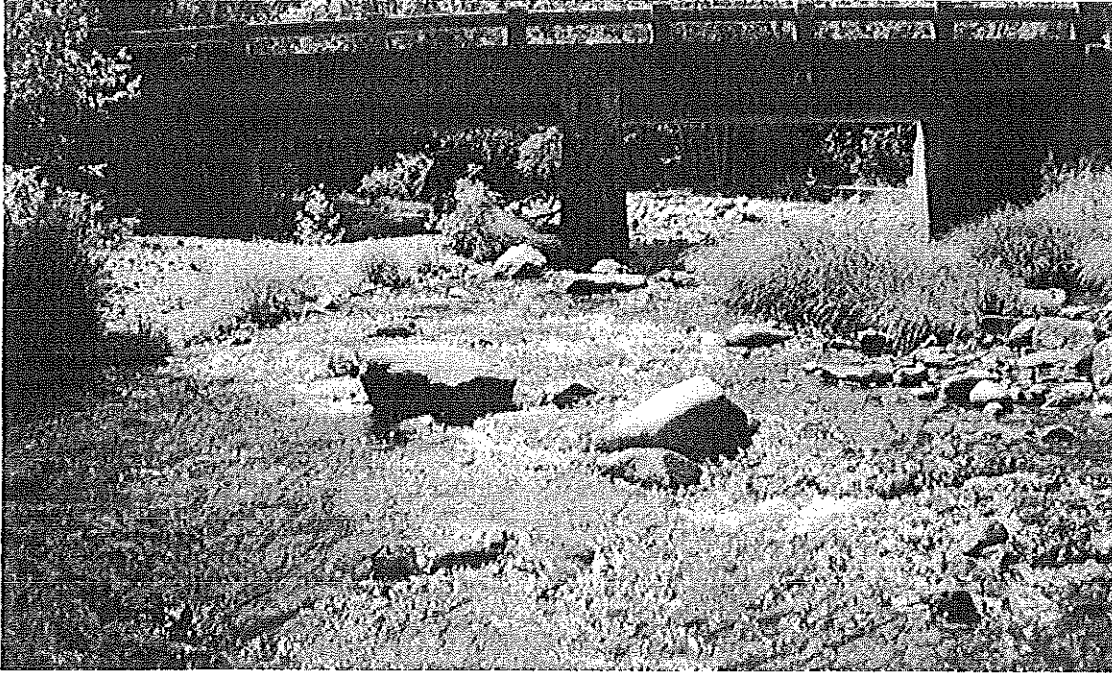
Transect 5 (control) looking upstream, 2007.

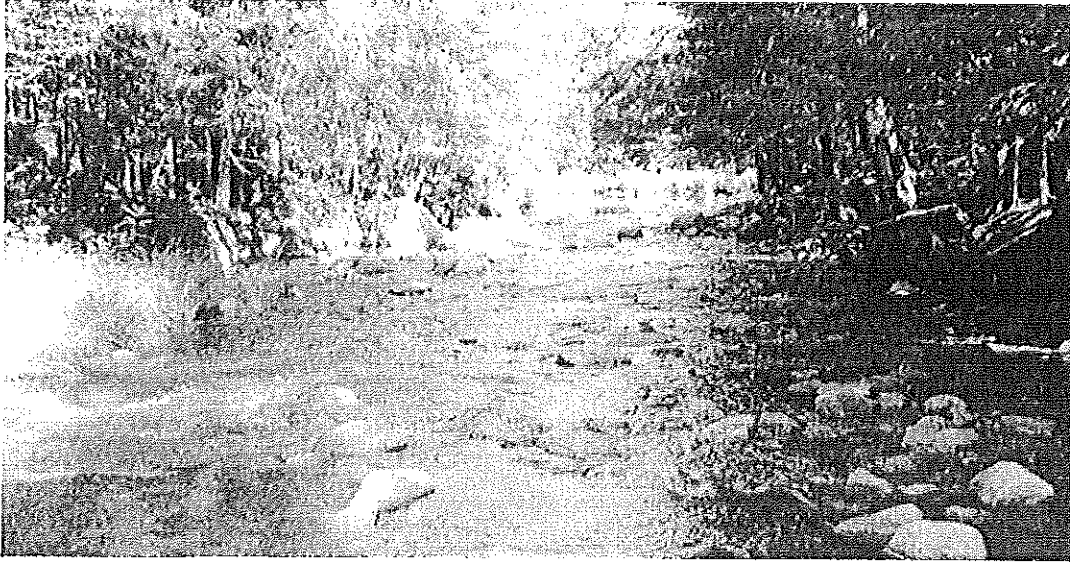
Transect 15 looking upstream, August 2007, prior to construction of Weir No. 2. Several log deflectors, including ice-damaged structure on right, are visible.
